**AN ASSESSMENT OF THE MARINE BIOLOGICAL
COMMUNITY STRUCTURE IN THE VICINITY OF THE PROPOSED
KAPALAMA CONTAINER TERMINAL
HONOLULU, HAWAI'I**

**State of Hawaii
Department of Transportation
Harbors Division**

October 15, 2012

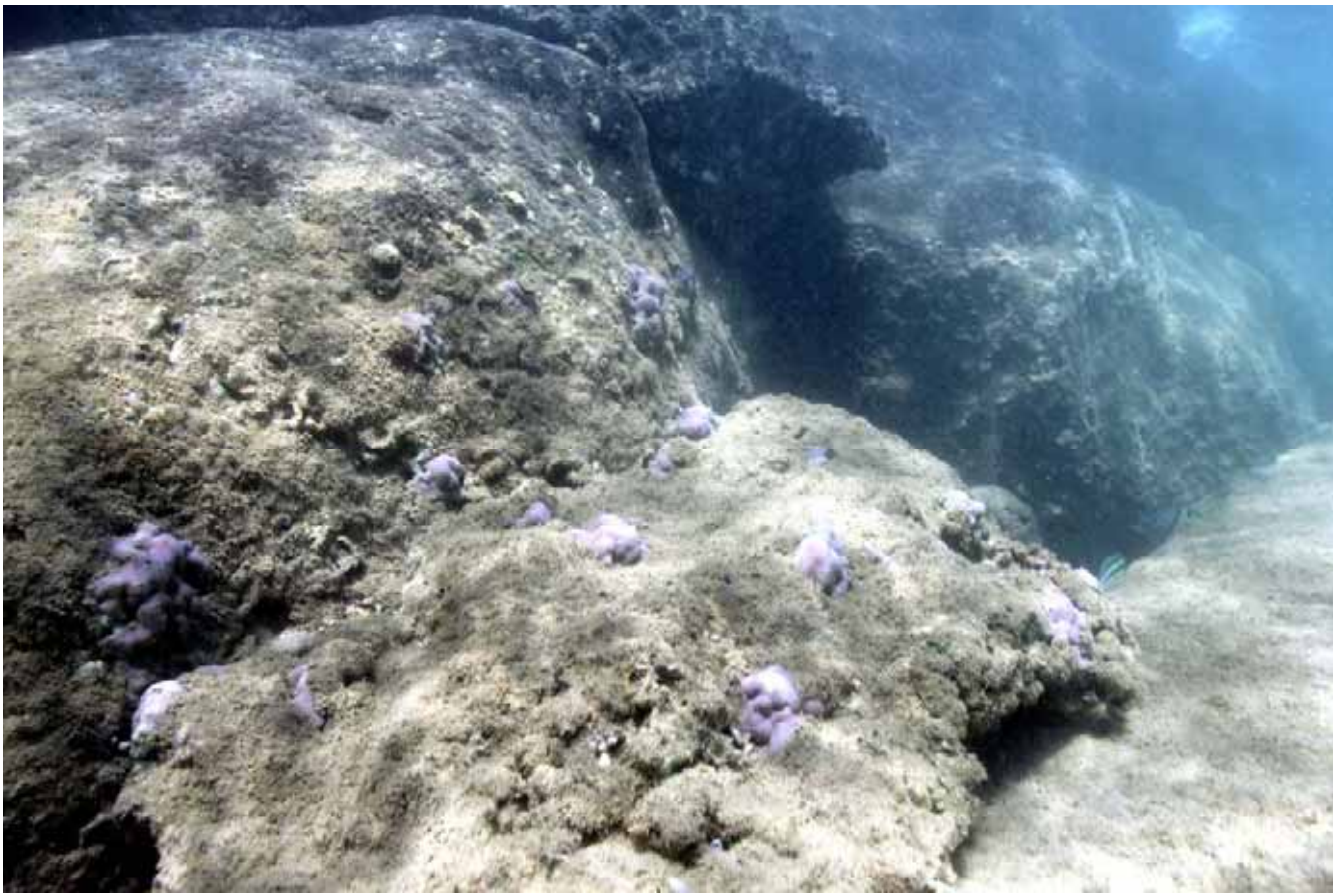
FIGURE 8. SECTOR A. Colonies of *Porites lobata* on the edge of the dredged channel wall of Sector A-1. Numerous small blue colonies were abundant throughout Sector A (top). Sediment covers all sides of larger colony in lower photo. For location of Sector A-1, see Figure 3.

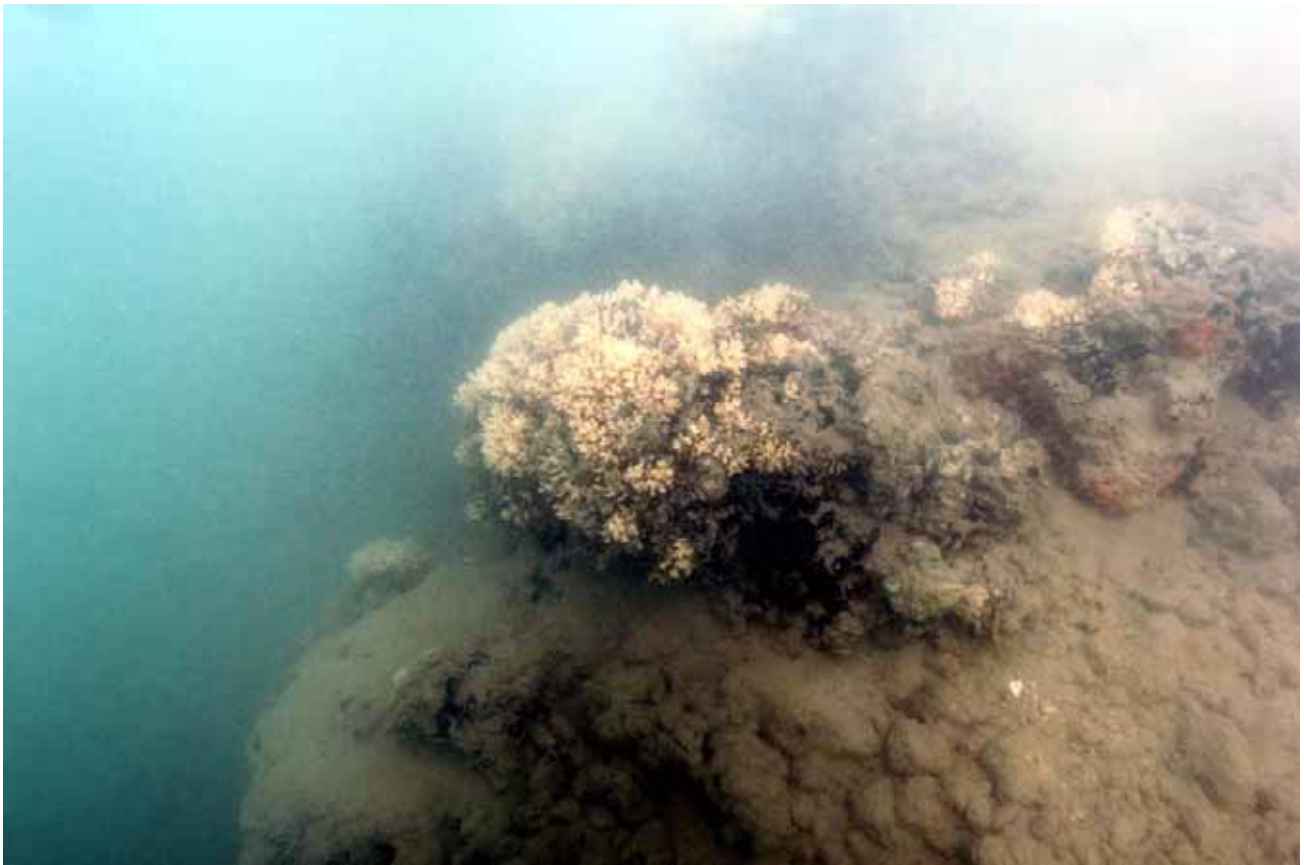
FIGURE 9. SECTOR B. Colonies of *Pocillopora damicornis* on the edge of the dredged channel wall of Sector B-2. Note extensive cover of fine-grained silt-mud over entire shelf and slope surface. For location of Sector B-2, see Figure 3.

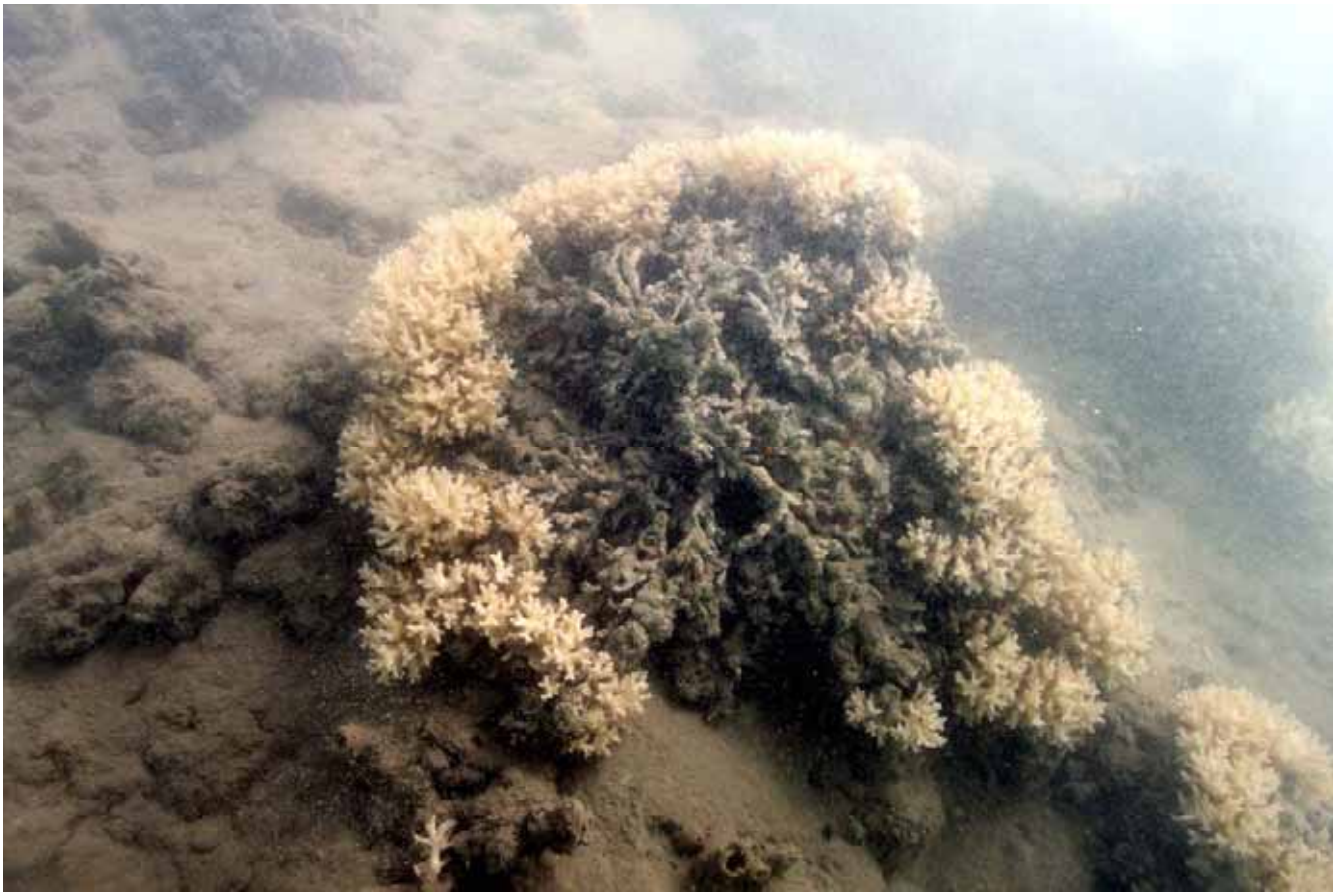
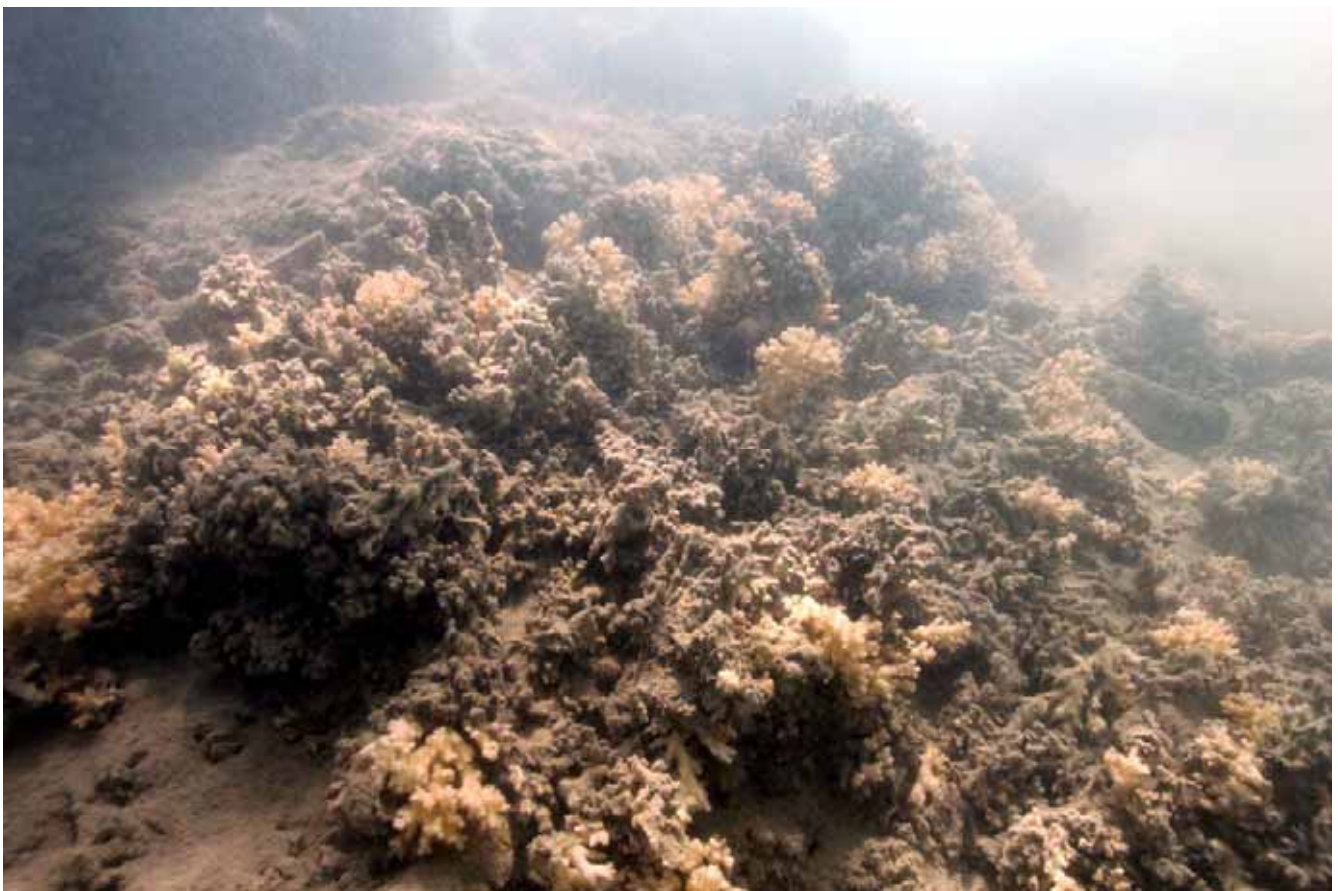
FIGURE 10. SECTOR B. Colonies of *Pocillopora damicornis* on the edge of the dredged channel wall of Sector B-1. In both photos, portions of the colonies are dead and encrusted with coralline algae. In both photos, it is not apparent if the living portions of the colonies are remnants from older larger colonies that have suffered partial mortality, or smaller individual colonies that have recolonized the older skeletal structure. For location of Sector B-1, see Figure 3.

Eleven species of coral were encountered over the course of the survey. Size-class counts of colonies in each sector are shown for eight species in Table 4 (3 species had observations of less than 5 colonies). Pooled data for each species in each size-class is shown in Table 5. When all sectors are pooled, the species with the most colonies is *Pocillopora damicornis* (1,840), followed by *Leptastrea purpurea* (1,497) and *Porites lobata* (1,039). These three species account for about 85% of the total observed colonies. *Pocillopora damicornis*, which occurs in a finely branching growth form, is restricted to habitats with limited wave stress. In Hawaii, such areas are primarily wave-protected embayments, where sedimentation is often high. The proliferation of this species throughout every sector of Kapalama Basin indicates that this species is indeed adapted to high sediment areas. In particular, the large coalescing colonies occurring on the dredged platform of Sector B are likely one of the densest populations, along with the largest colonies of this species found on Oahu (Figures 10-

11). Many of the large coalesced colonies of *P. damicornis* were observed with dead patches encrusted with calcareous algae. However, these areas also contained multiple small colonies that were either remaining living remnants or new recruits on available hard substratum (Figure 10).

Of particular interest are the observations that in several survey areas there were skeletal remains of large colonies some of which contained what appeared to be new recruits, and some of which were completely devoid of coral. Such colonies were apparent for large colonies of *P. damicornis* at Sector B (Figure 10) and *Montipora* spp. at Pier 26 (Figures 40-42). The relevance of these observations is

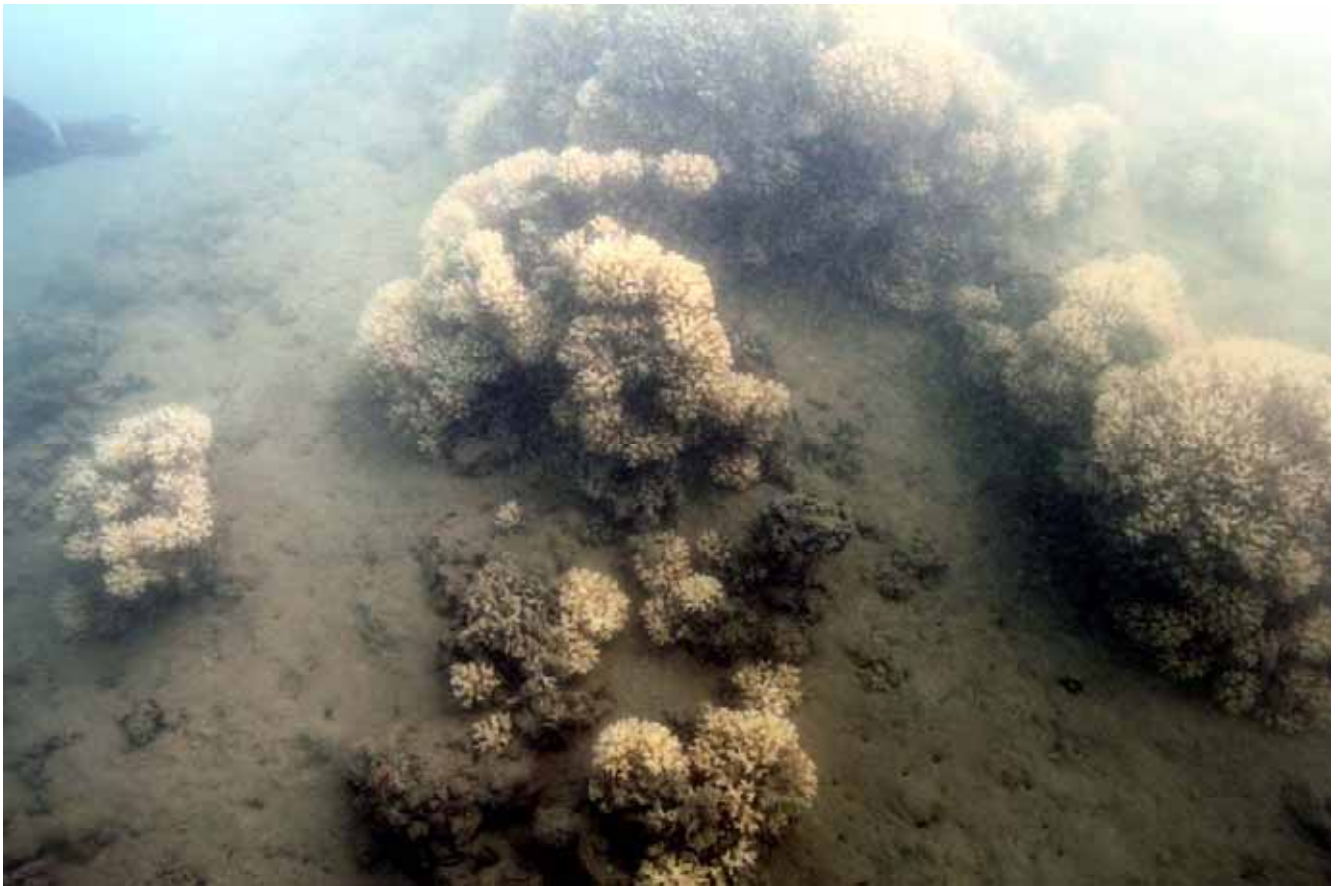
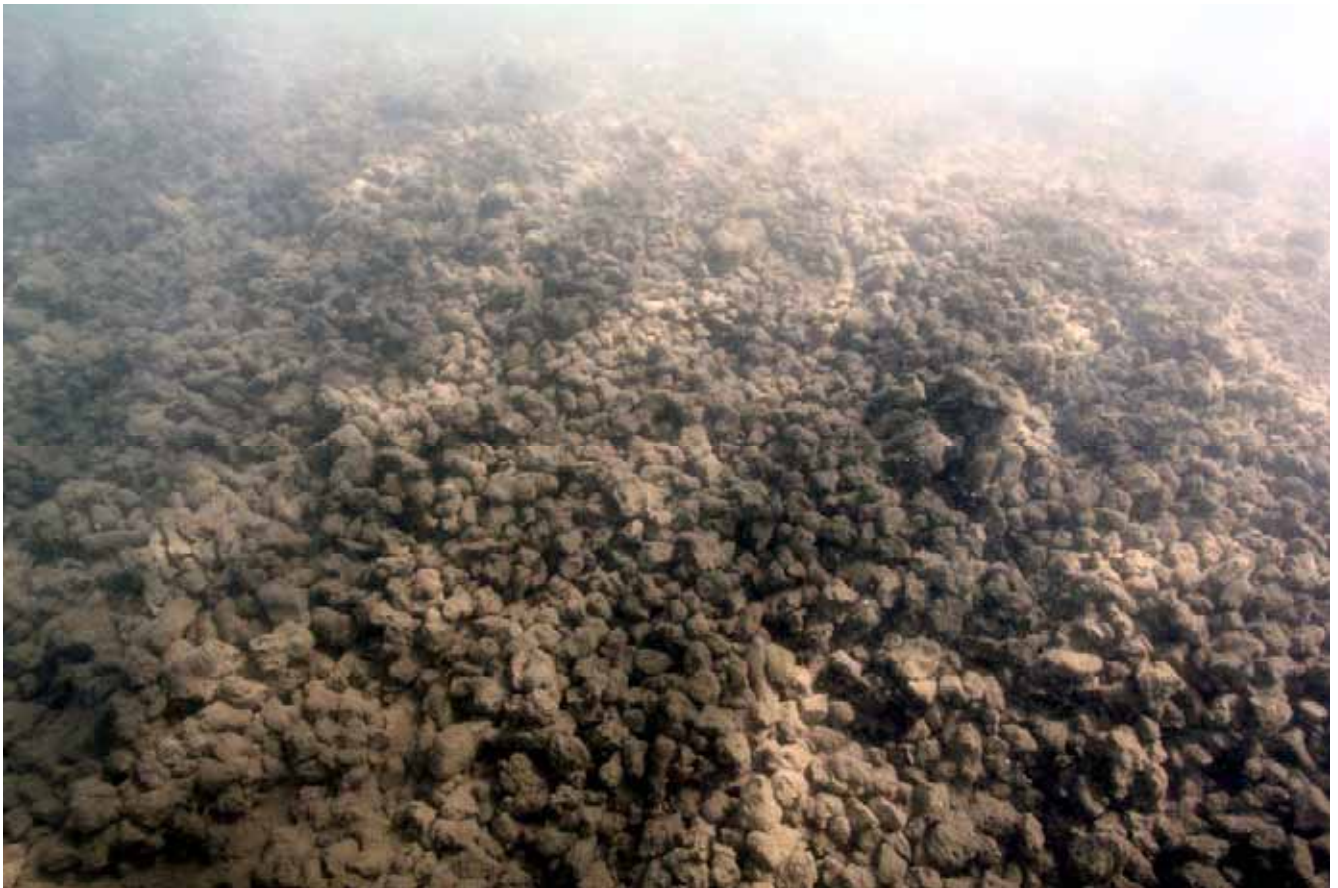
FIGURE 11. SECTOR B. Clustered colonies of *Pocillopora damicornis* on the top of the dredged channel shelf of Sector B-3. Bottom photo shows rubble bed that covers much of the top of the dredged channel shelf of Sector B-4. Colonies of *P. damicornis* were far less abundant in Sector B-4 compared to Sectors B1-3. For location of Sectors B-3 and B-4, see Figure 3.

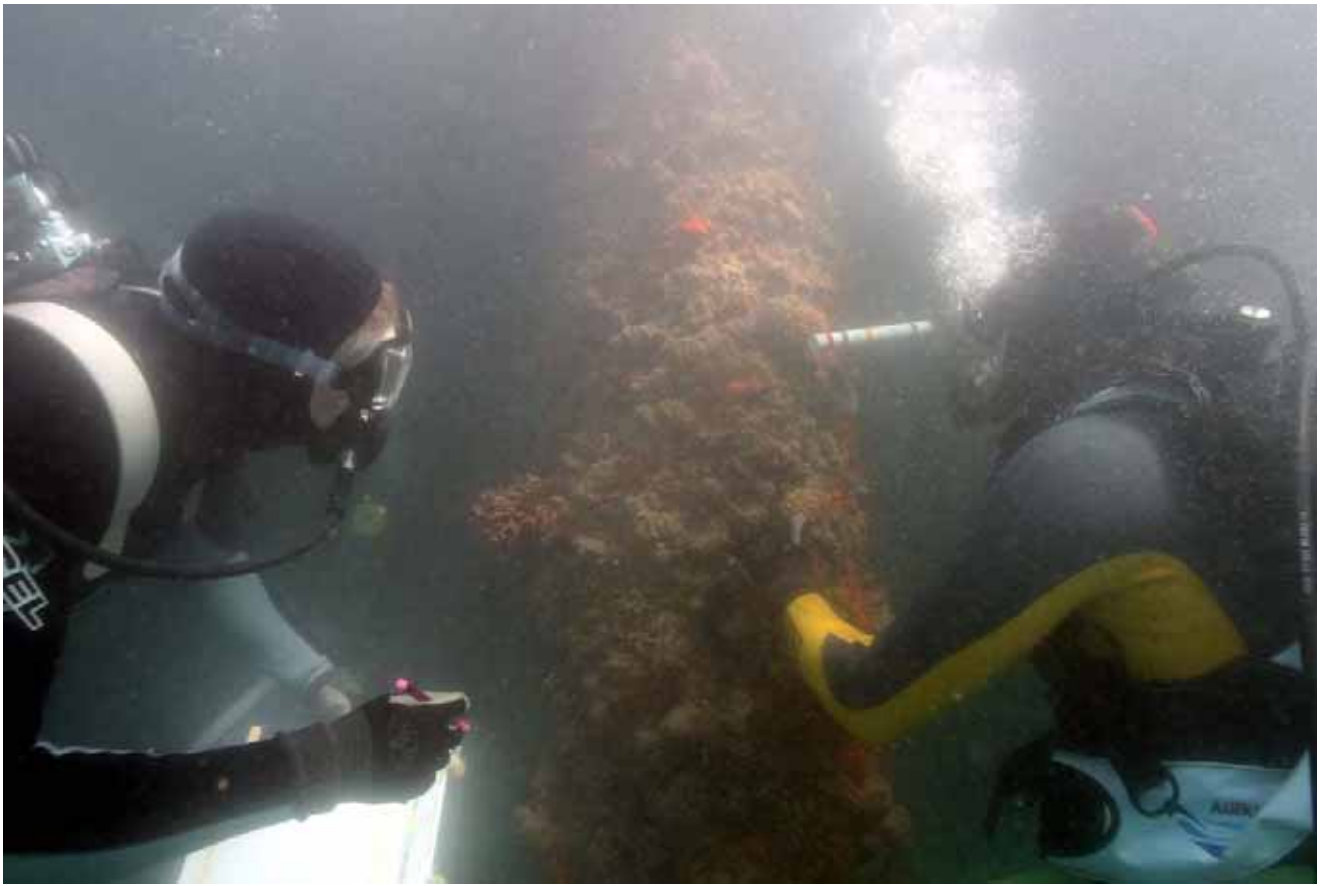
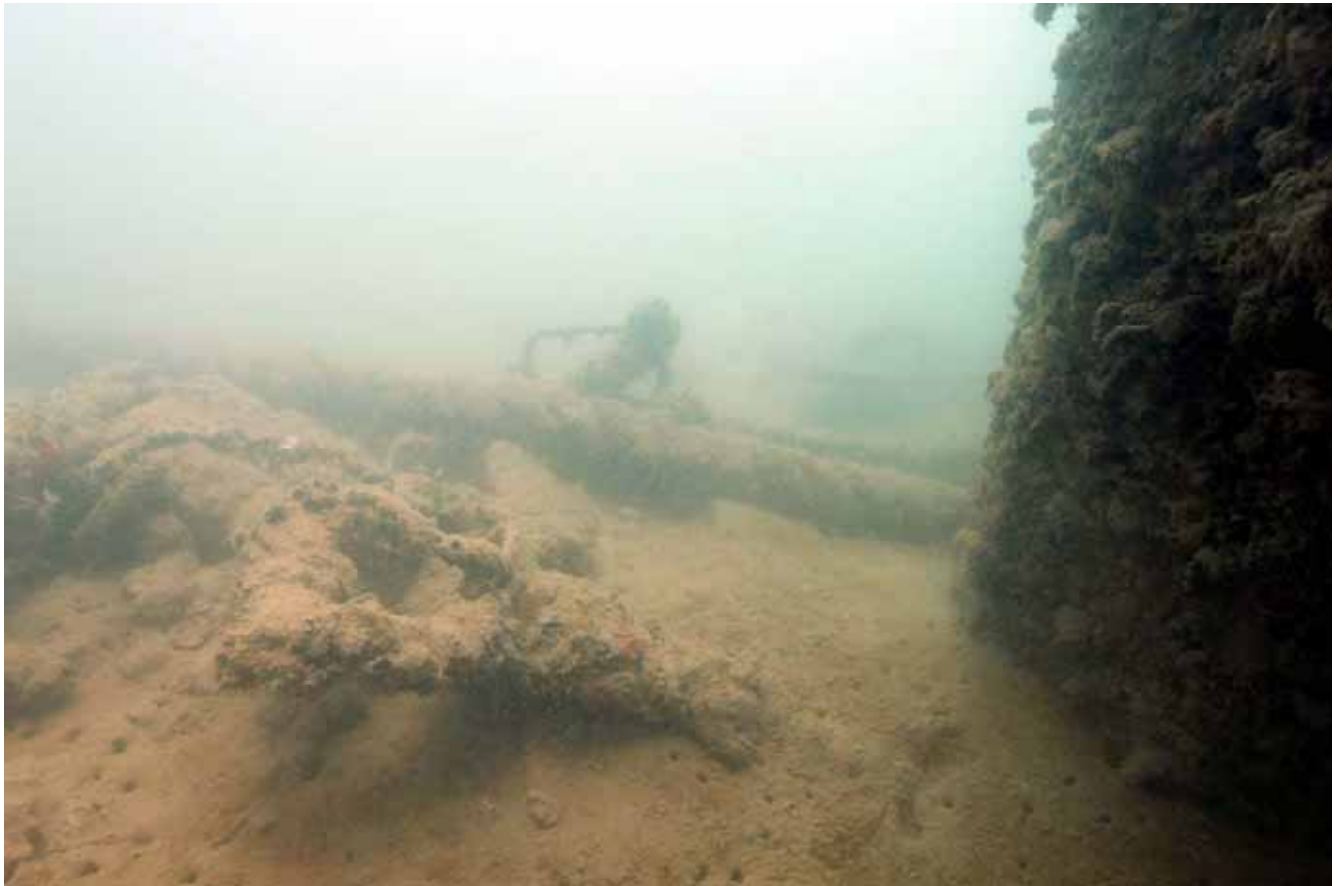
FIGURE 12. SECTOR C. Divers conducting benthic surveys measuring and recording size-class of corals on vertical pilings of Sector C-1 using rod marked with size class designations (top). Juncture of piling and sediment surface along with discarded debris on floor of Snug Harbor (bottom). For location of Sectors C-1, see Figure 4.

The floor of the entire Harbor adjacent to all survey sites within Kapalama Basin consists of deposits of fine-grained silty mud that is pocked with openings from burrowing fauna. Throughout the Harbor, extensive metal and wood debris was noted on the harbor floor adjacent to piers (Figure 12). Observations of the Harbor floor throughout the survey area revealed no colonization by corals or other macro-benthos on the mud surface.

The physical structure of Sectors C, D, E, I, J, consist of square concrete pilings (0.489 m dimension of each side) that extend into the mud comprising the Harbor floor (Figure 12). Most of the surface area of the pilings not covered by living biota is encrusted with remnant mollusc shells. The coating of mollusc shell forms the settlement substratum for other invertebrates. Figures 13-20 provide views of concrete piles located in Sector C, along with typical colonizing organisms. In Sector D the vertical piles support a submerged horizontal concrete slab that supports the pier structure. As with the vertical piles, the horizontal slab is fully encrusted with remnant mollusc shells and living invertebrates (Figure 21).

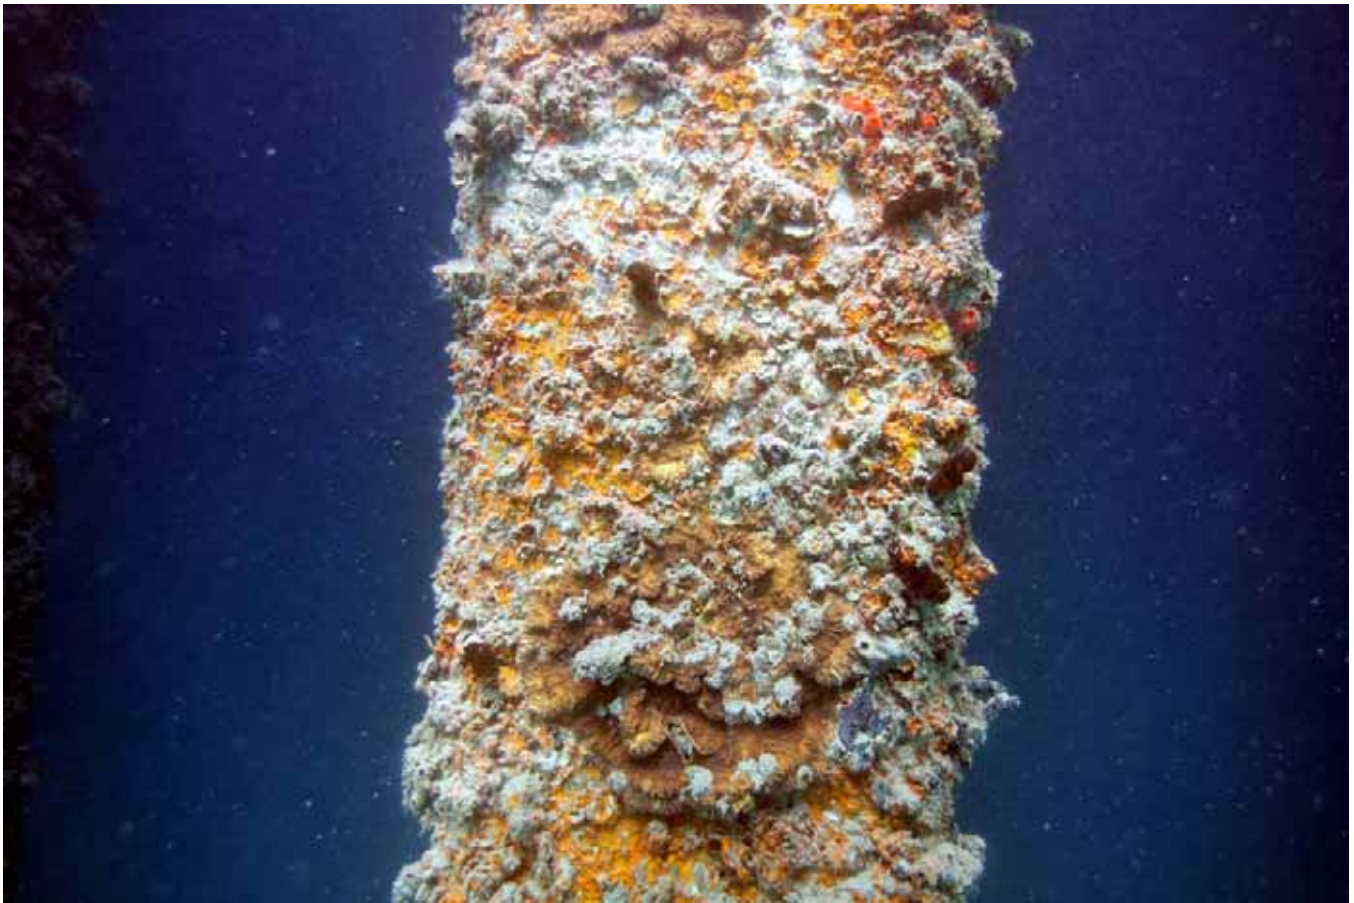
FIGURE 13. SECTOR C. Typical invertebrate colonizers on pilings comprising Snug Harbor include orange colored sponges *Mycale armata* (top) and *Dactyospongia* sp. (bottom). Piling in bottom photo is also encrusted with the coral *Pavona varians*. For location of Sector C, see Figure 4.

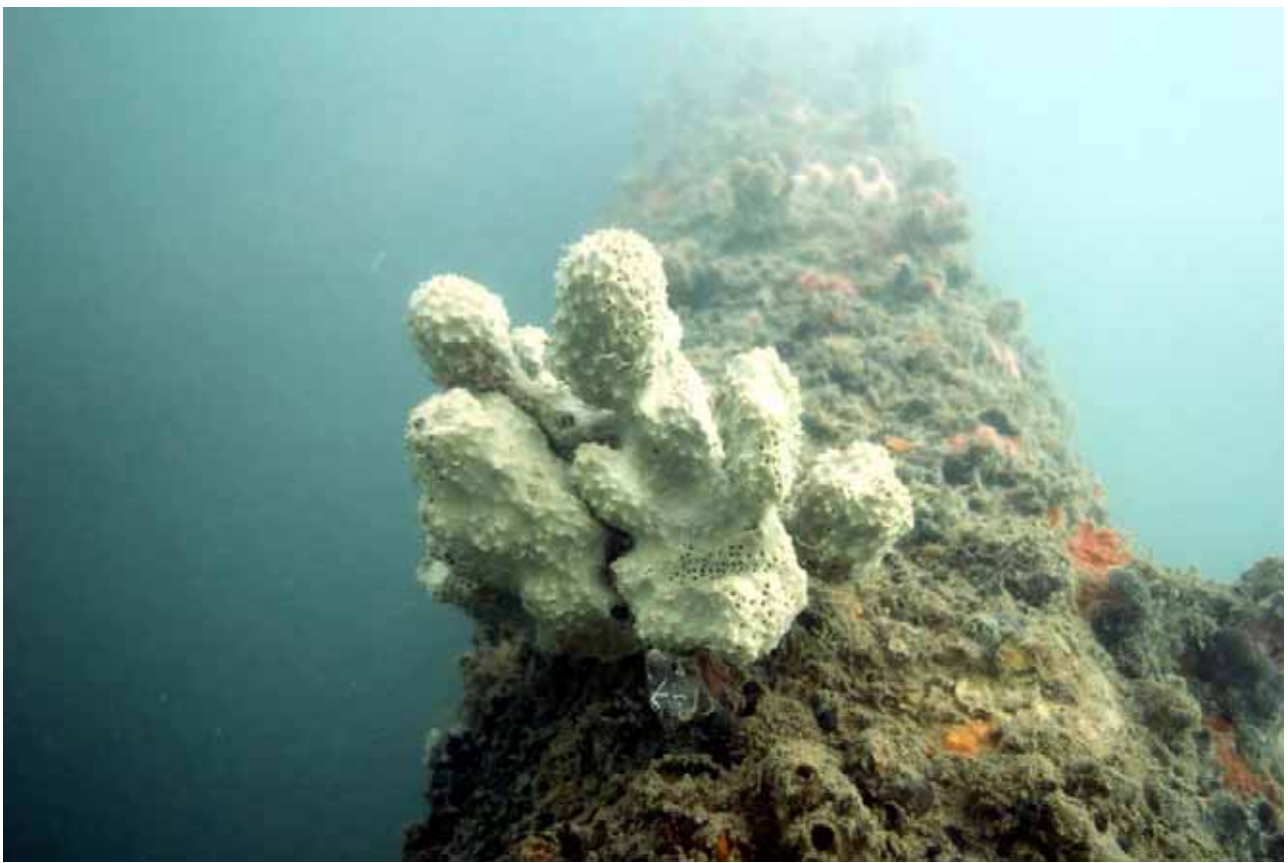
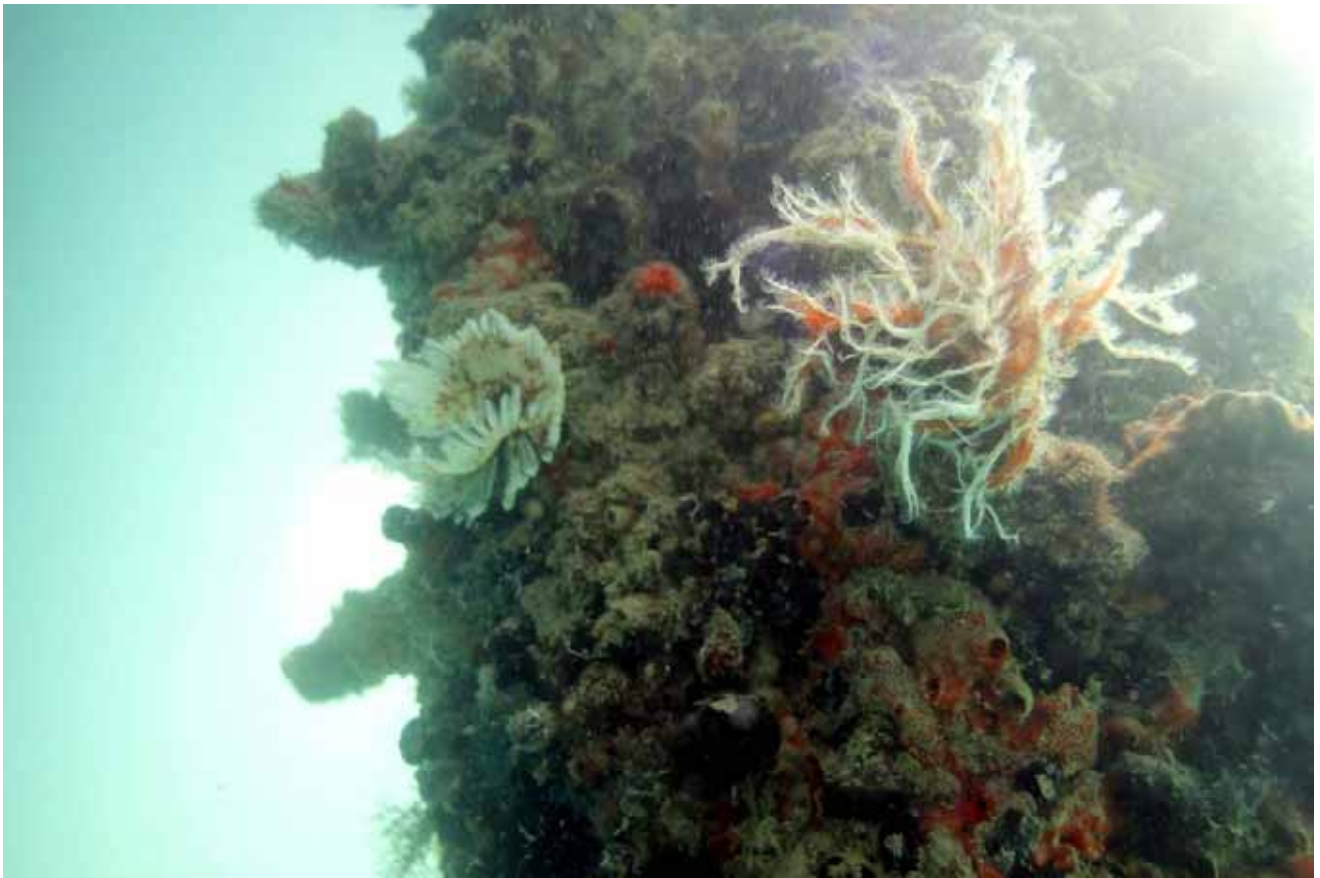
FIGURE 14. SECTOR C. Typical invertebrate colonizers on pilings comprising Snug Harbor include sponges *Liosina paradoxa* (top), the serpulid worm *Salmacina dysteri* (bottom right) and the polychaete worm *Sabellastarte spectabilis* (bottom left). For location of Sector C, see Figure 4.

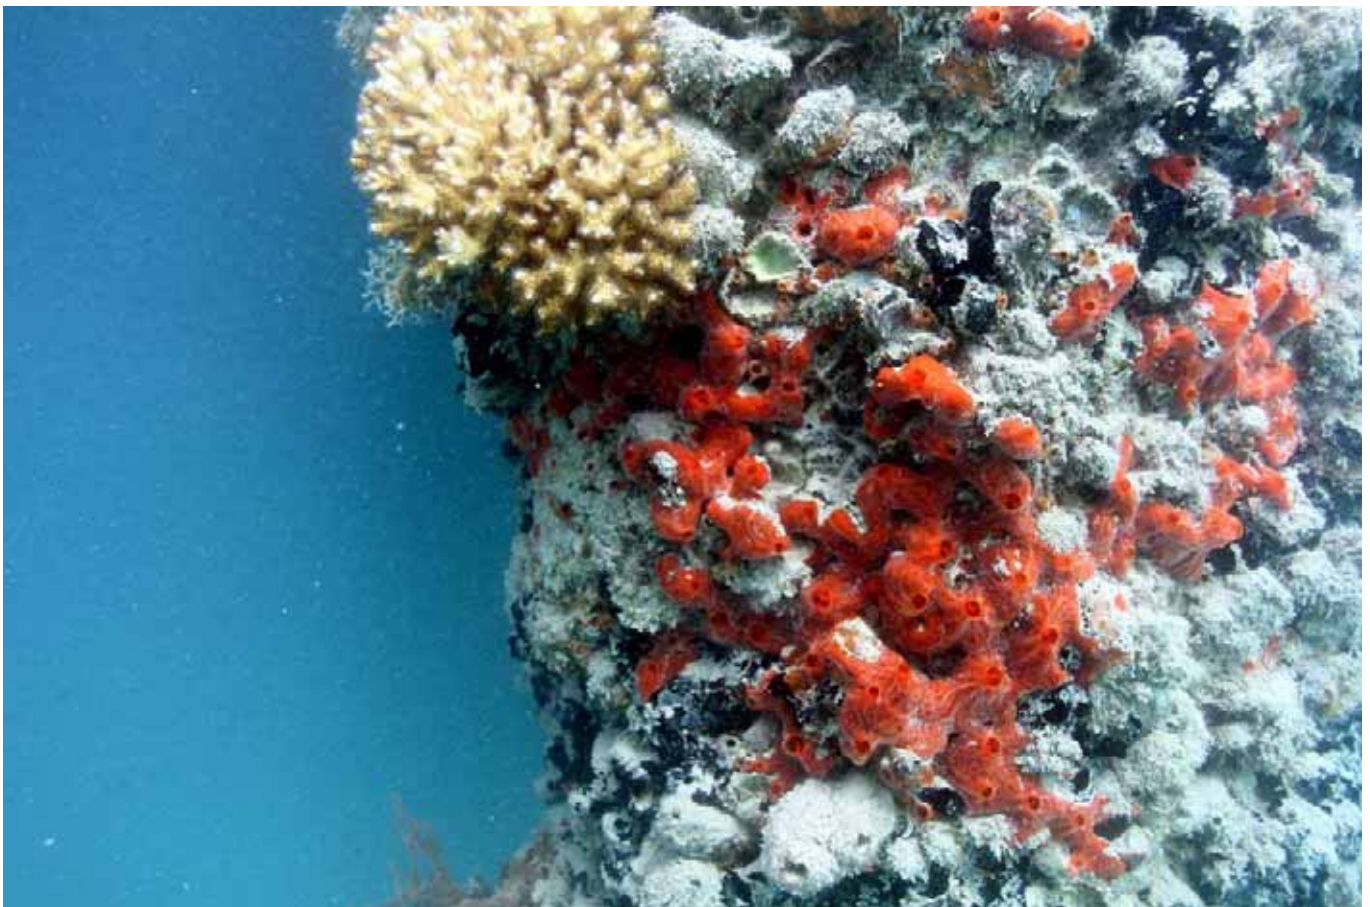
FIGURE 15. SECTOR C. Typical invertebrate colonizers on pilings comprising Snug Harbor include sponges *Mycale* sp. (top) and *Phorbas amaranthus* (bottom). For location of Sector C, see Figure 4.

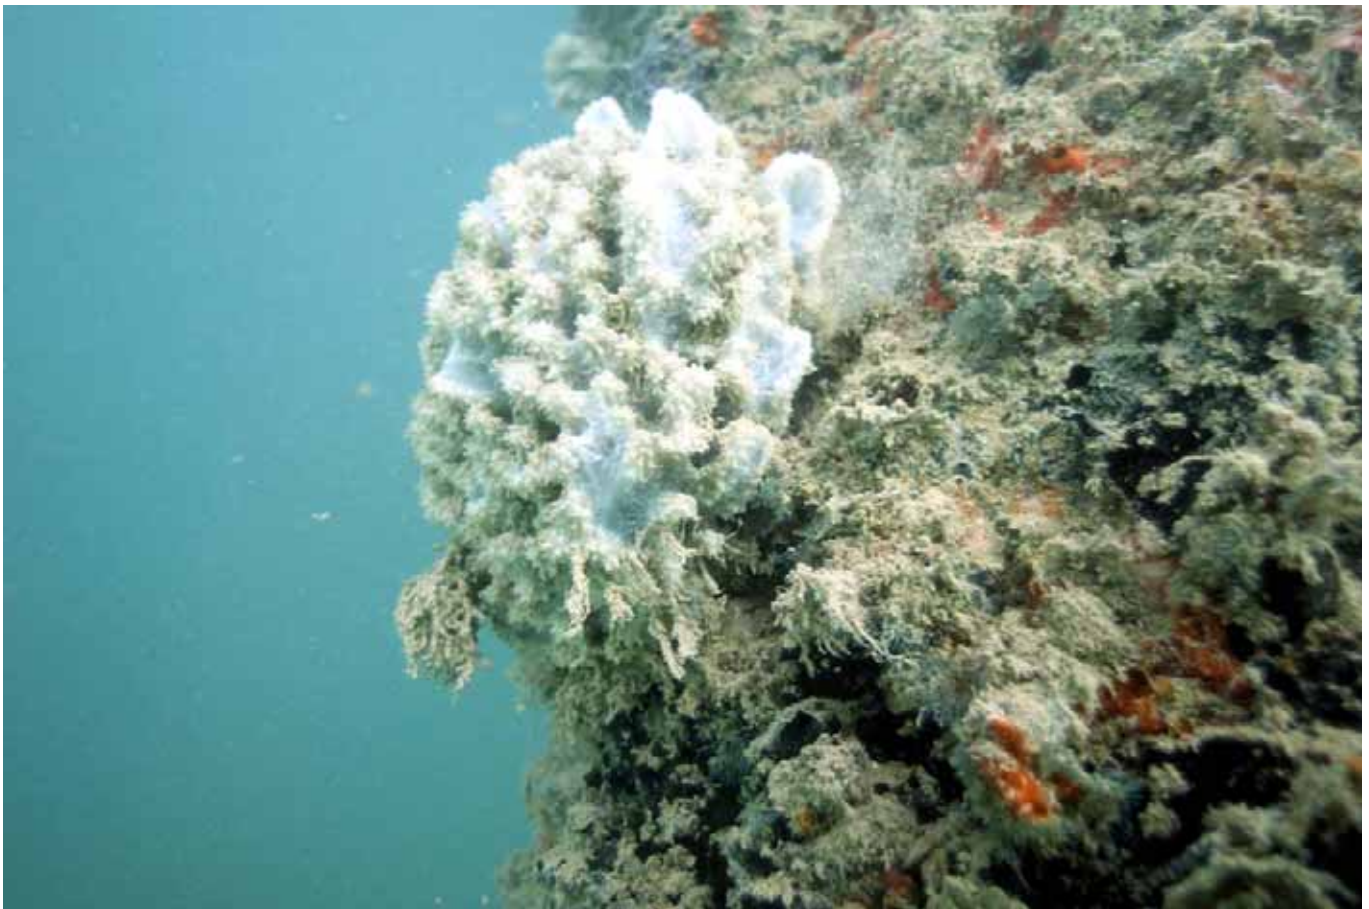
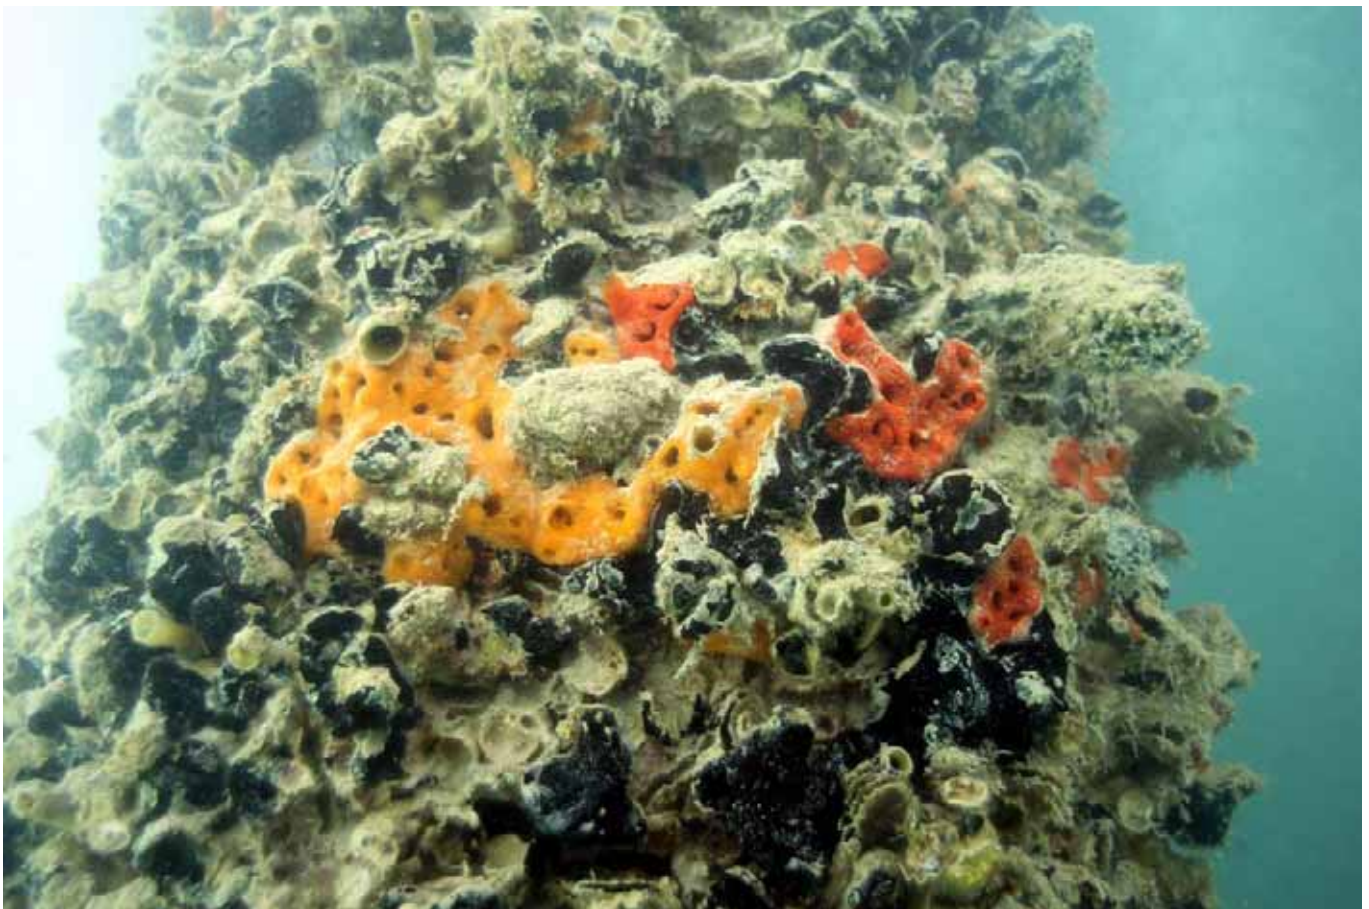
FIGURE 16. SECTOR C. Typical invertebrate colonizers on pilings comprising Snug Harbor include sponges *Sigmadocia* sp. (top), *Chondrosia chucalla* (black), *Mycale* sp. (orange) in bottom photo. For location of Sector C, see Figure 4.

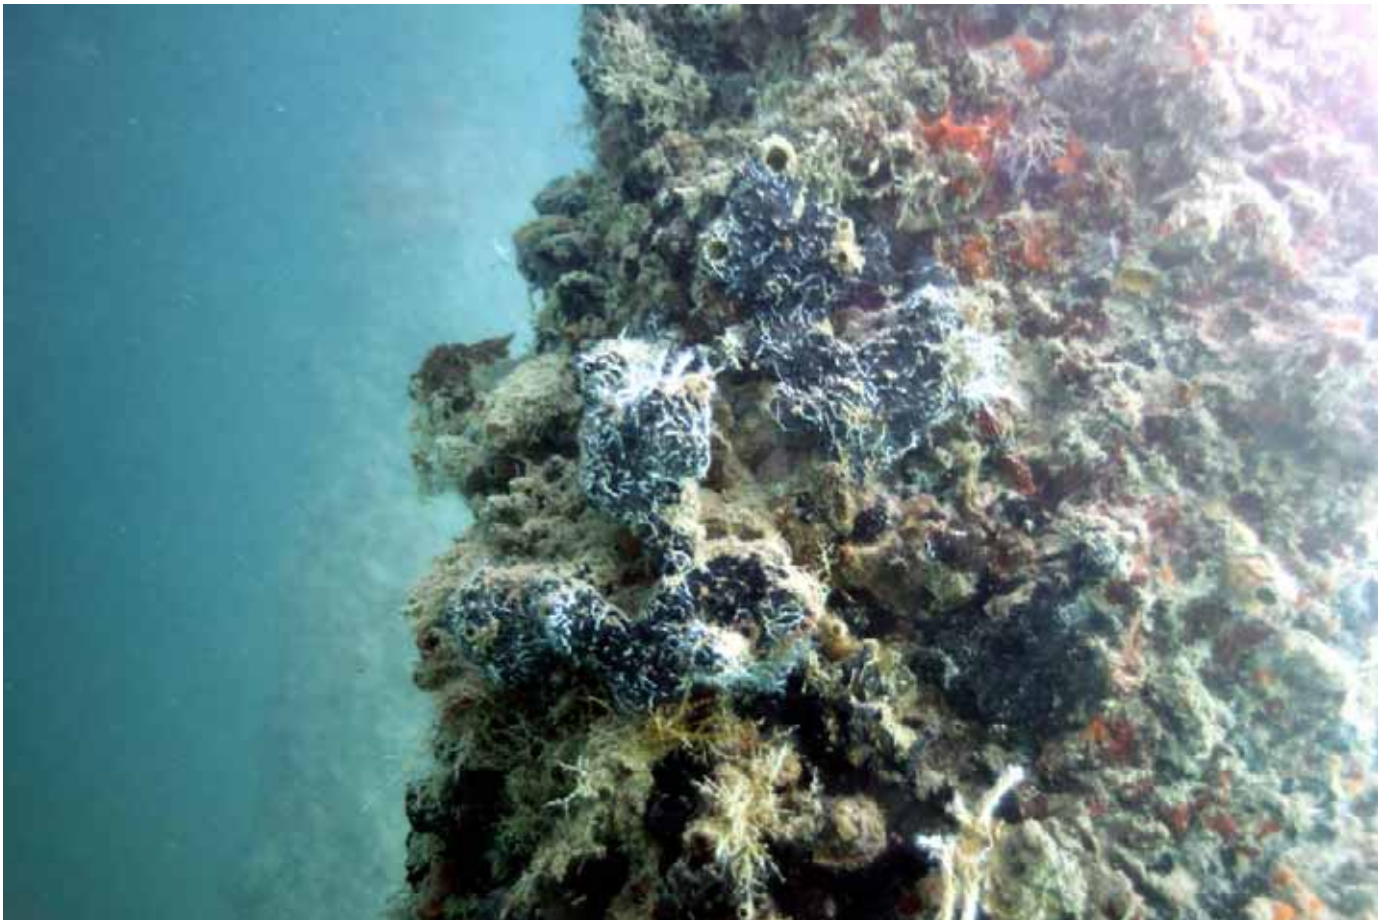
FIGURE 17. SECTOR C. Typical invertebrate colonizers on pilings comprising Snug Harbor include sponges *Clathria* sp. (top) and *Gelloides fibrosa* (bottom). For location of Sector C, see Figure 4.

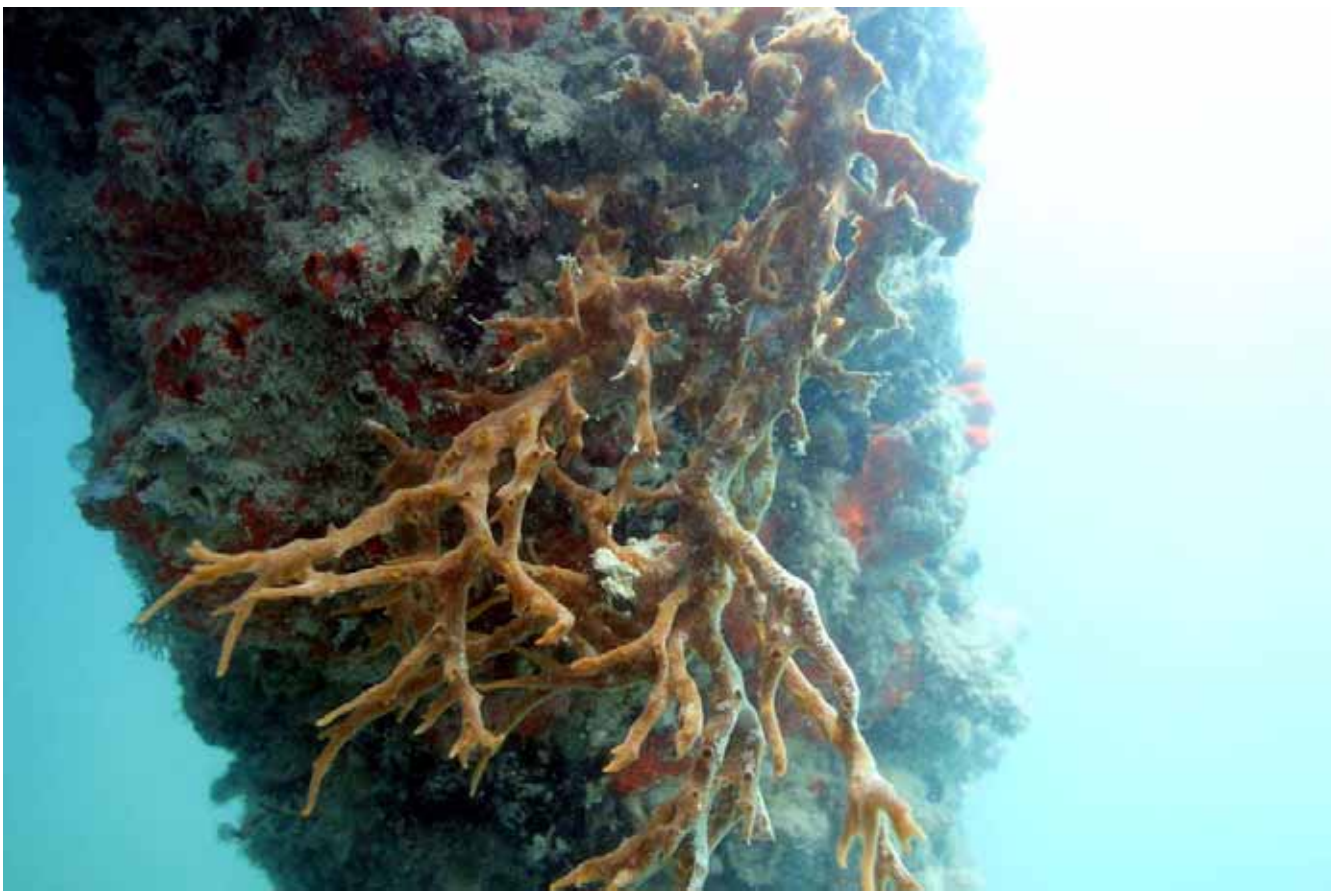
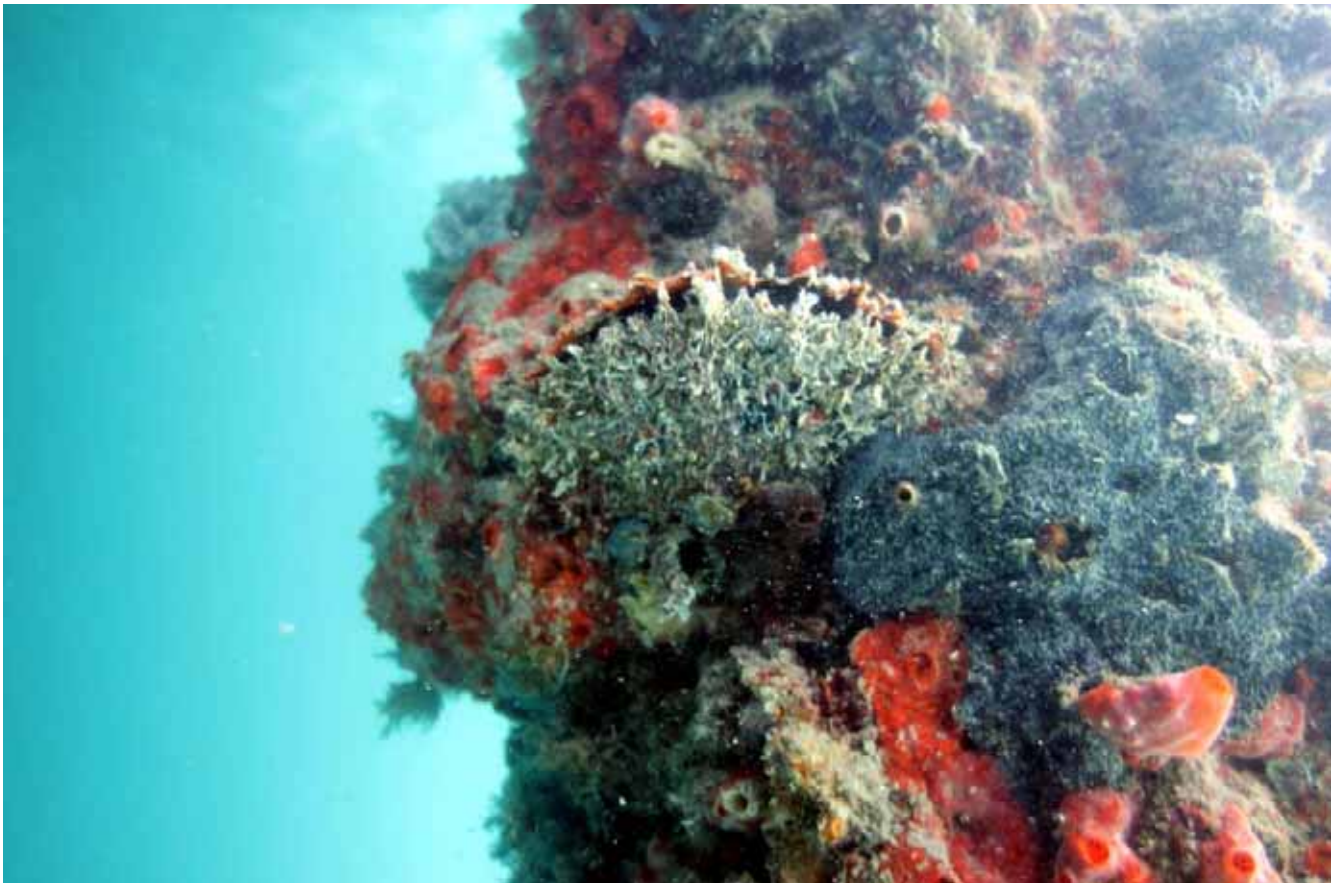
FIGURE 18. SECTOR C. Typical invertebrate colonizers on pilings comprising Snug Harbor include the sponge *Callyspongia diffusa* (top) and the bivalve *Pinctada margaritifera* (bottom). For location of Sector C, see Figure 4.
