**AN ASSESSMENT OF THE MARINE BIOLOGICAL
COMMUNITY STRUCTURE IN THE VICINITY OF THE PROPOSED
KAPALAMA CONTAINER TERMINAL
HONOLULU, HAWAI'I**

**State of Hawaii
Department of Transportation
Harbors Division**

October 15, 2012

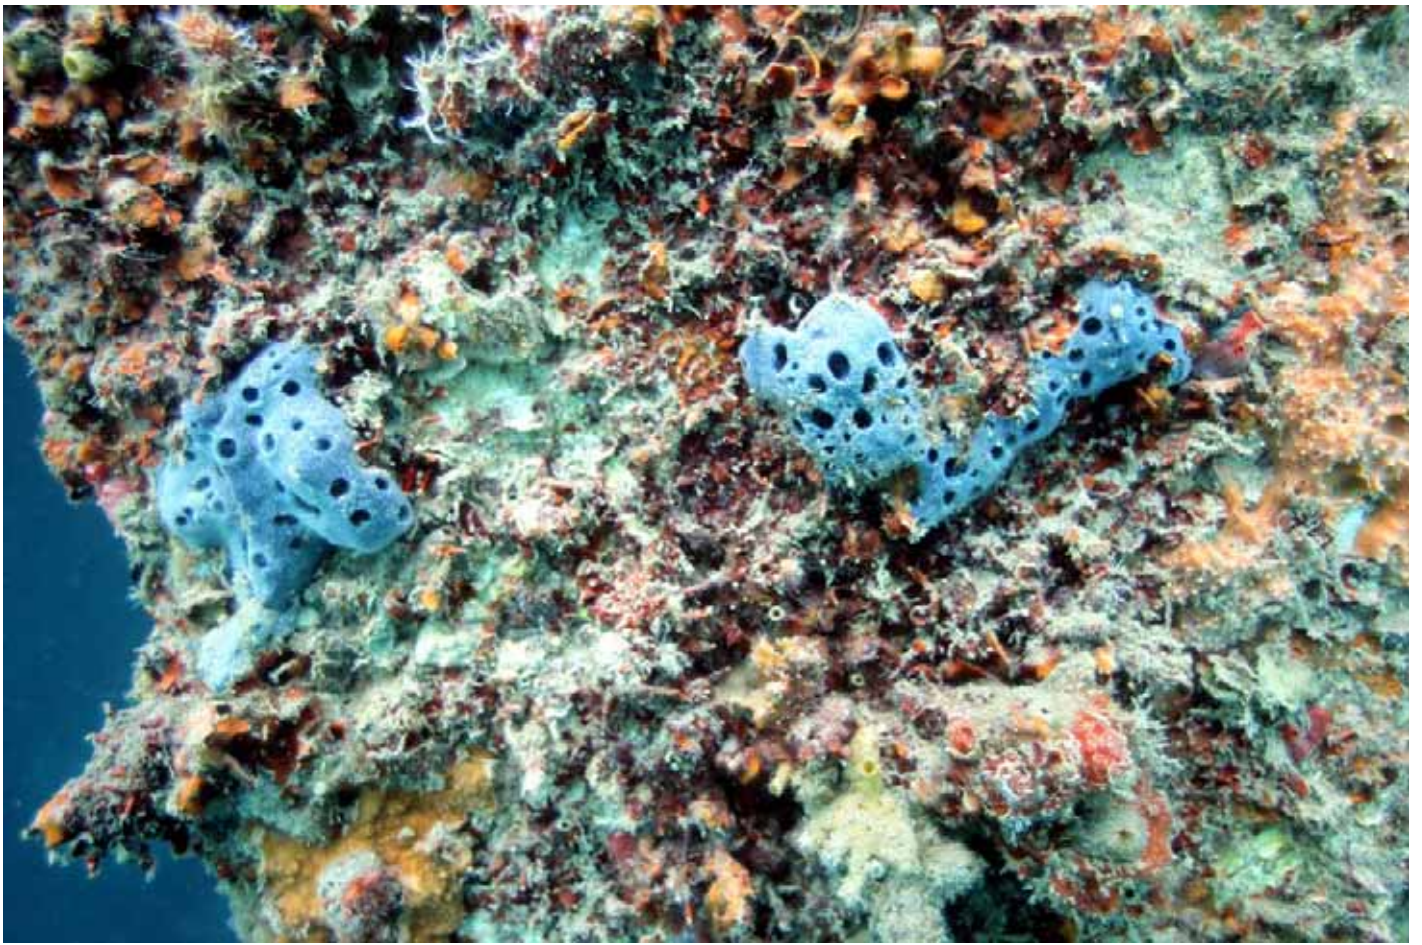
FIGURE 19. SECTOR C. Typical invertebrate colonizers on pilings comprising Snug Harbor include the sponges *Chalinula pseudomolitba* (top) and *Liosina paradoxa* (bottom). For location of Sector C, see Figure 4.

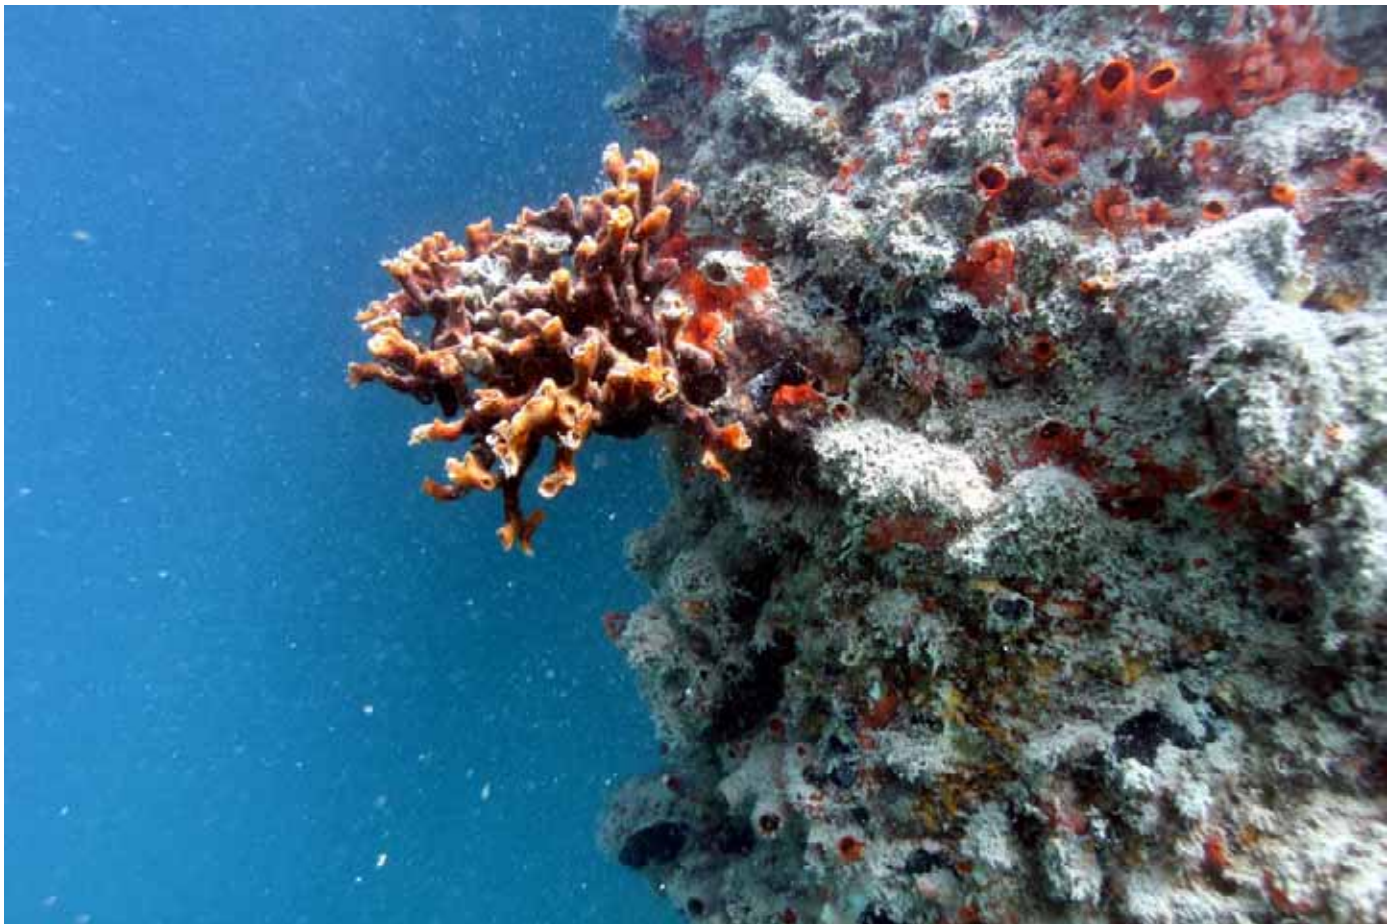
FIGURE 20. SECTOR C. Typical invertebrate colonizers on pilings comprising Snug Harbor include the bryozoans *Amansia distans* (top) and *Schizoporella errata* (bottom). For location of Sector C, see Figure 4.

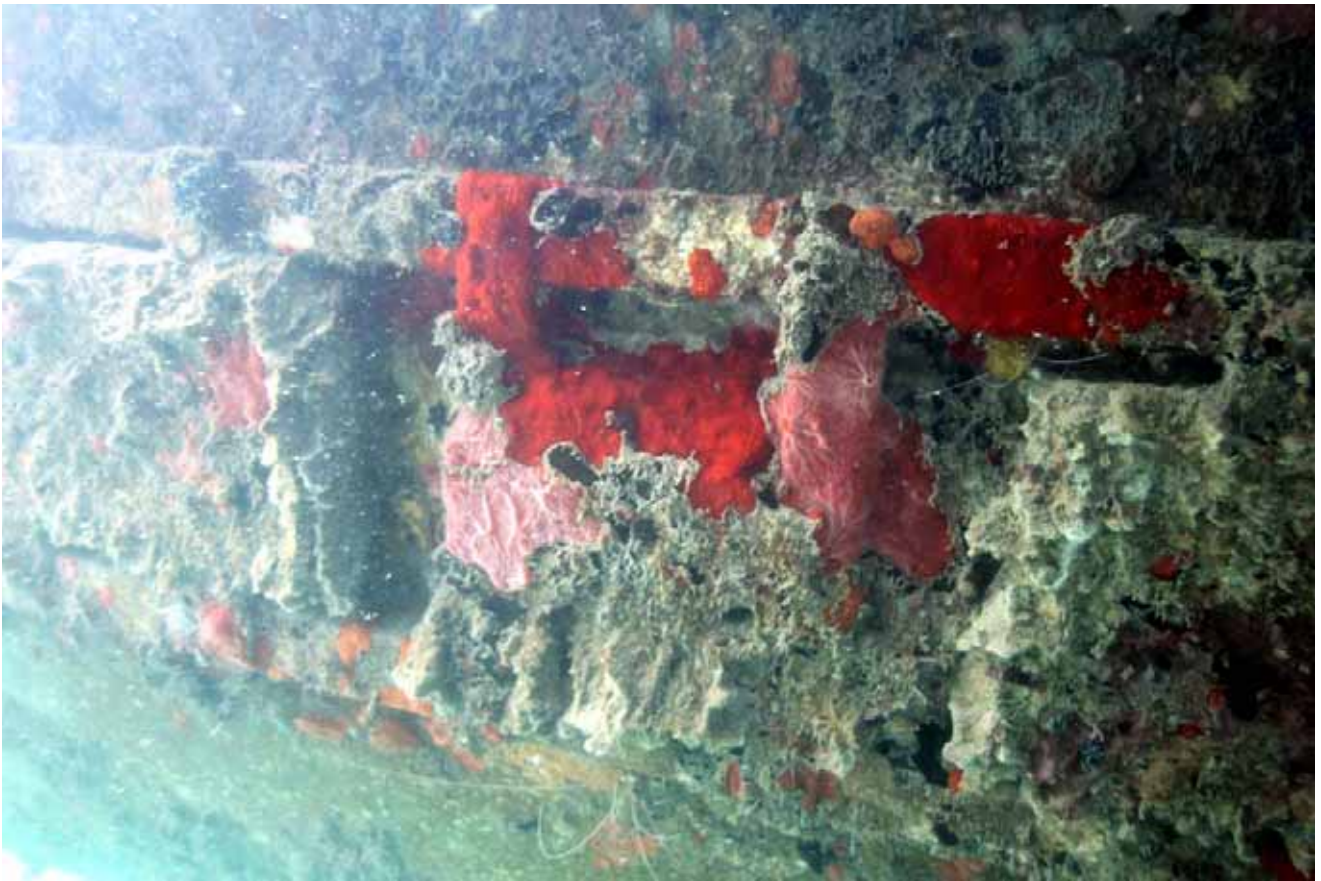
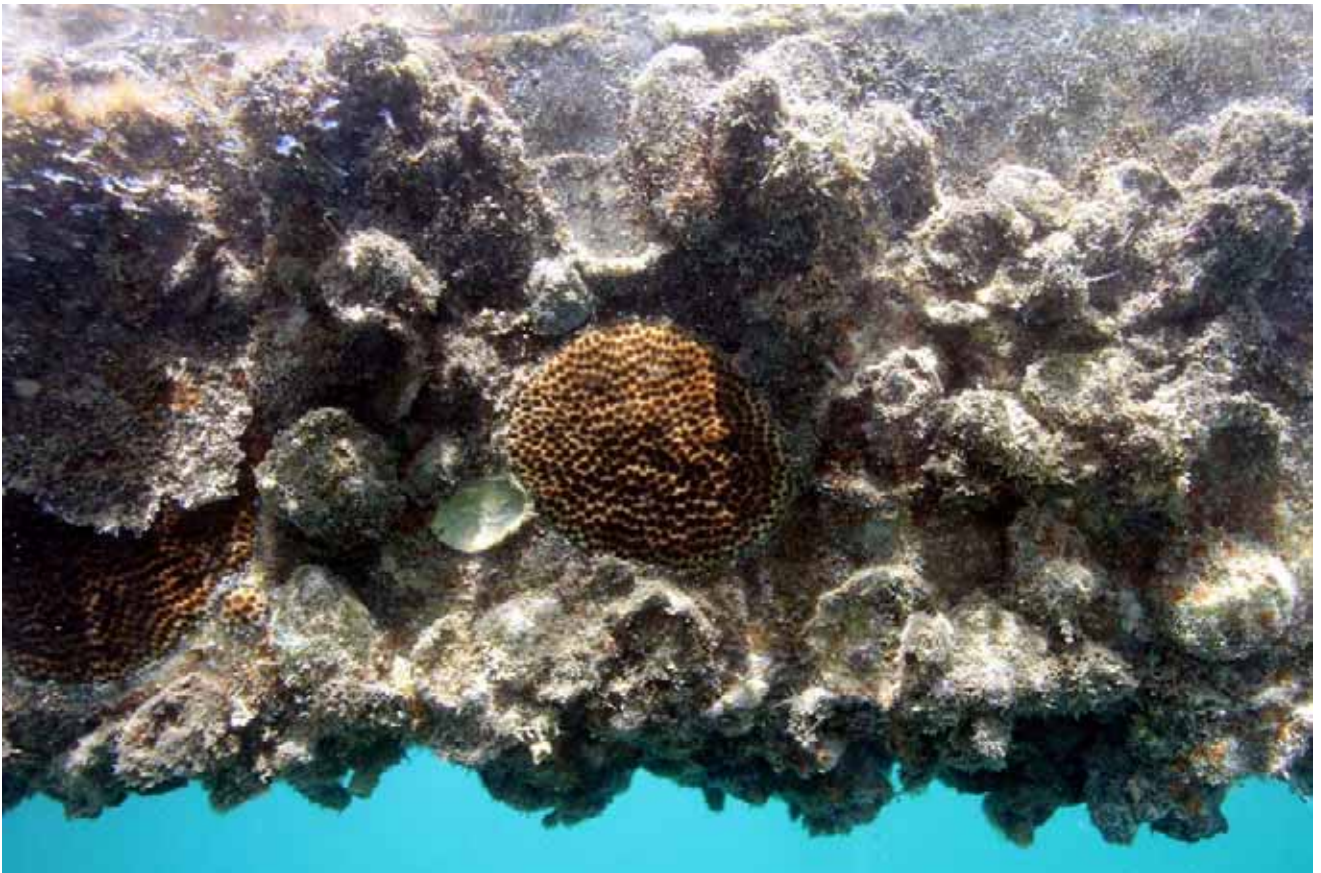
FIGURE 21. SECTOR D. Various species of sponges (*Zygomycale parishii* (pink) and *Phorbastrea amaranthus* (red) colonizing submerged edge of Snug Harbor in Sector D (top). Several round colonies of *Leptastrea purpurea* on Pier edge (bottom). For location of Sector D, see Figure 4.

The physical structure of Sectors C, D, E, I, J, consist of square concrete pilings (0.489 m dimension of each side) that extend into the mud comprising the Harbor floor (Figure 12). Most of the surface area of the pilings not covered by living biota is encrusted with remnant mollusc shells. The coating of mollusc shell forms the settlement substratum for other invertebrates. Figures 13-20 provide views of concrete piles located in Sector C, along with typical colonizing organisms. In Sector D the vertical piles support a submerged horizontal concrete slab that supports the pier structure. As with the vertical piles, the horizontal slab is fully encrusted with remnant mollusc shells and living invertebrates (Figure 21).

The second most abundant species was *Leptastrea purpurea*, which occurs within the Harbor as small generally round or oval shaped encrustations (Figures 21 and 39). All colonies observed were less than 20 cm in longest diameter (Table 3). Few of the smaller size-classes of both *P. damicornis* and *L. purpurea* exhibited signs of sediment damage.

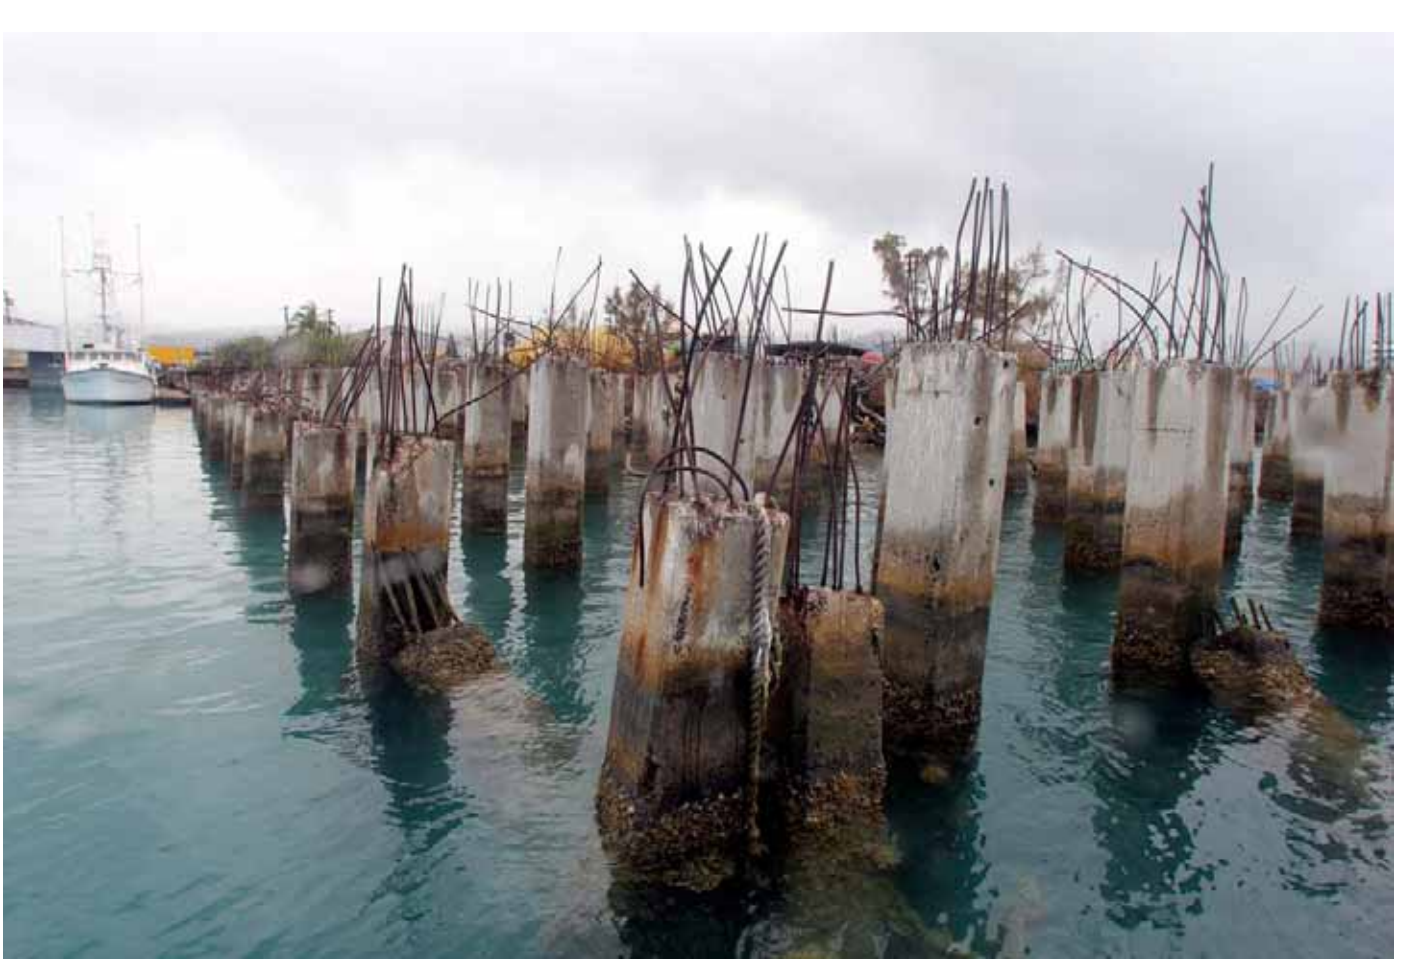
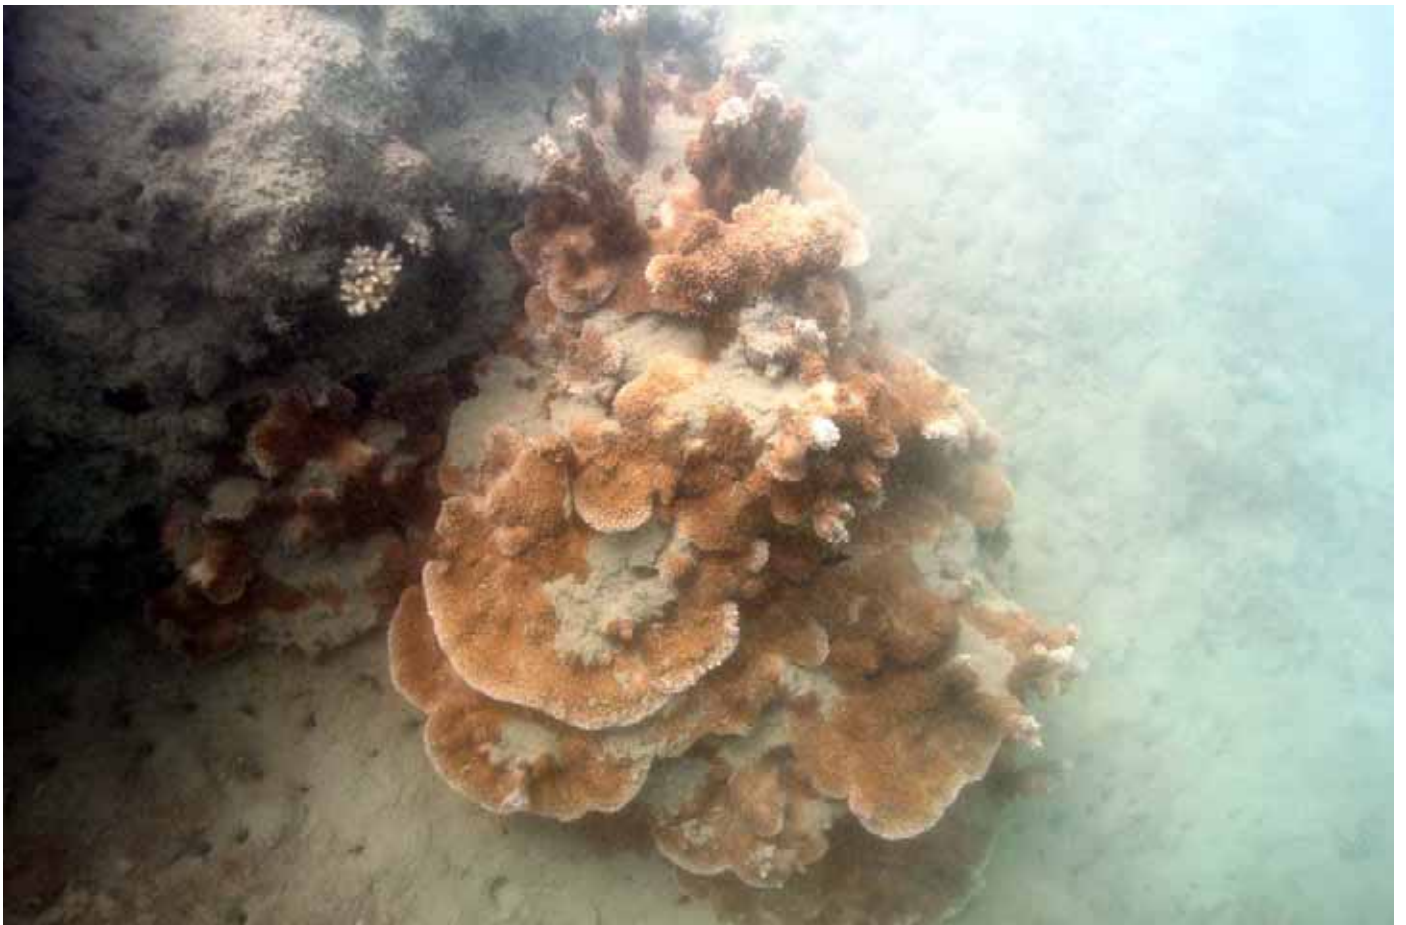
Sector E consists of a matrix of approximately 180 partially submerged concrete piles extending from the shoreline (Figure 22). Exposed re-bar extending from the tops of these piles suggests that a pier was removed from the piling foundation. As a result, the submerged piles provide a relatively unique habitat in that light is not restricted within the matrix of columns as is the case on pilings overtopped by piers. Sector E contains some of the largest coral colonies within the Kapalama basin area (Figures 22-26). The seaward terminus of Sector E at the western origin of Sector F is also somewhat unique, consisting of a dredged shelf/slope region similar to areas A and B. The presence of the pilings as well as the dredged shelf and slope at the juncture of Sectors E and F results in higher structural habitat complexity than other regions of the Kapalama survey area, reflected in one of the more diverse aggregations of reef fish noted in the survey (Figure 27).

FIGURE 22. SECTOR E. Top photo shows field of 180 square concrete pilings on the east shoreline of Snug Harbor that comprise Sector E. Bottom photo shows multi-tiered colony of *Montipora capitata* growing on edge of dredged channel wall at juncture of Sectors D and E. For location of Sector E, see Figure 4.

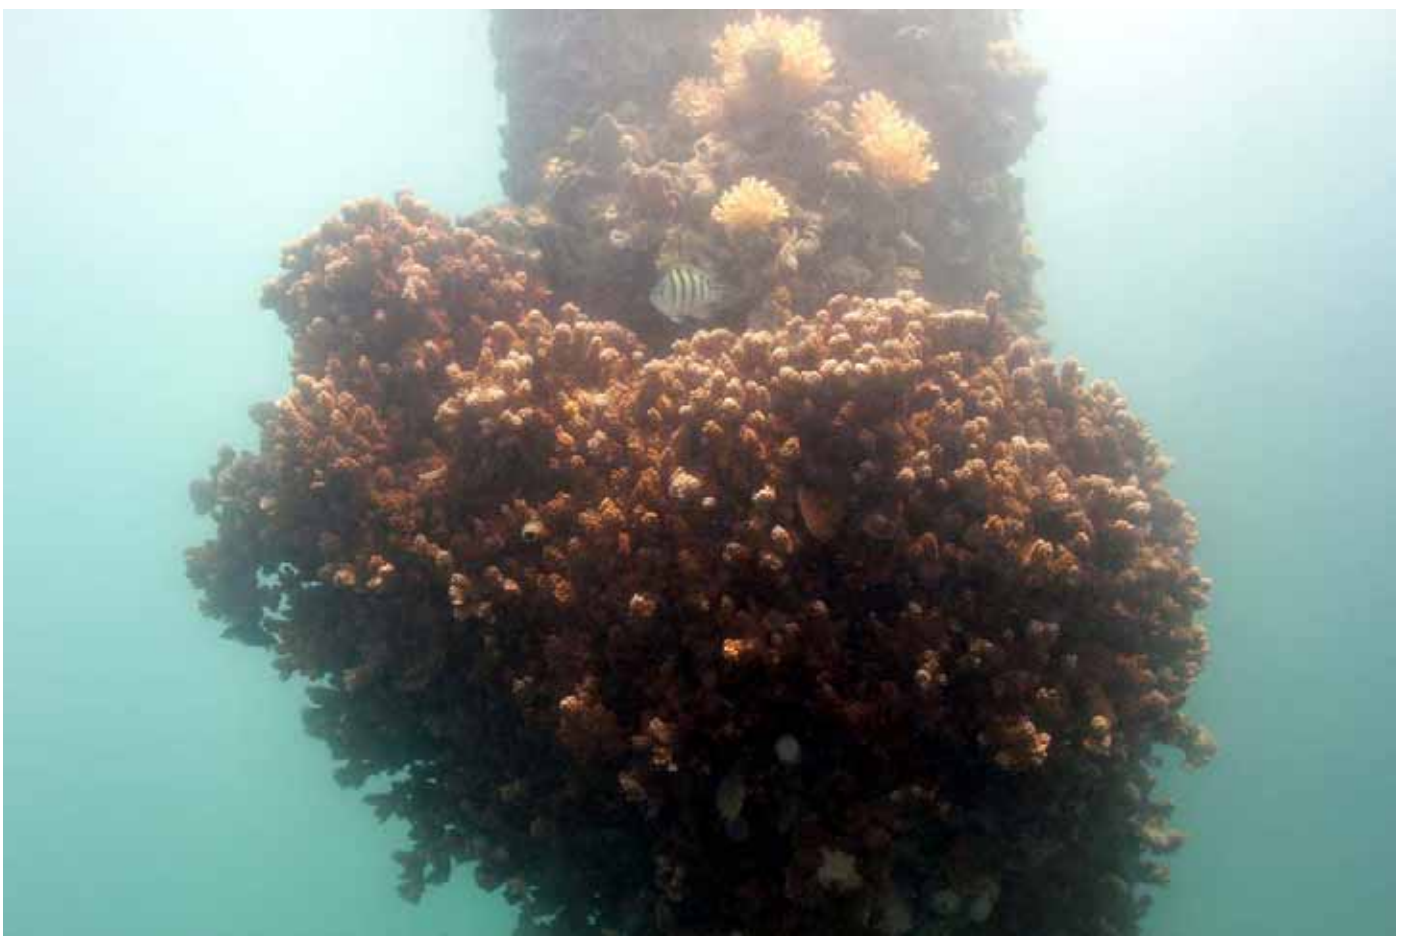
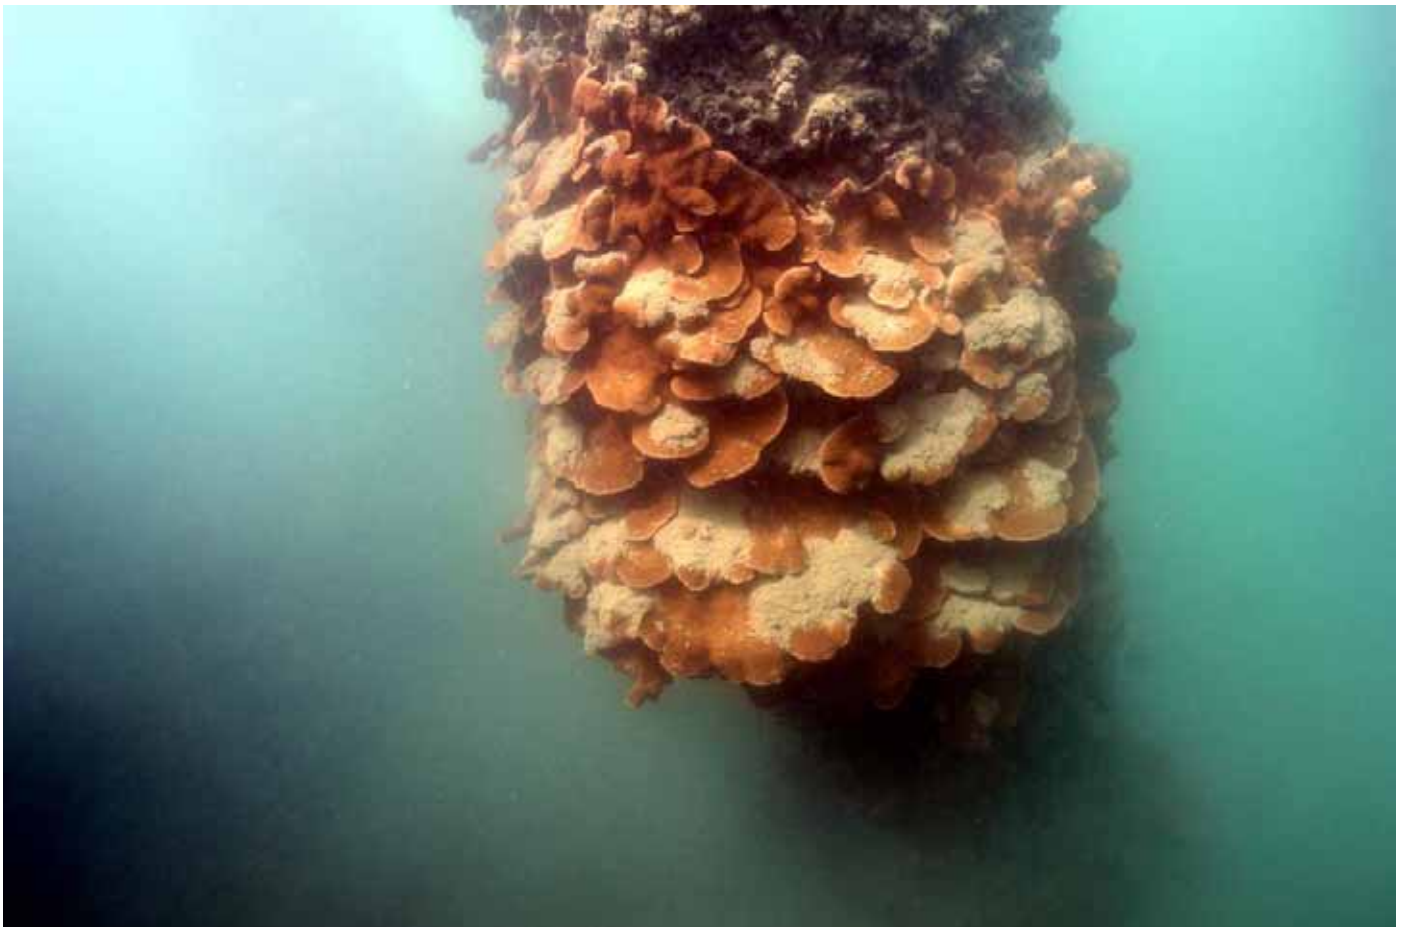
FIGURE 23. SECTOR E. Top photo shows branching colony of *Montipora capitata* encircling piling in Sector E. The branching growth form of *M. capitata* was rare throughout the survey area. Bottom photo shows more typical growth form of *M. capitata* observed in the survey area as a mass of overlapping thin plates. For location of Sector E, see Figure 4.

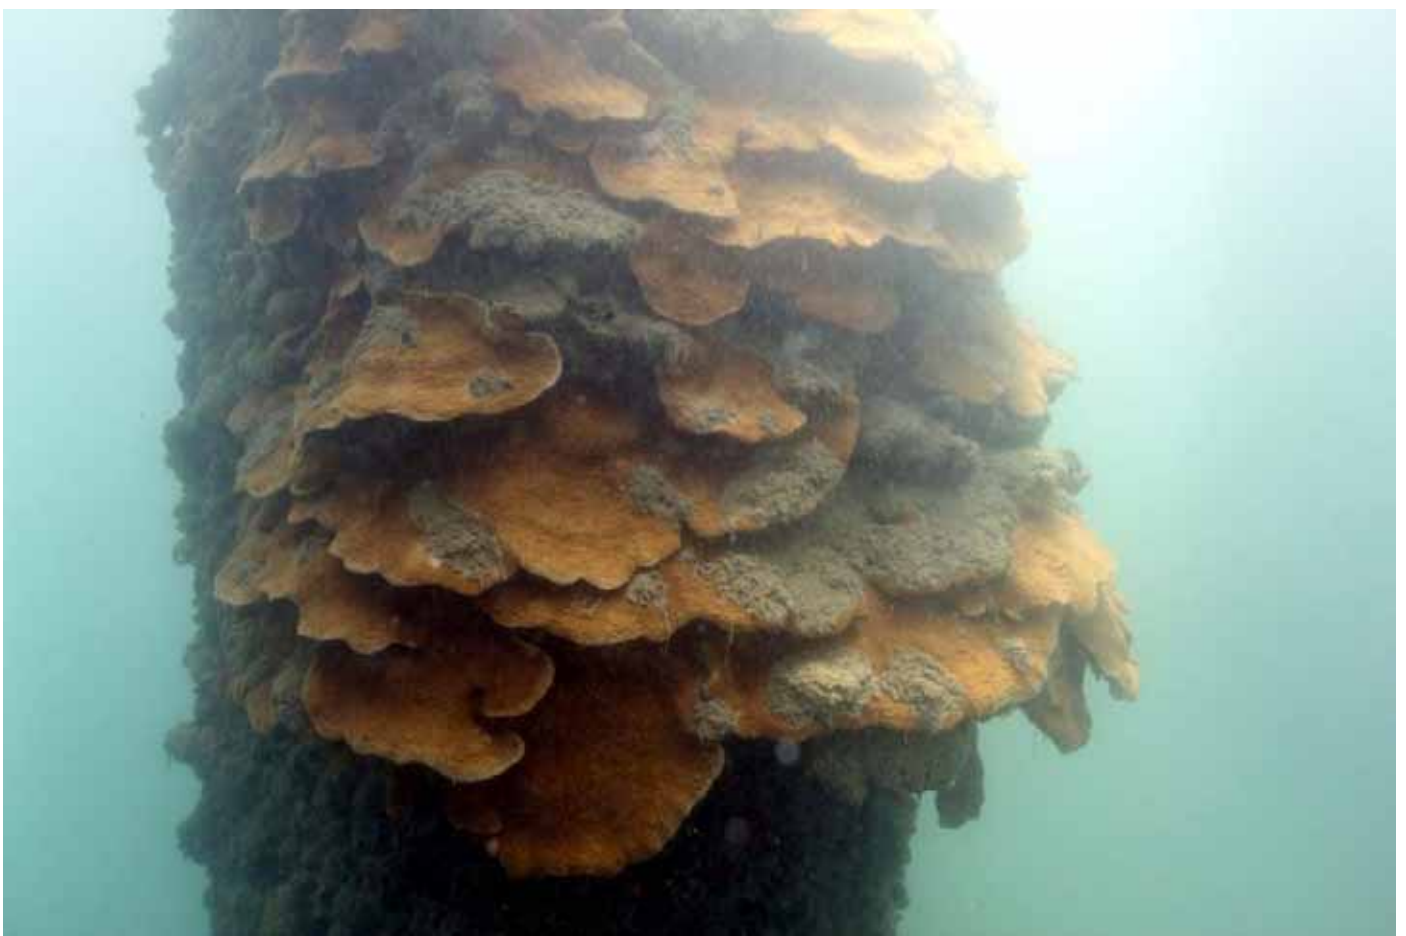
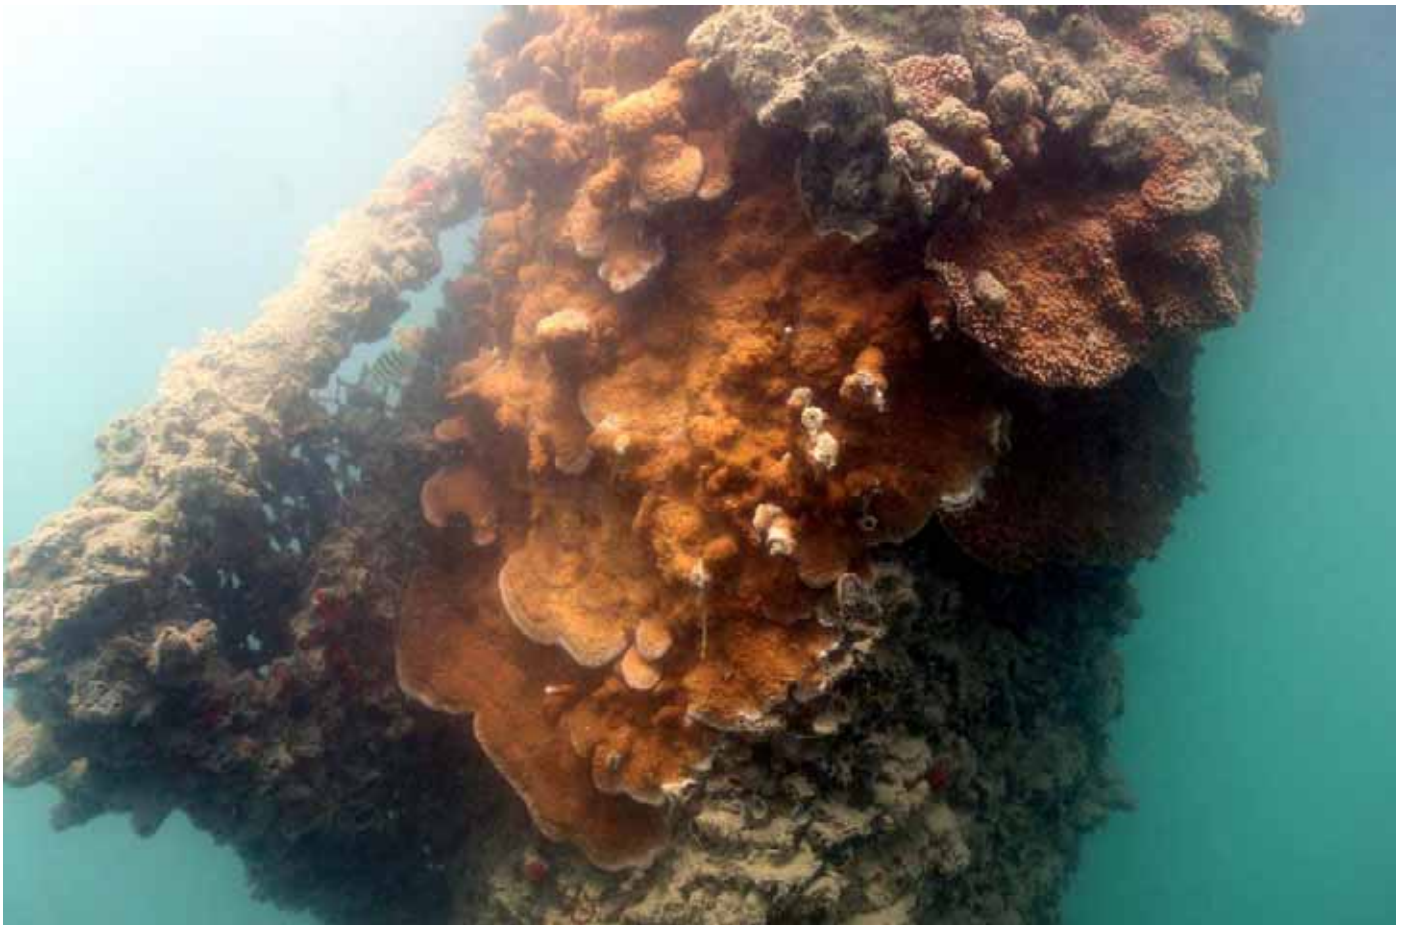
FIGURE 24. SECTOR E. Top and bottom photos show typical overlapping plating growth form of *Montipora patala* on pilings in Sector E. For location of Sector E, see Figure 4.

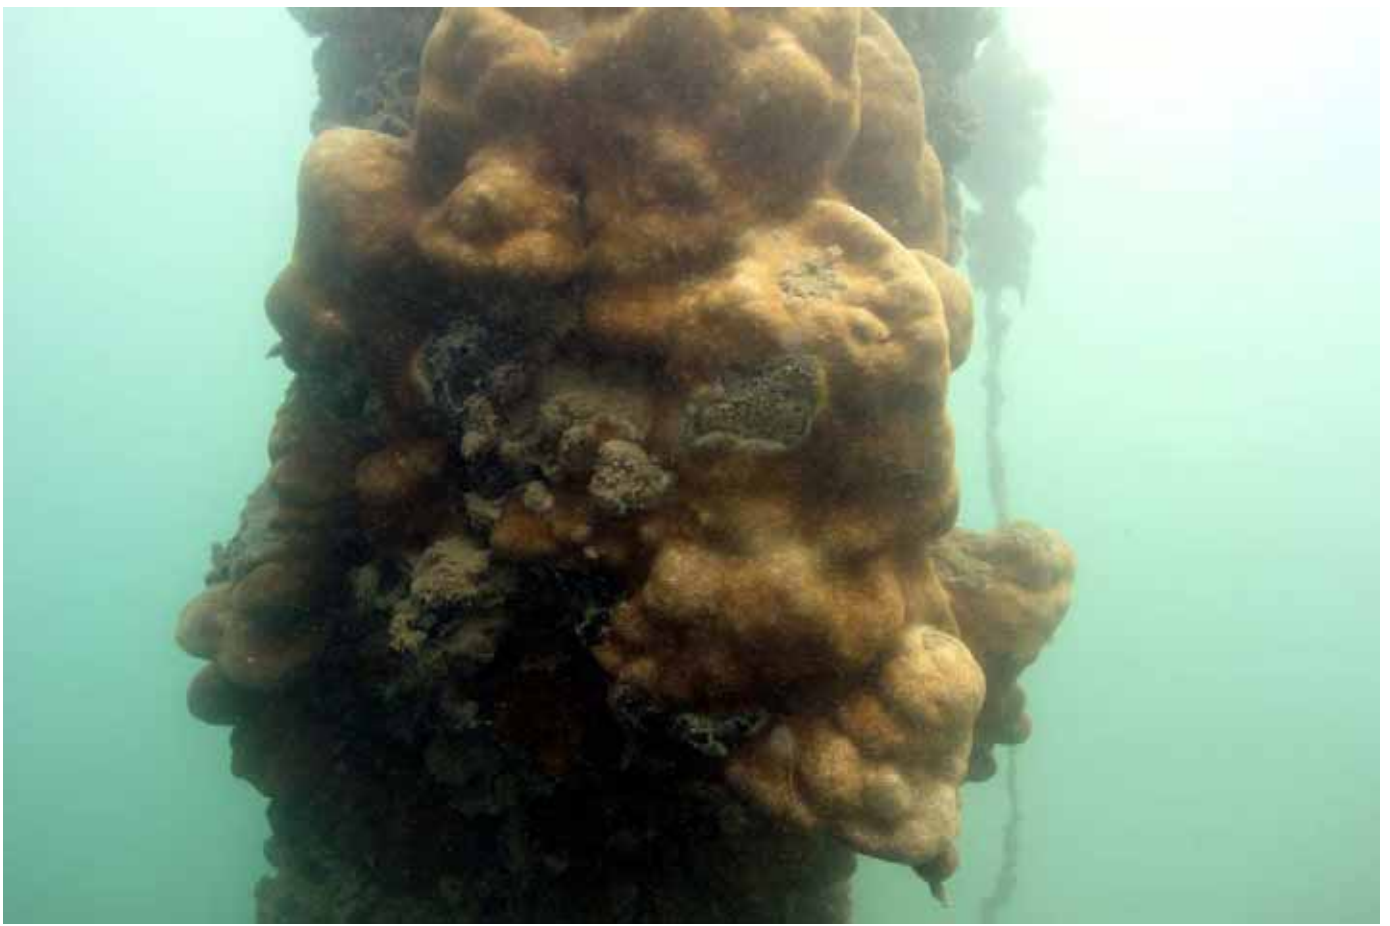
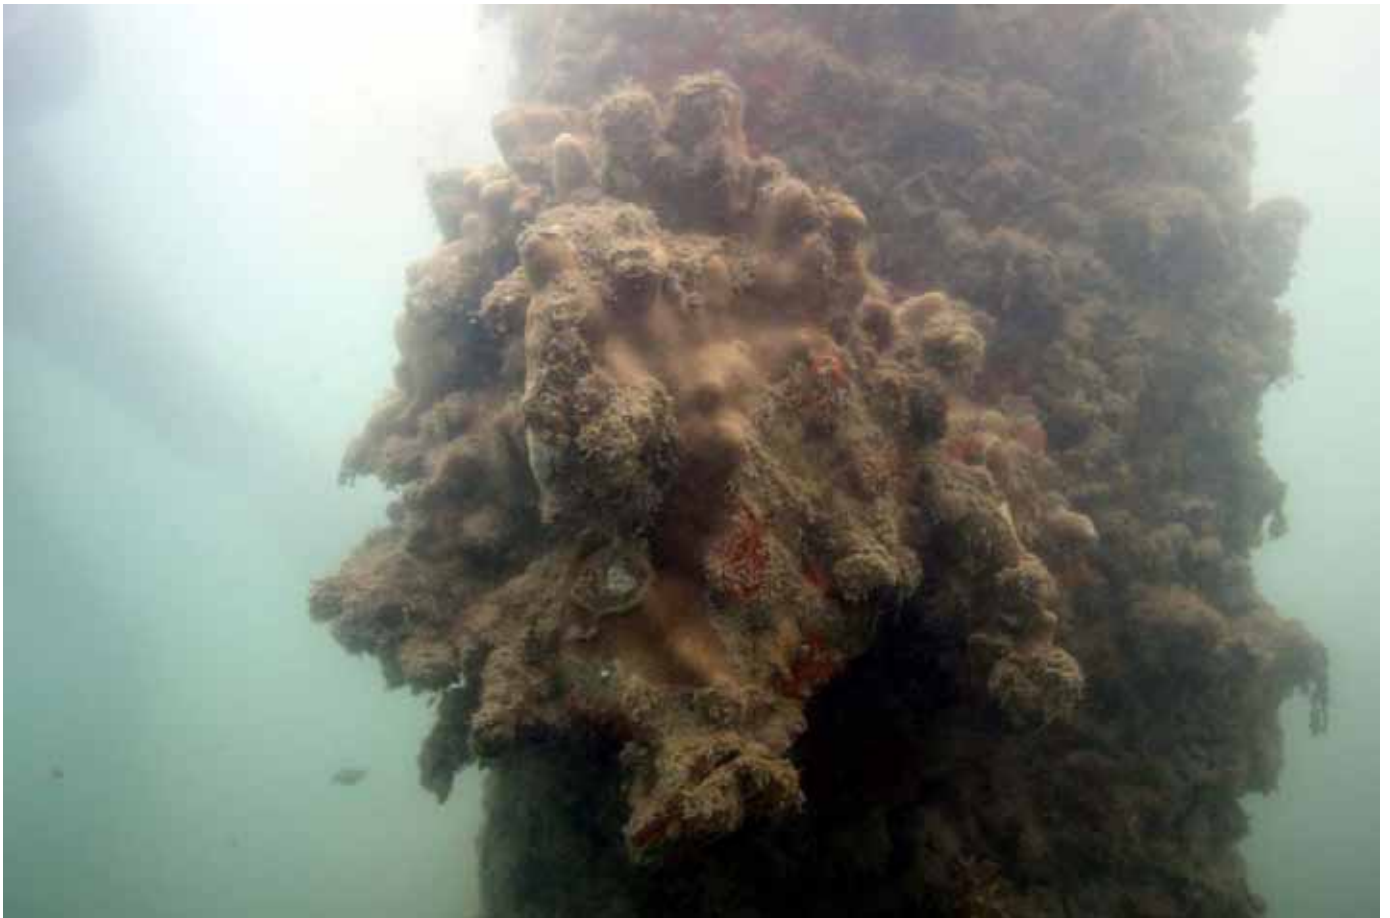
FIGURE 25. SECTOR E. Top and bottom photos show typical mounded growth form of *Porites lobata* on pilings in Sector E. For location of Sector E, see Figure 4.

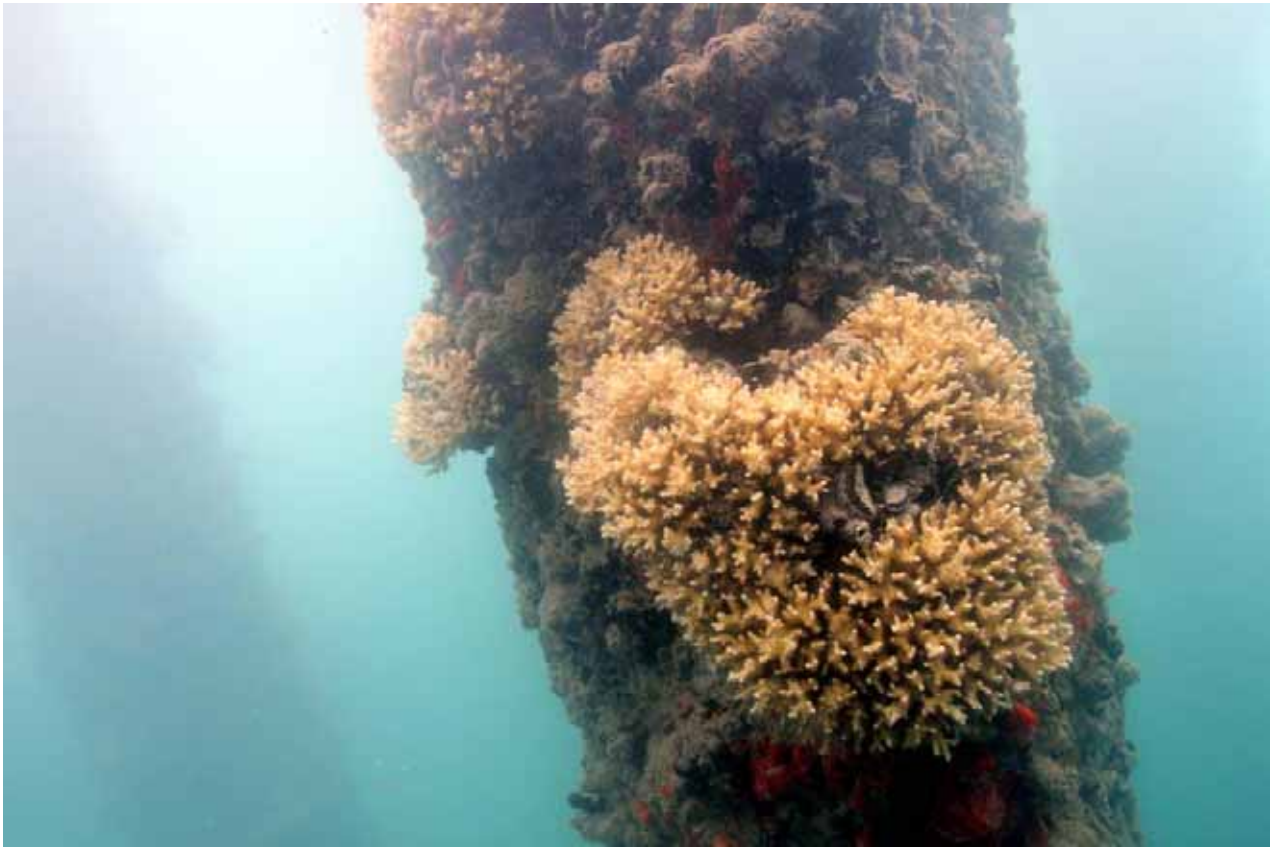
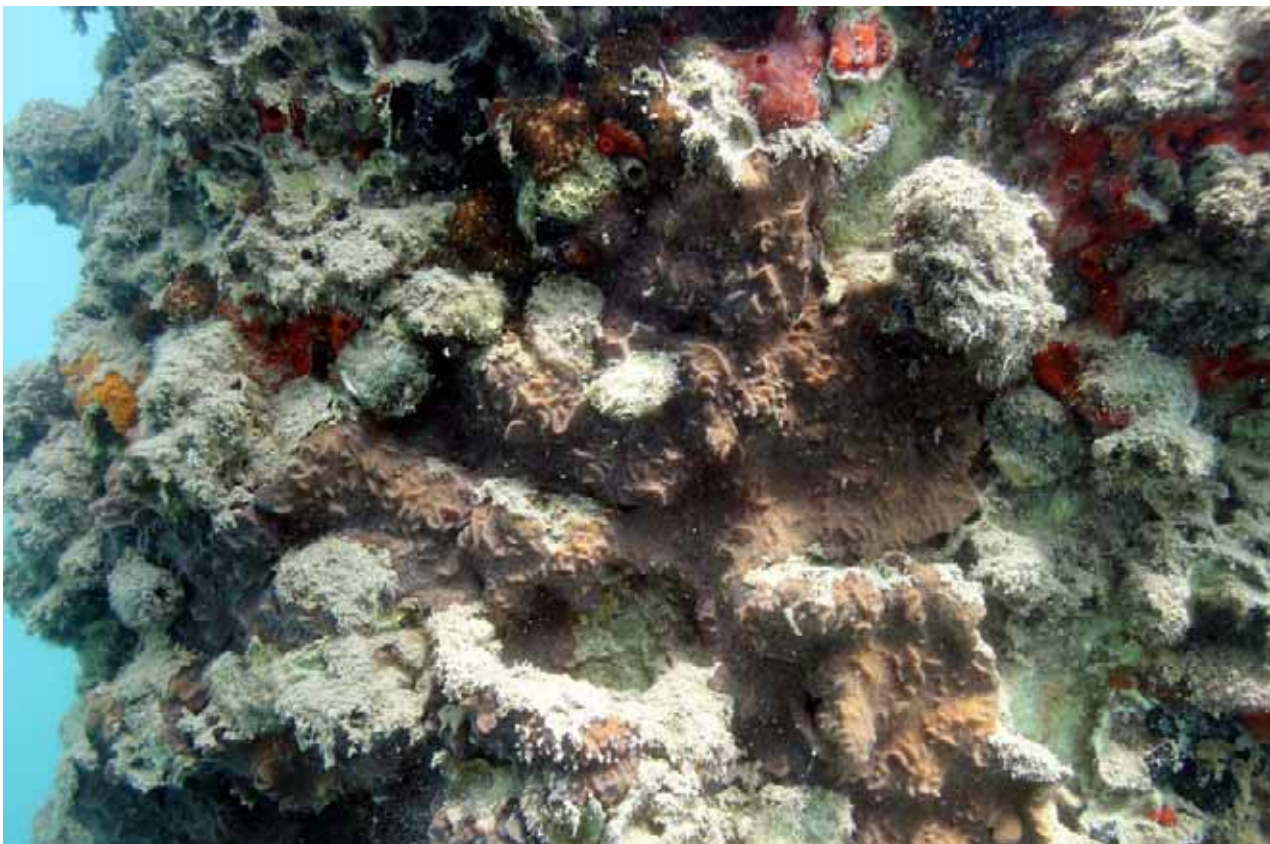
FIGURE 26. SECTOR E. Top photos shows typical finely branched growth form of *Pocillopora damicornis* occurring on pilings in Sector E. Bottom photo shows flat encrusting colony of *Pavona varians* which occurred rarely within Sector E. For location of Sector E, see Figure 4.

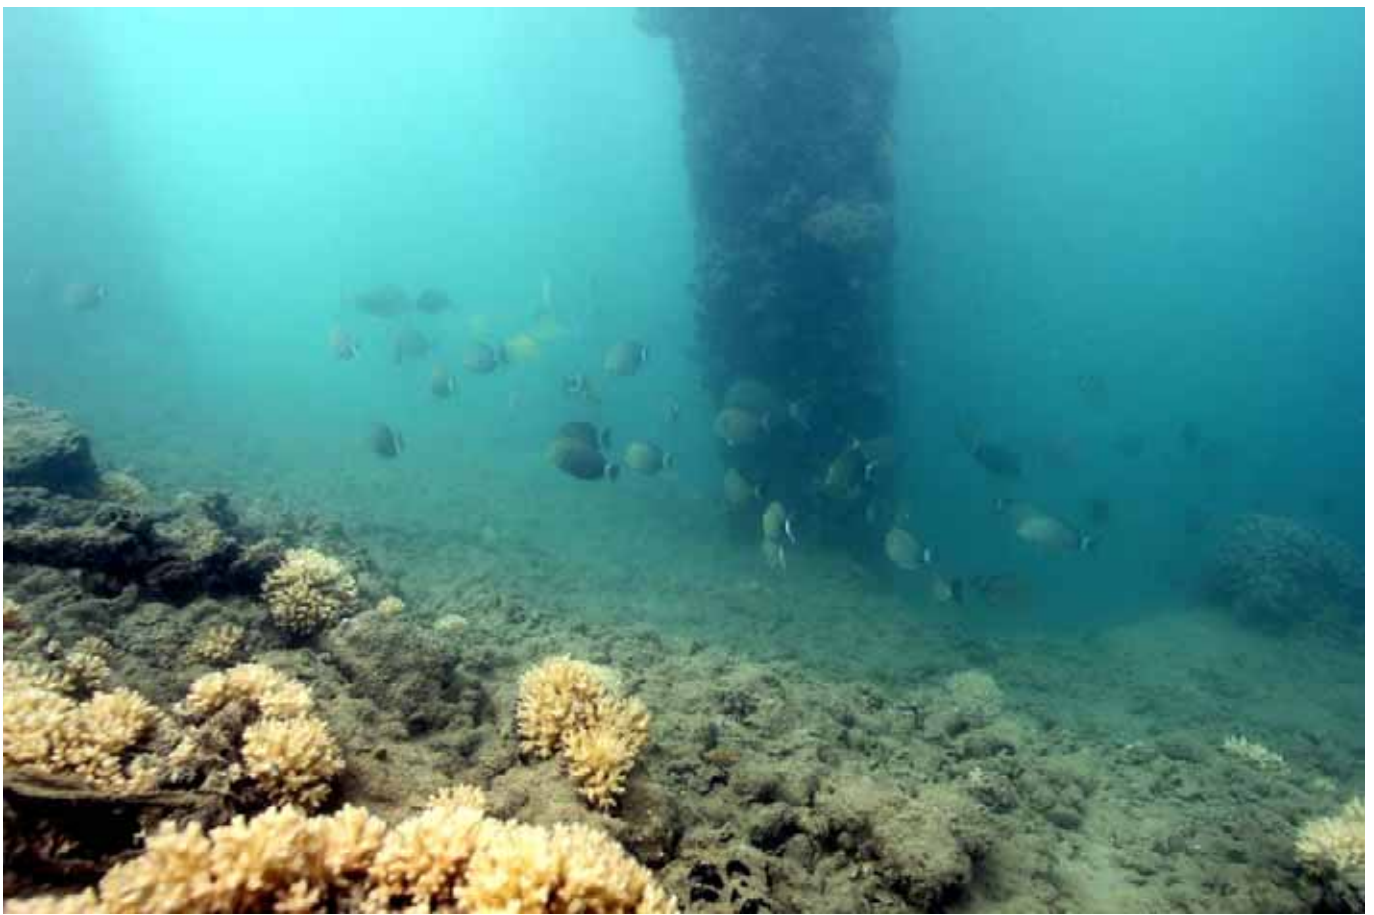
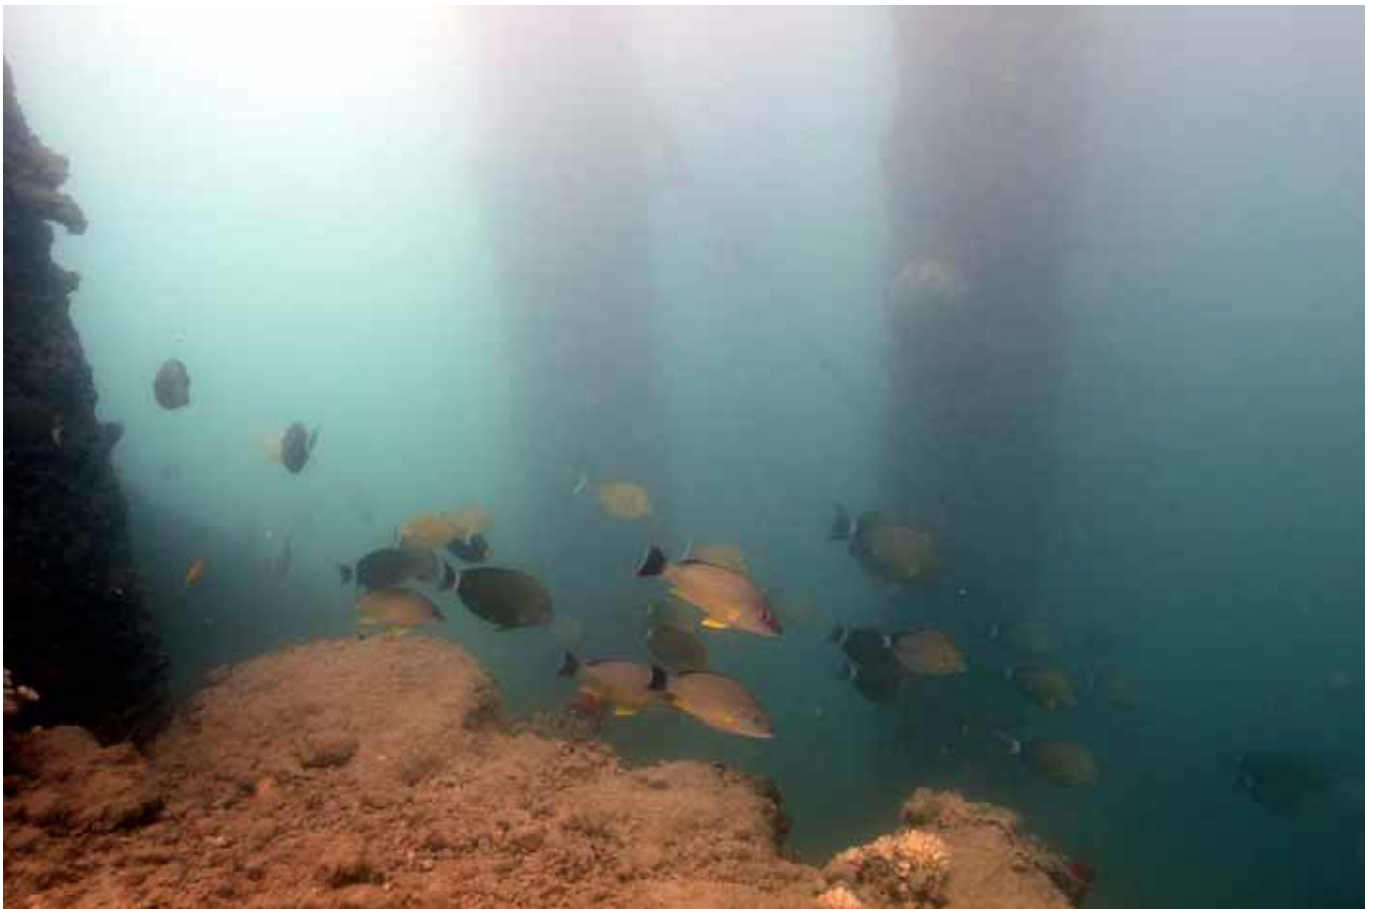
FIGURE 27. SECTOR E. Two views of the southern terminus of the pilings comprising Sector E at the edge of Kapalama Basin. The sloping dredged face and array of pilings provides one of the only habitats within the Kapalama survey area where fish were considered abundant. Top photo shows school of blue-lined surgeonfish (*Acanthurus nigroris*). Fish in center of bottom photo are black-tailed snapper (*Lutjanus fulvus*). For location of Sector E, see Figure 4.

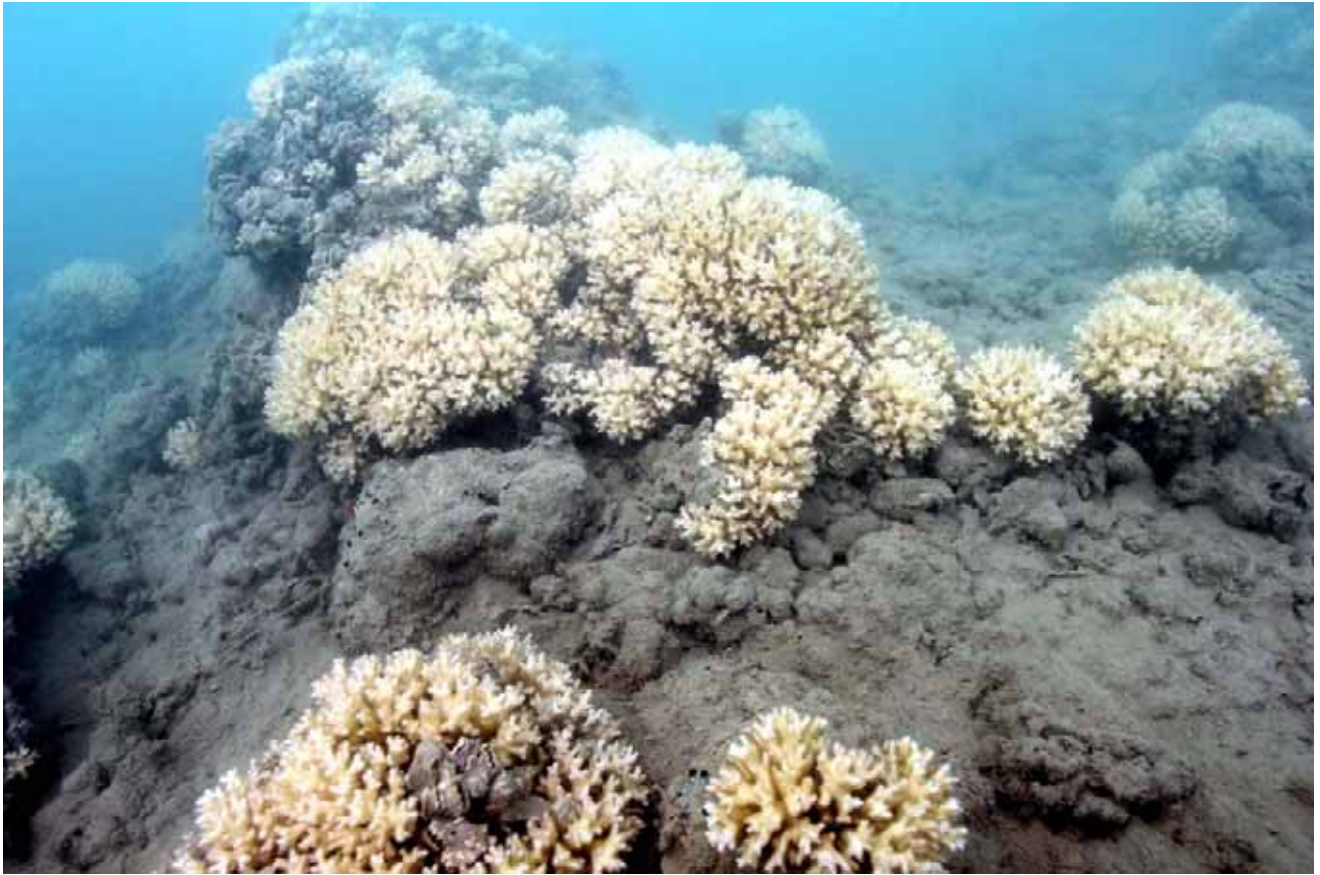
FIGURE 28. SECTOR F. Top photo shows typical assemblages of *Pocillopora damicornis* occurring on dredged shelf at western corner of Sector F. Bottom photo shows colony of *Montipora patula* encrusting metal debris on the dredged shelf within Sector F. For location of Sector F, see Figure 4.
