**AN ASSESSMENT OF THE MARINE BIOLOGICAL
COMMUNITY STRUCTURE IN THE VICINITY OF THE PROPOSED
KAPALAMA CONTAINER TERMINAL
HONOLULU, HAWAI'I**

**State of Hawaii
Department of Transportation
Harbors Division**

October 15, 2012

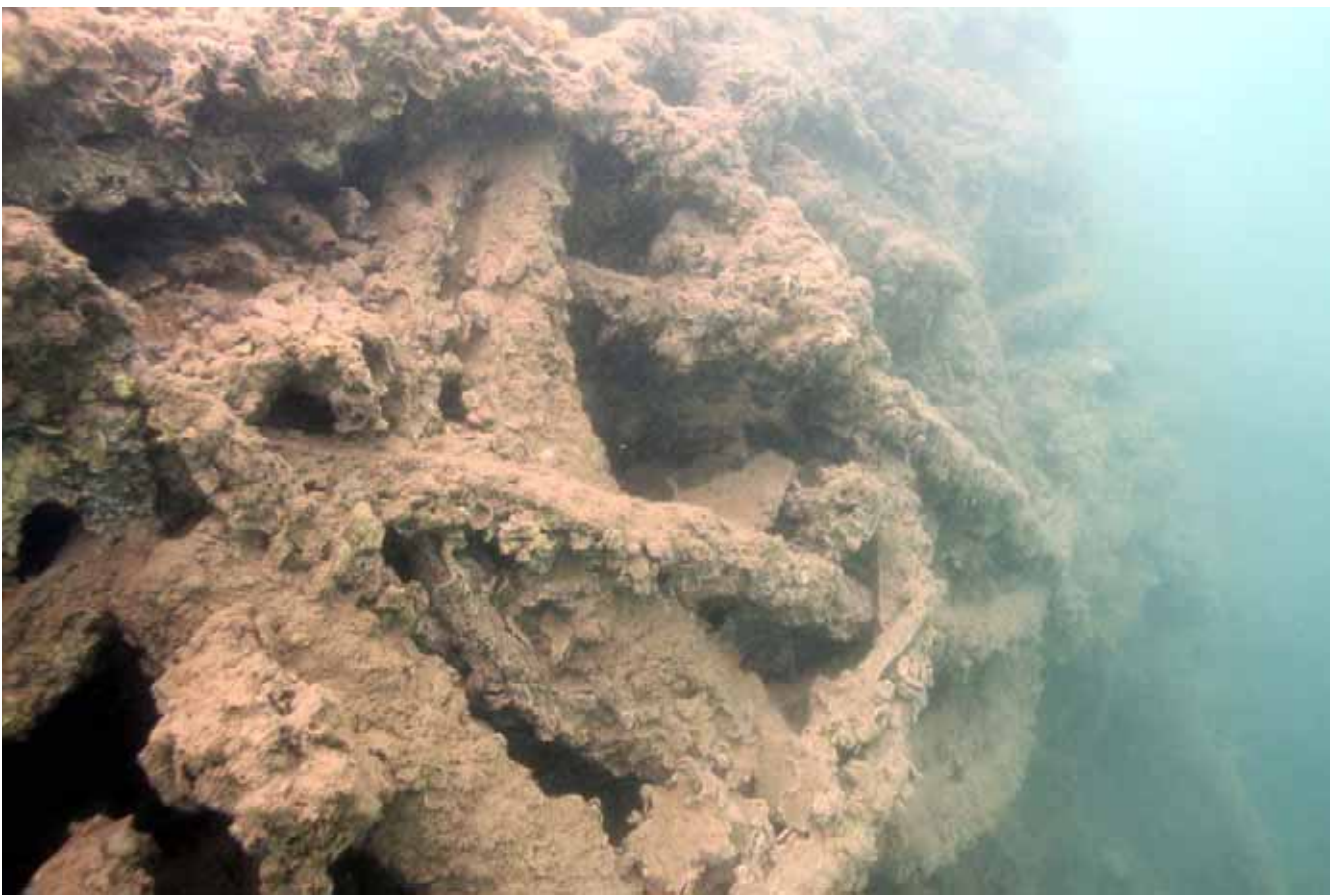
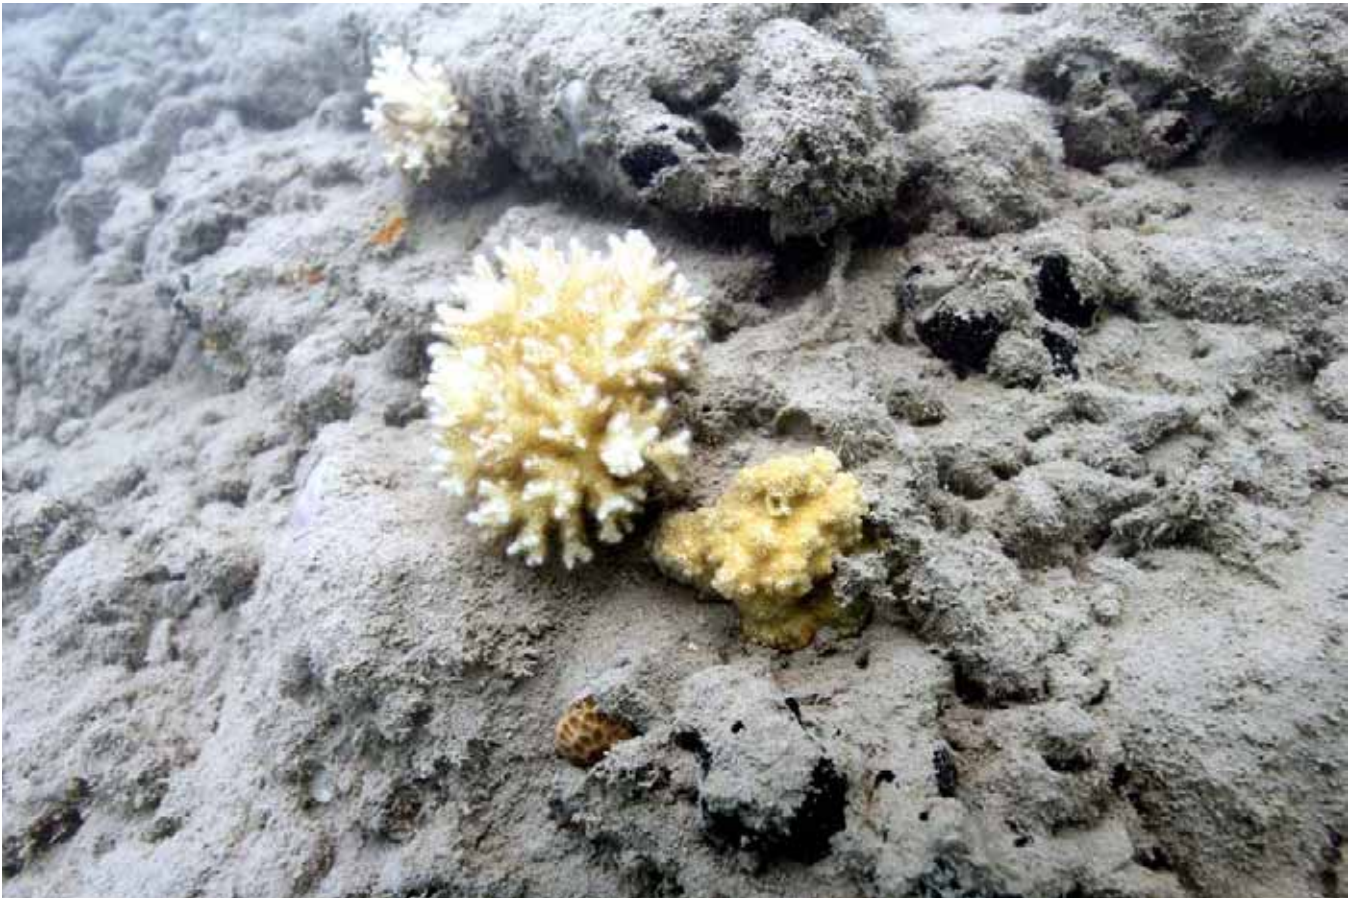
FIGURE 30. SECTOR F. Upper photo shows encrusted debris covering vertical channel wall at eastern end of Sector F. Numerous dead and sediment covered colonies of *Porites lobata* can be discerned on the debris. Bottom photo shows small colonies of *Pocillopora damicornis*, *Cyphastrea ocellina*, and *Leptastrea purpurea* on dredged shelf of Sector F. *Pocillopora damicornis* and *L. purpurea* were abundant throughout the survey area while *C. ocellina* was rarely observed. For location of Sector F, see Figure 4.

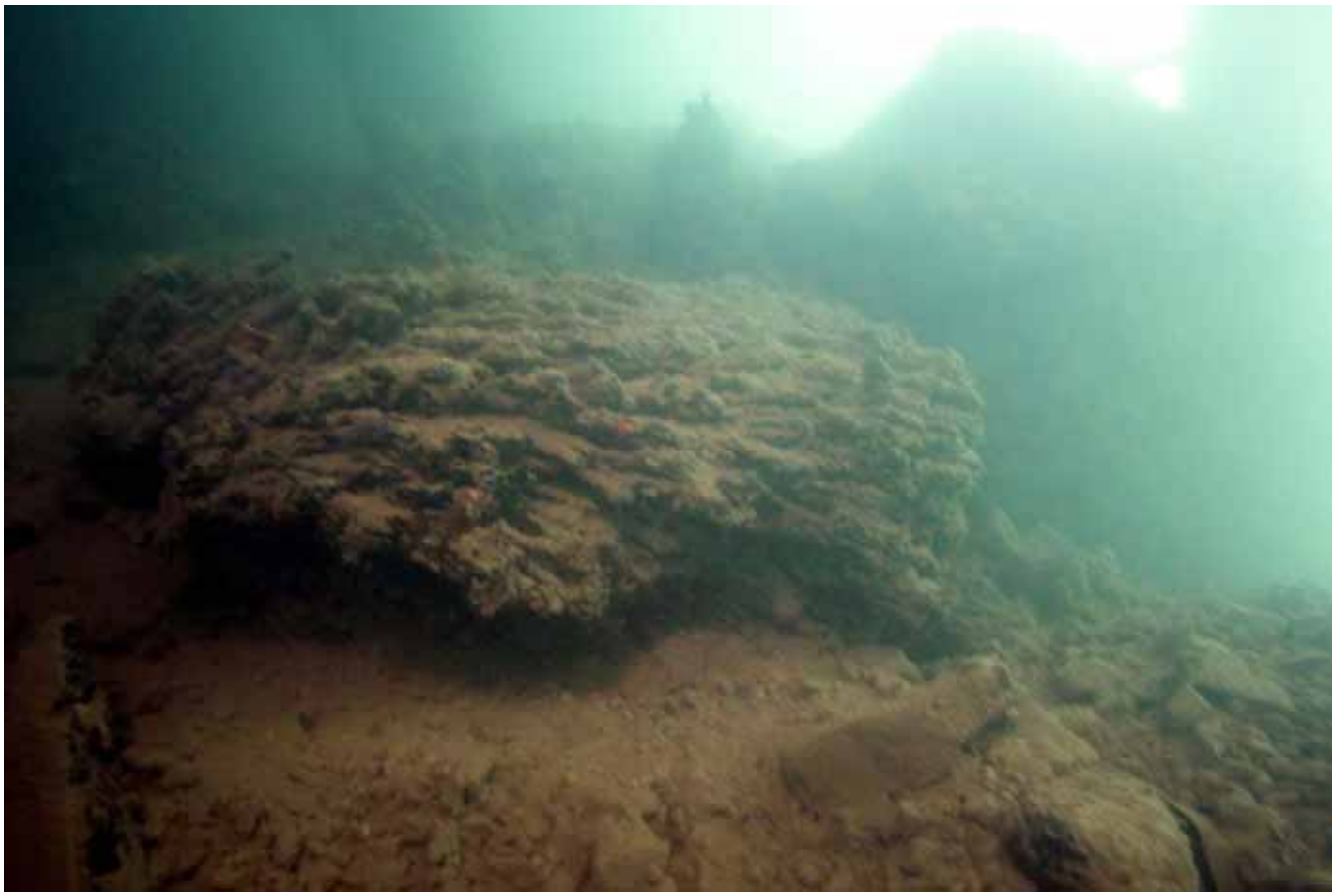
FIGURE 31. SECTOR I. Two photos showing large chunks of calved off sections of old reef that are likely remnants of dredging of Pier 41. For location of Sector I, see Figure 5.

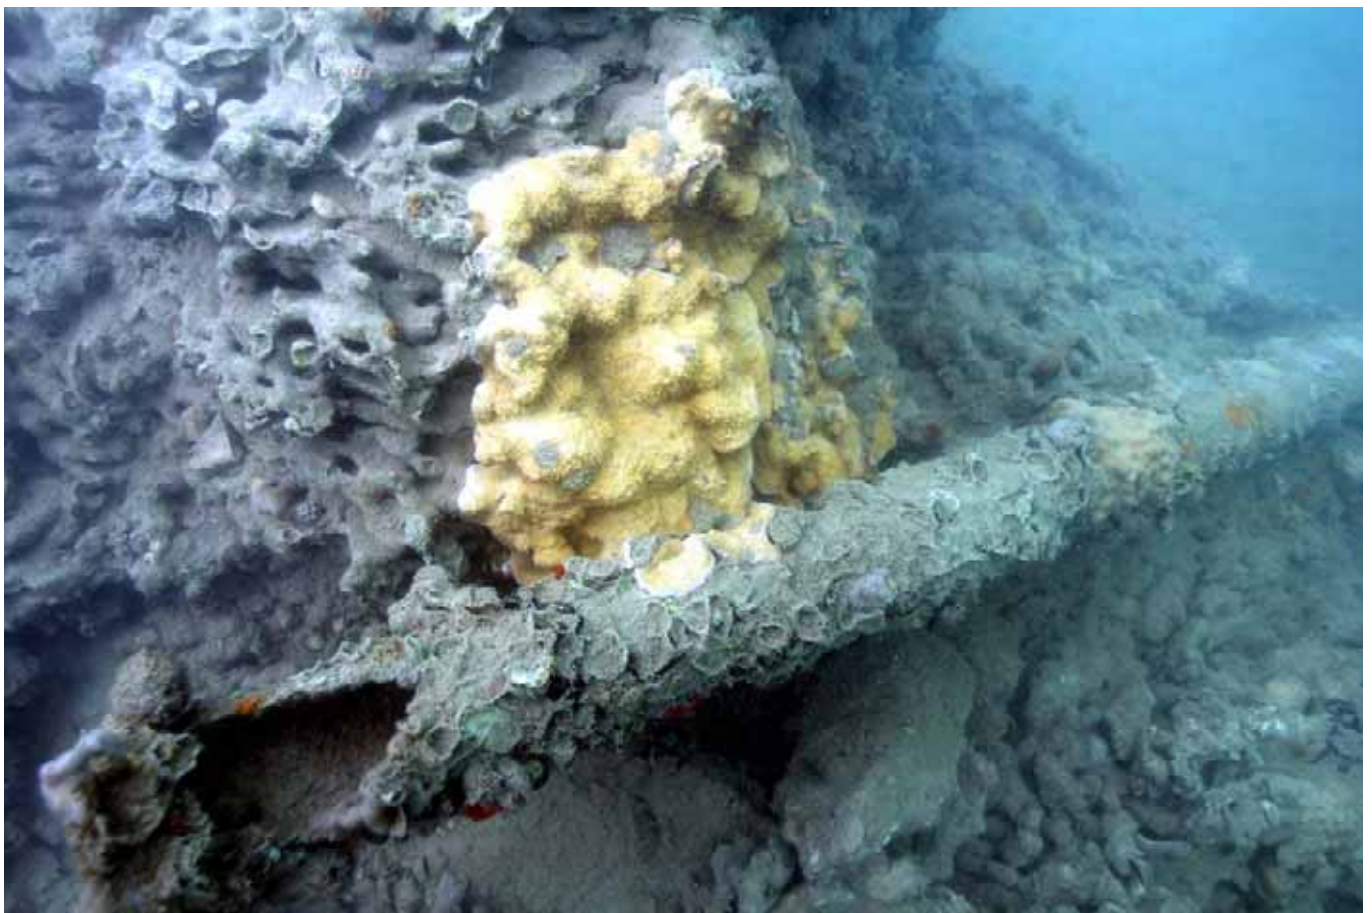
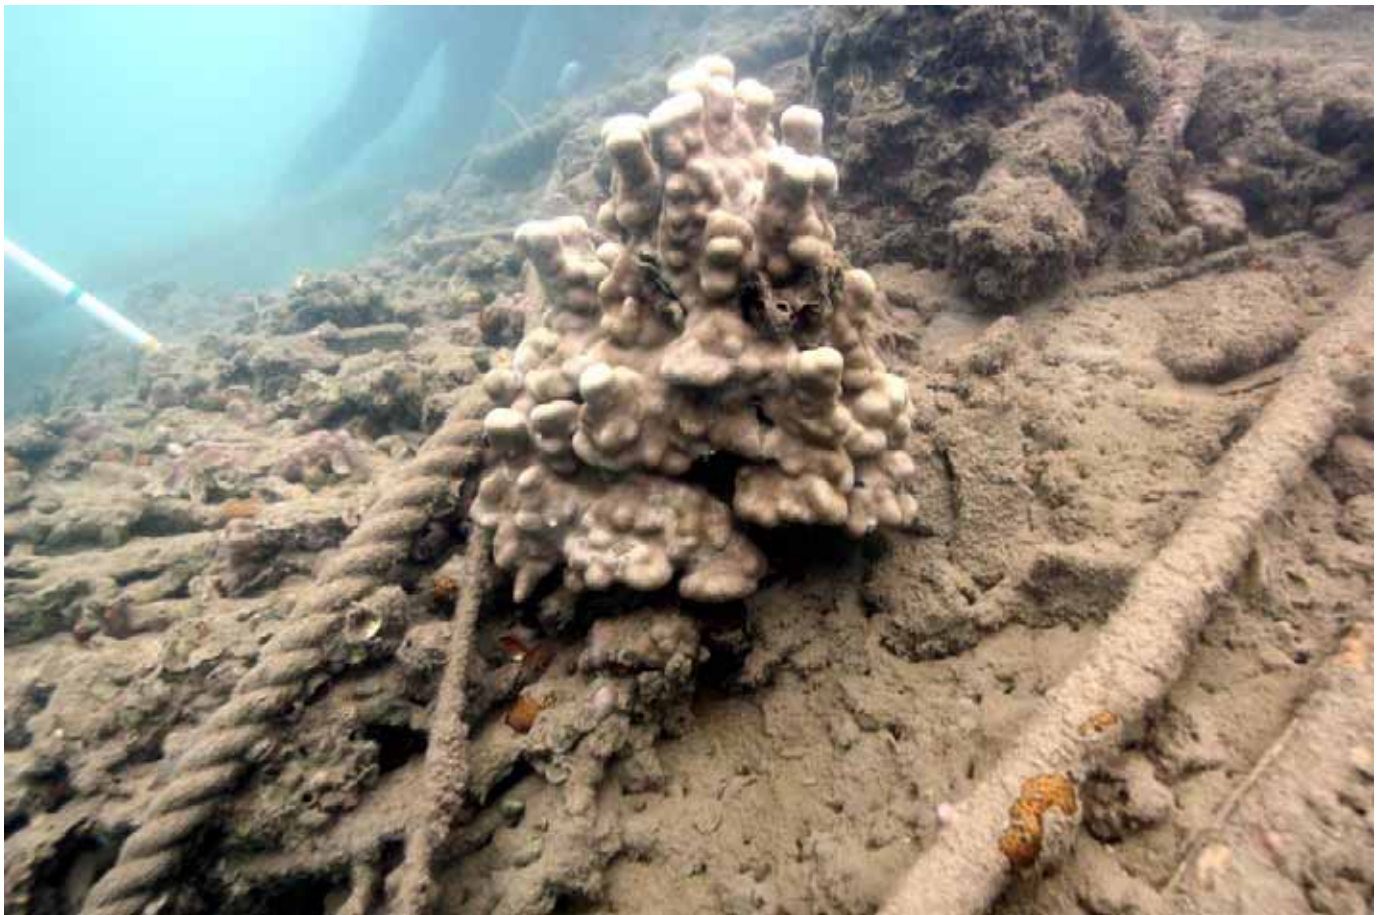
FIGURE 32. SECTOR I. Two photos showing coral colonies growing on dredged platform at inland end of Sector I. For location of Sector I, see Figure 5.

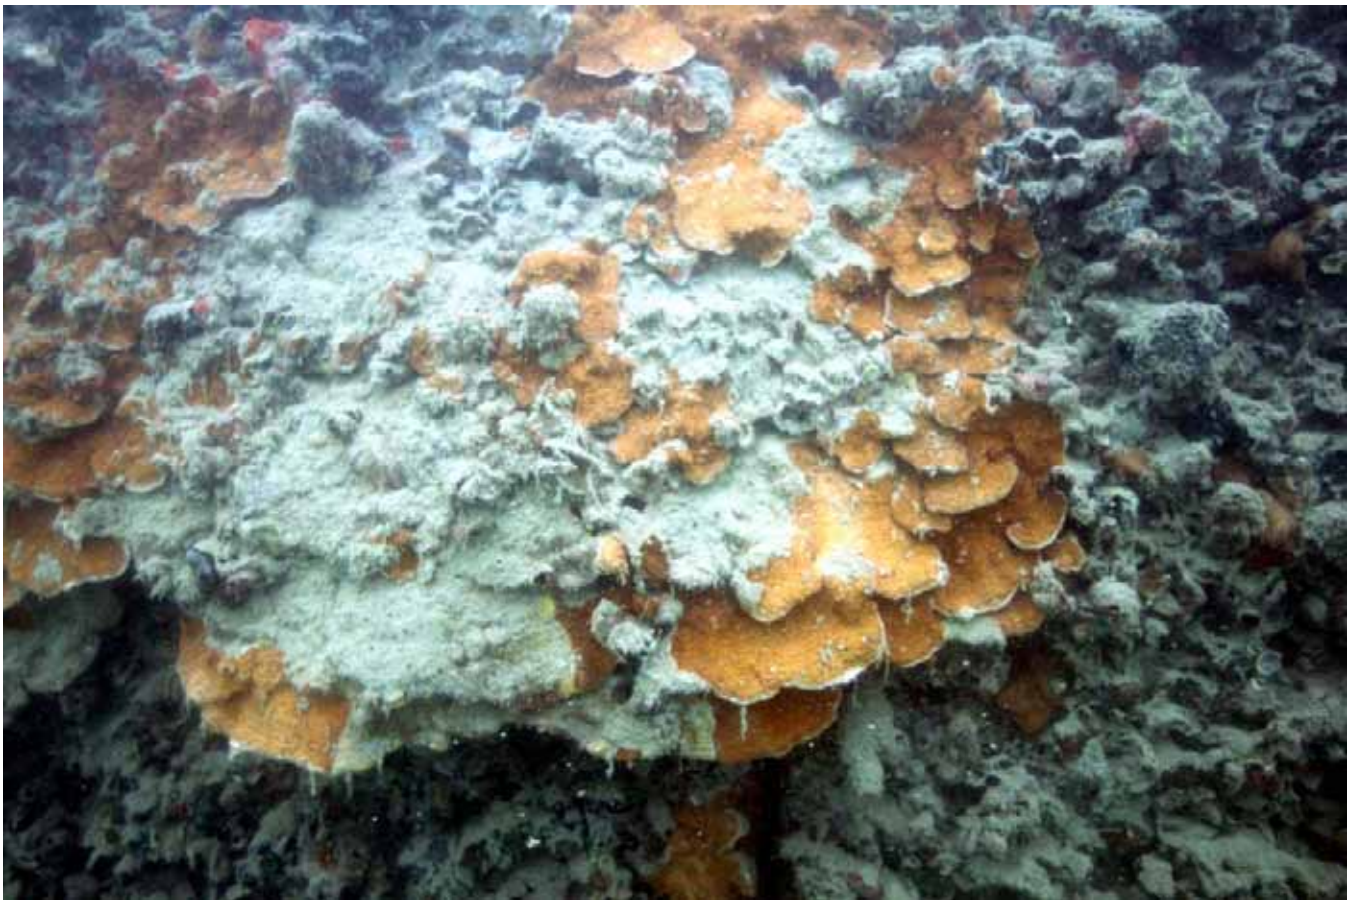
FIGURE 33. SECTOR K. Two photos showing large flat colonies of *Montipora patula* growing on vertical sheet piling comprising Sector K. For location of Sector K, see Figure 5.

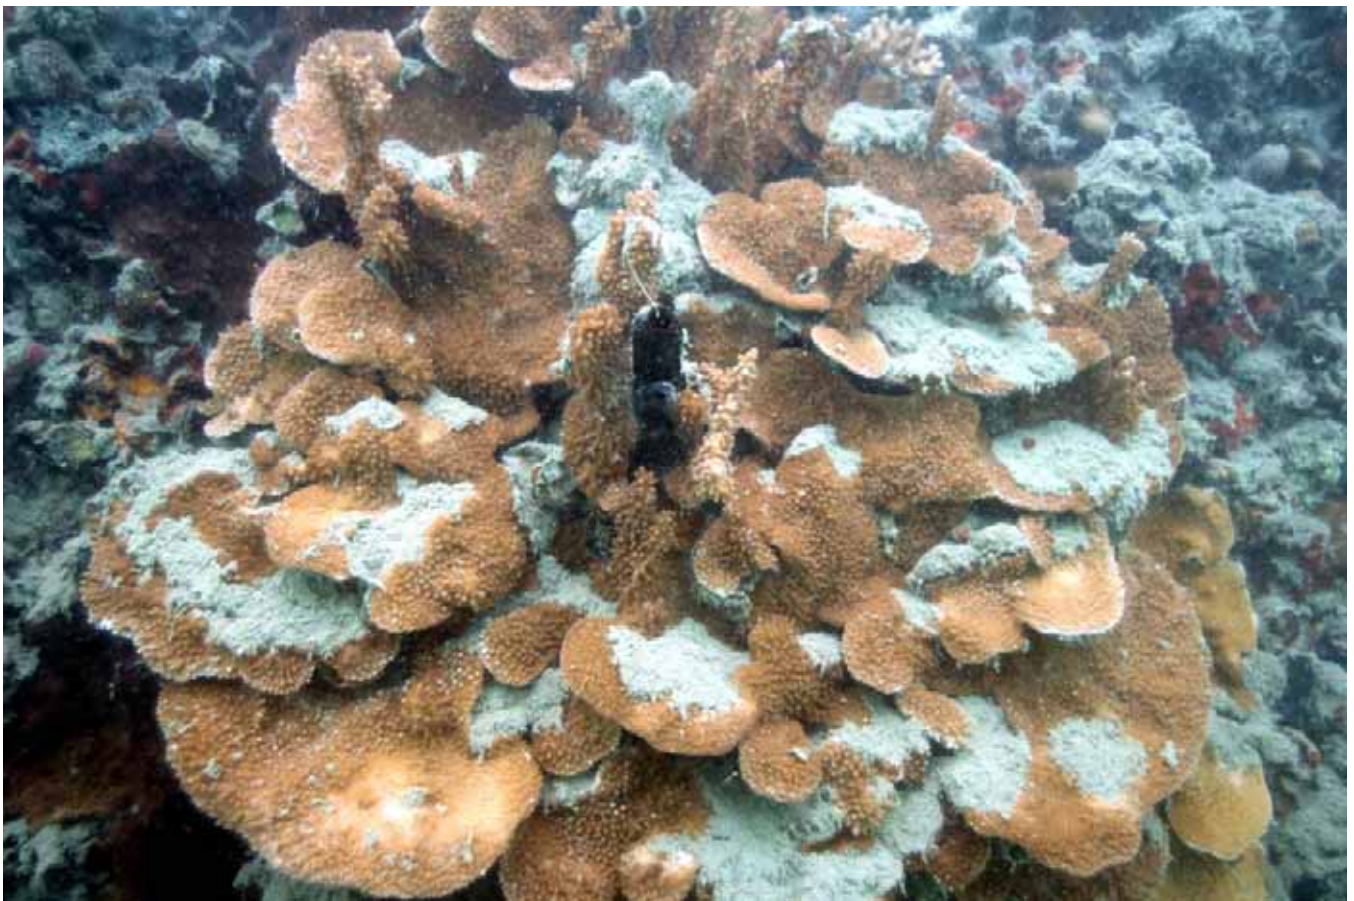
FIGURE 34. SECTOR K. Two photos of colonies of *Montipora capitata* growing on vertical sheet piling comprising Sector K. For location of Sector K, see Figure 5.

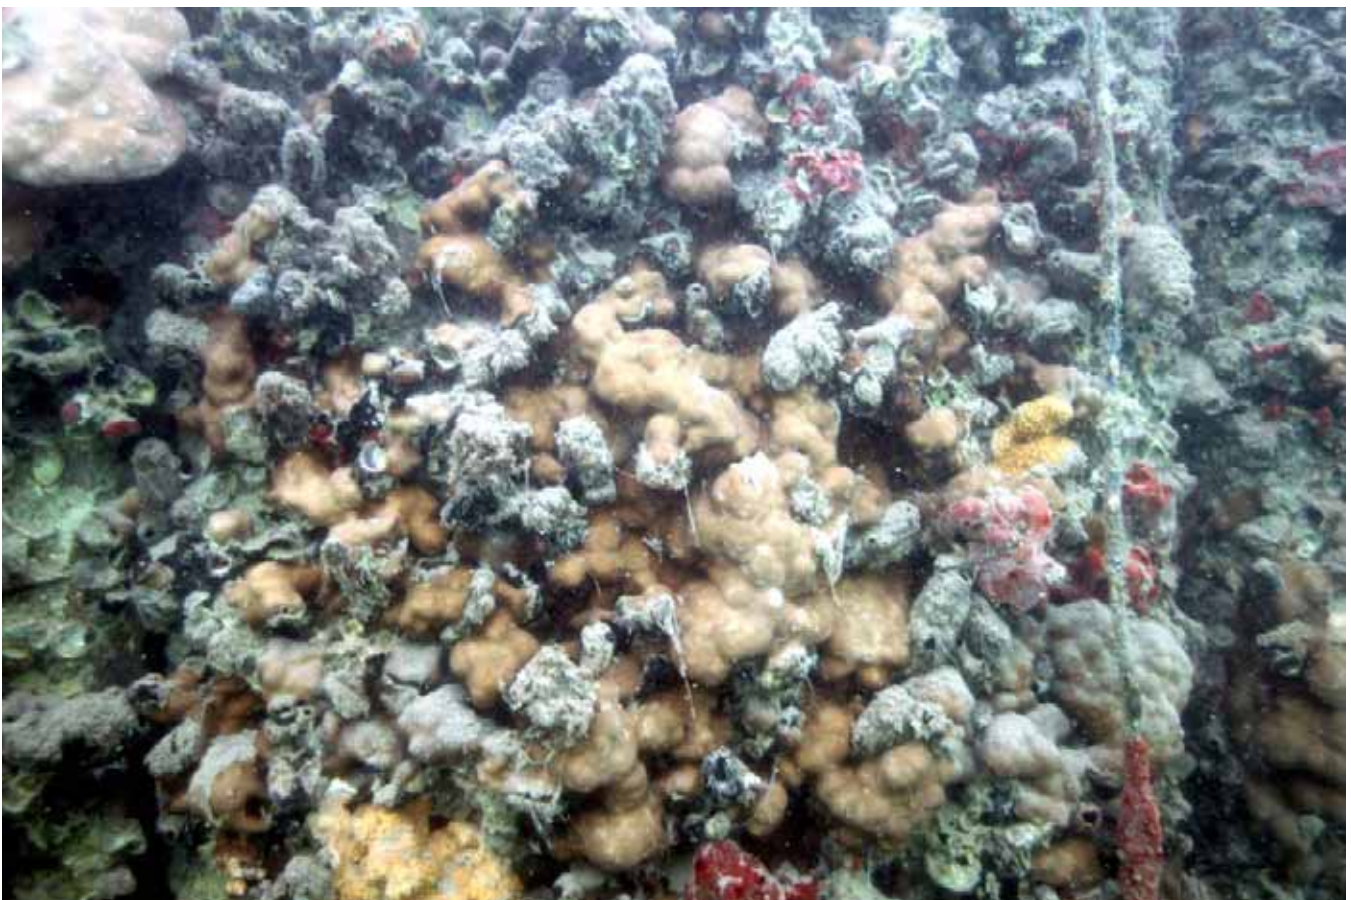
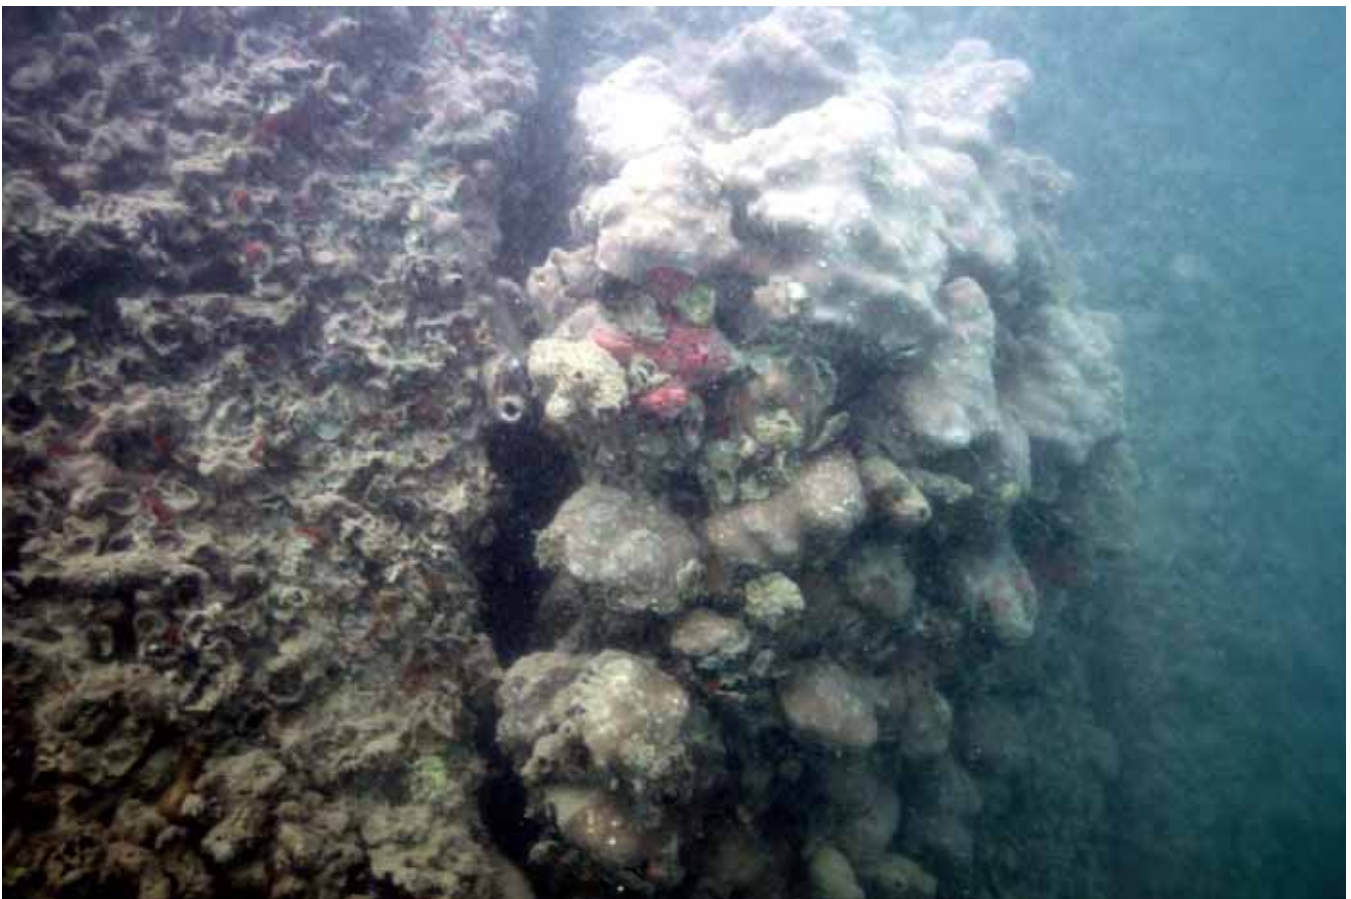
FIGURE 35. SECTOR K. Two photos of colonies of *Porites lobata* growing on vertical sheet piling comprising Sector K. For location of Sector K, see Figure 5.

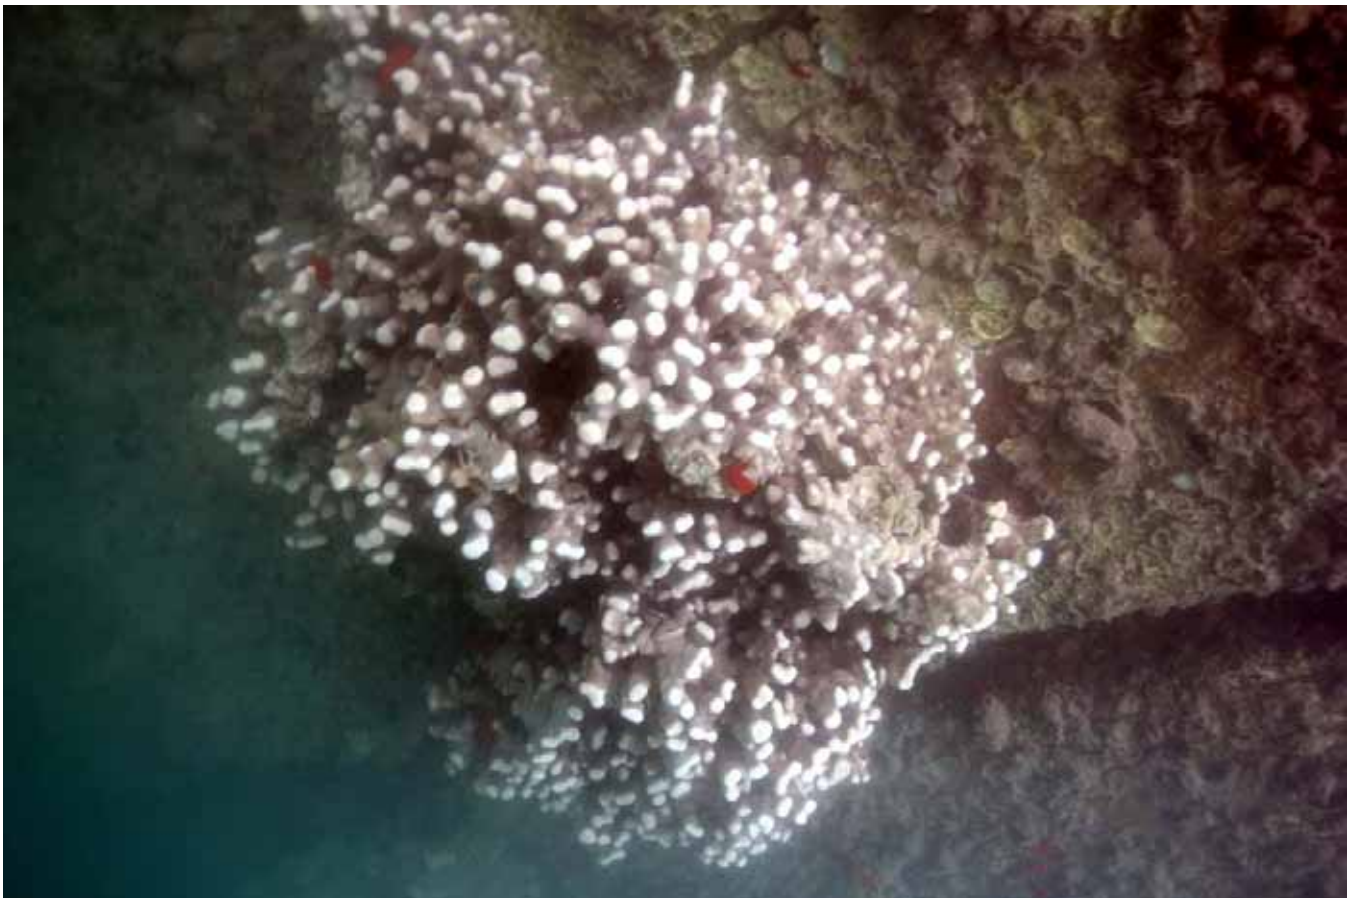
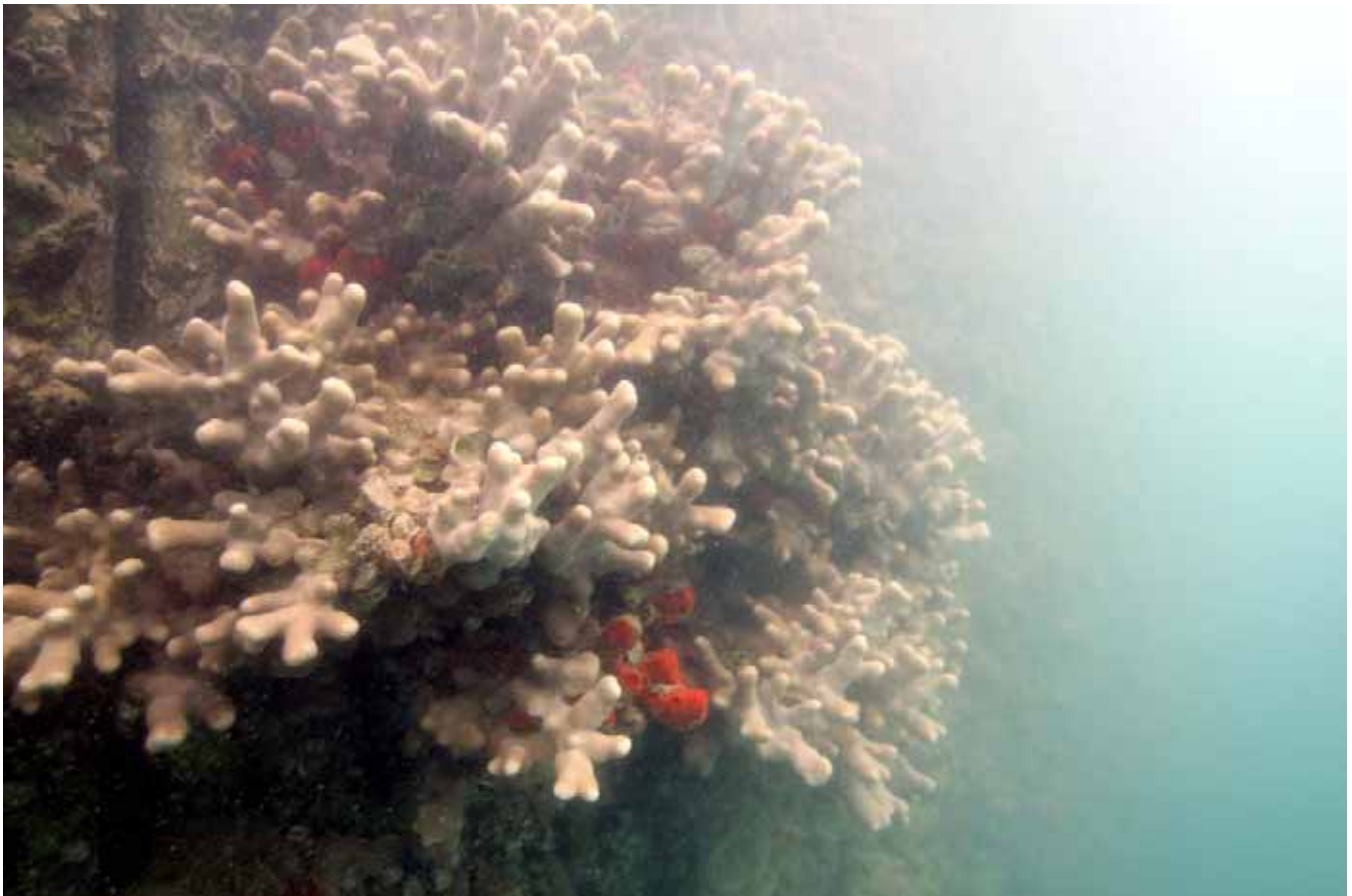
FIGURE 36. SECTOR K. Two photos of colonies of *Porites compressa* growing on vertical sheet piling comprising Sector K. This sector was the only location within the Kapalama Basin survey area where large colonies of *P. compressa* occurred. For location of Sector K, see Figure 5.

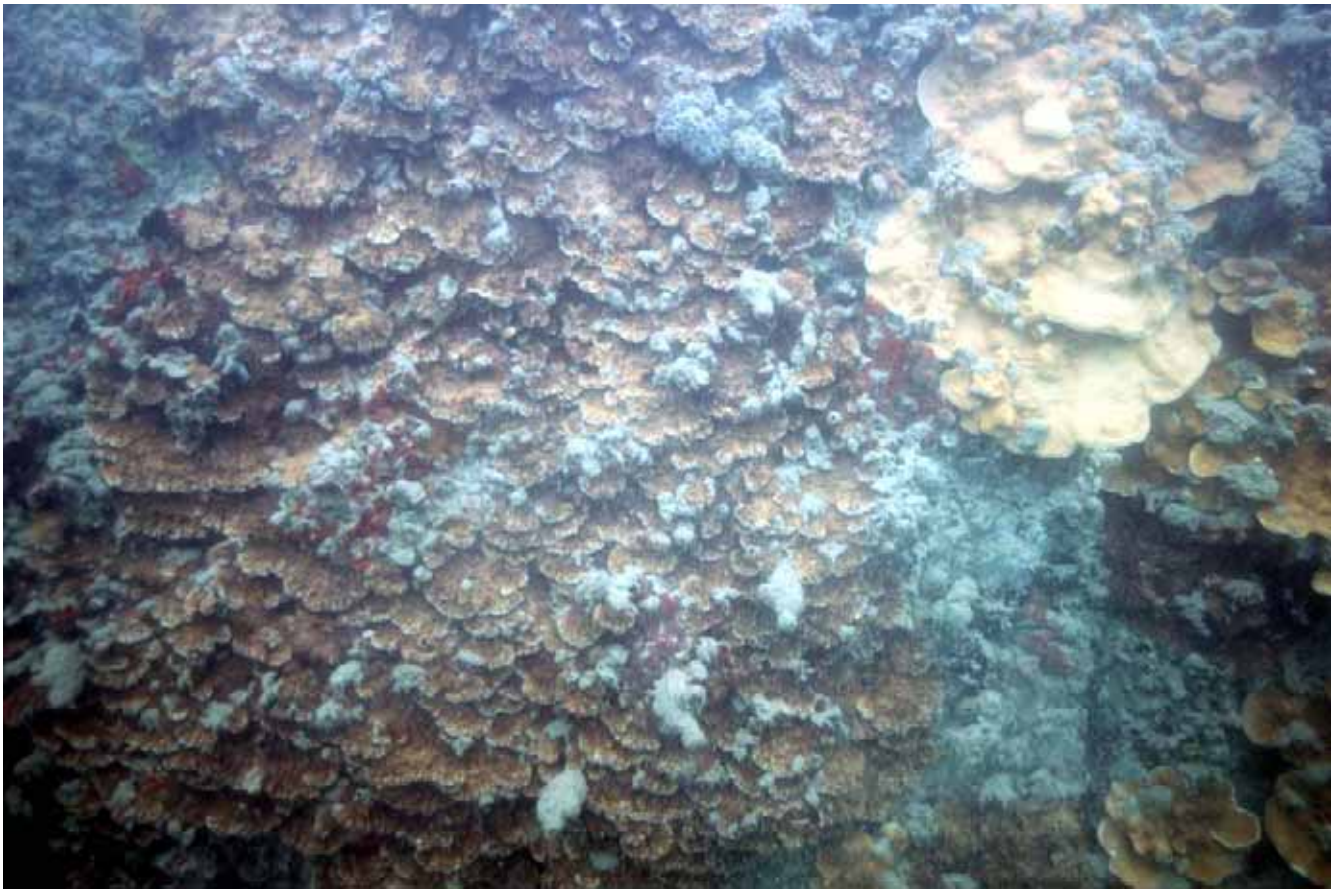
Other corals observed in the Kapalama Basin area are *Pavona varians*, with a growth form consisting of flat encrustations. *Pavona varians* occurred primarily on the sheet-piling of Sector K (Figure 37). *Porites compressa*, commonly referred to as "finger coral" is often one of the most abundant corals in wave-sheltered Hawaiian environments and on deep reef slopes. Only three colonies of *P. compressa* were observed in Kapalama Basin, all occurring in Sector D (Figure 36). One colony each of *Porites monticulosa* (Figure 37) and *Pocillopora eydouxi* were observed throughout the study area, both of which occurred in Sector K (Figure 38).

FIGURE 37. SECTOR K. Upper photo shows large colony of overlapping plates of *Pavona varians* on sheet piling comprising Sector K. While other colonies of *P. varians* was observed sporadically in other sectors of the Kapalama survey area, none were as large as the one shown. Lower photo shows a large encrusting colony of *Porites monticulosa*, which was the only colony of this species observed anywhere in the study area. For location of Sector K, see Figure 5.

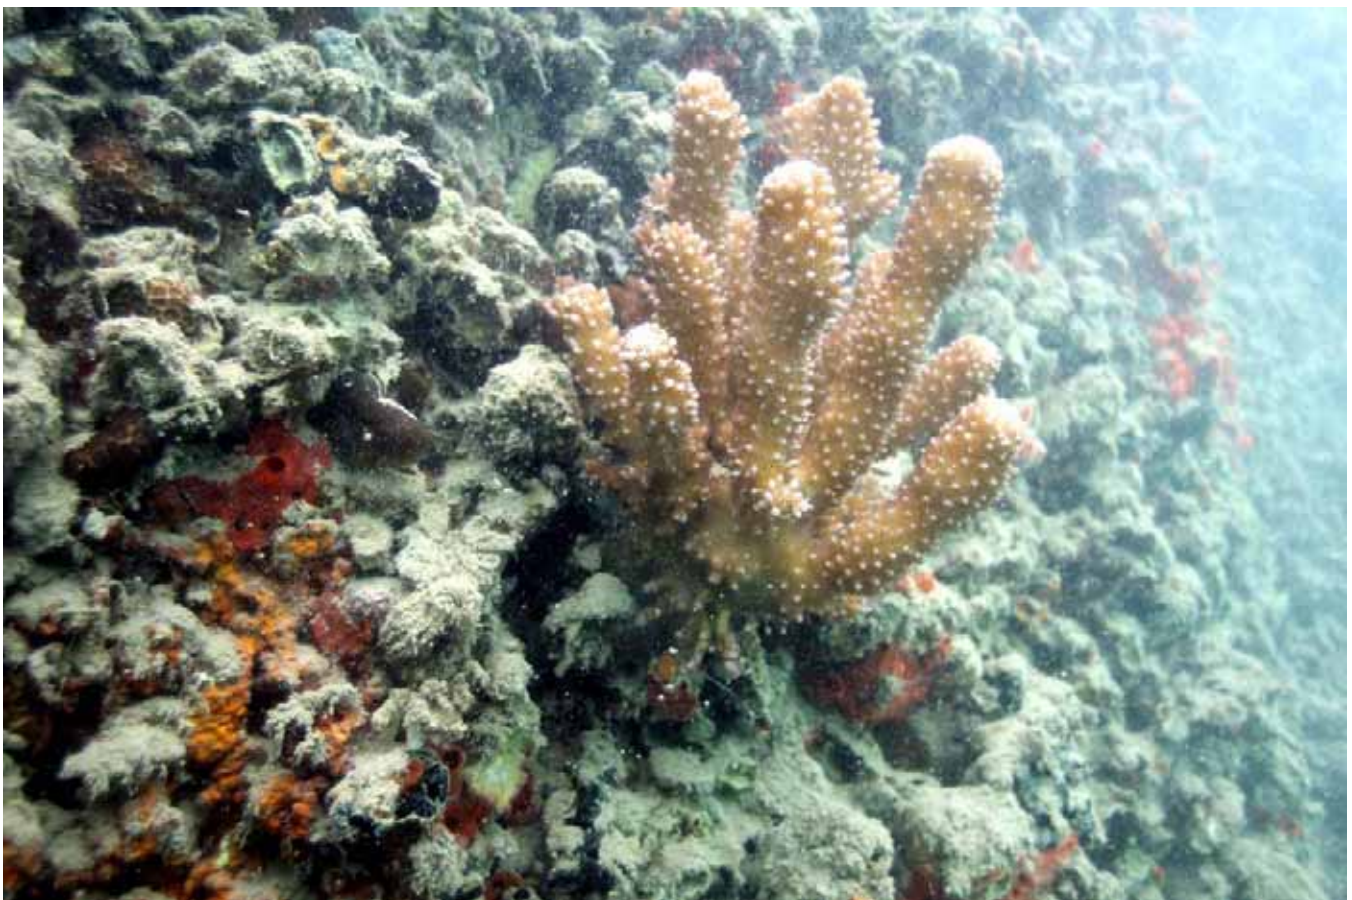
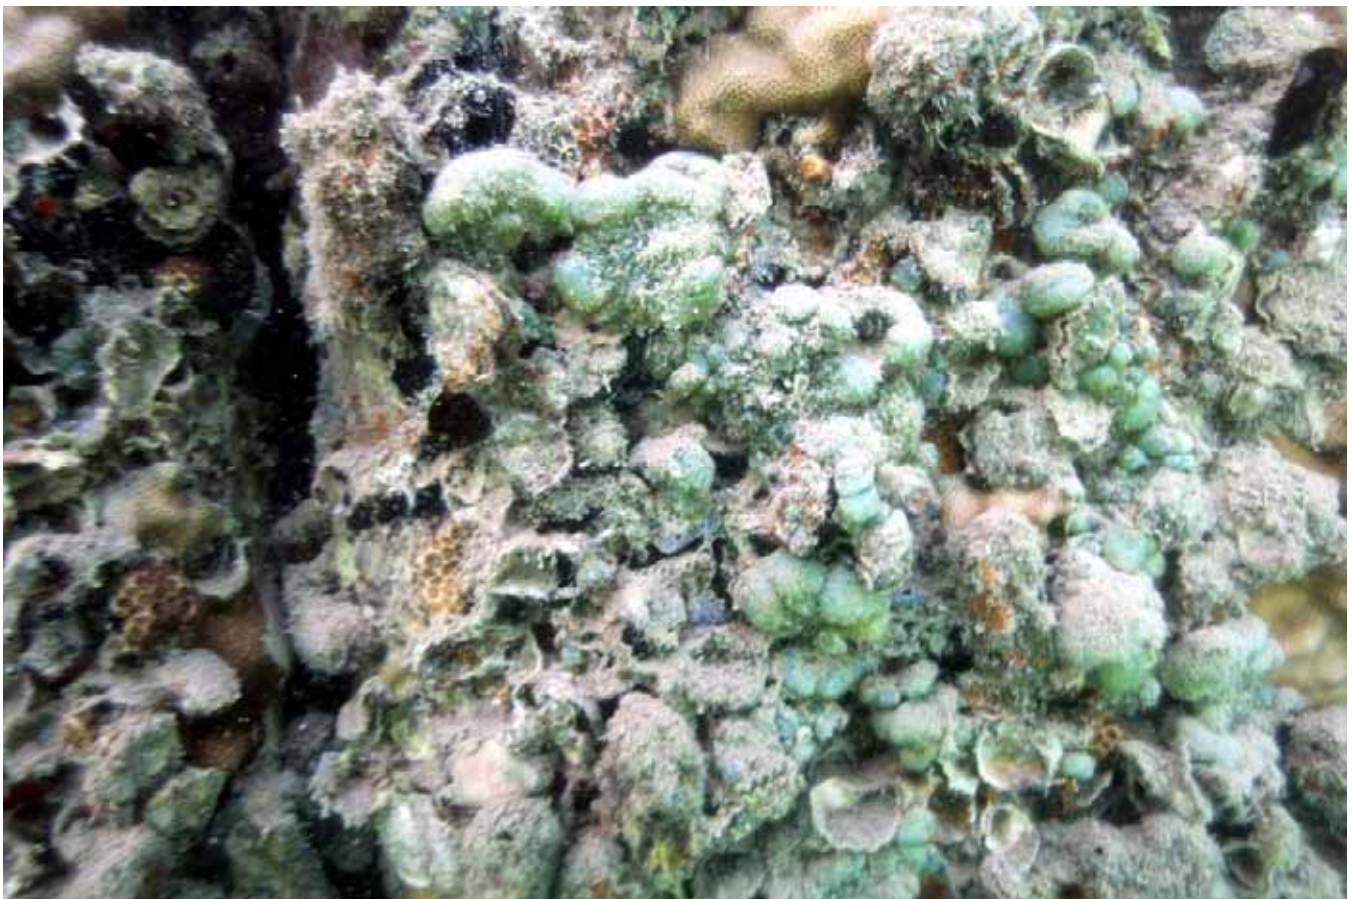
FIGURE 38. SECTOR K. Upper photo shows single colony of *Pocillopora eydouxi* on sheet piling comprising Sector K. This colony was the only one of the species observed in the Kapalama survey area. Lower photo shows encrustations of the green alga *Dictyosphaeria cavernosa* growing on the sheet piling of Sector K. Frondose algae were extremely rare throughout the Kapalama survey area. For location of Sector K, see Figure 5.

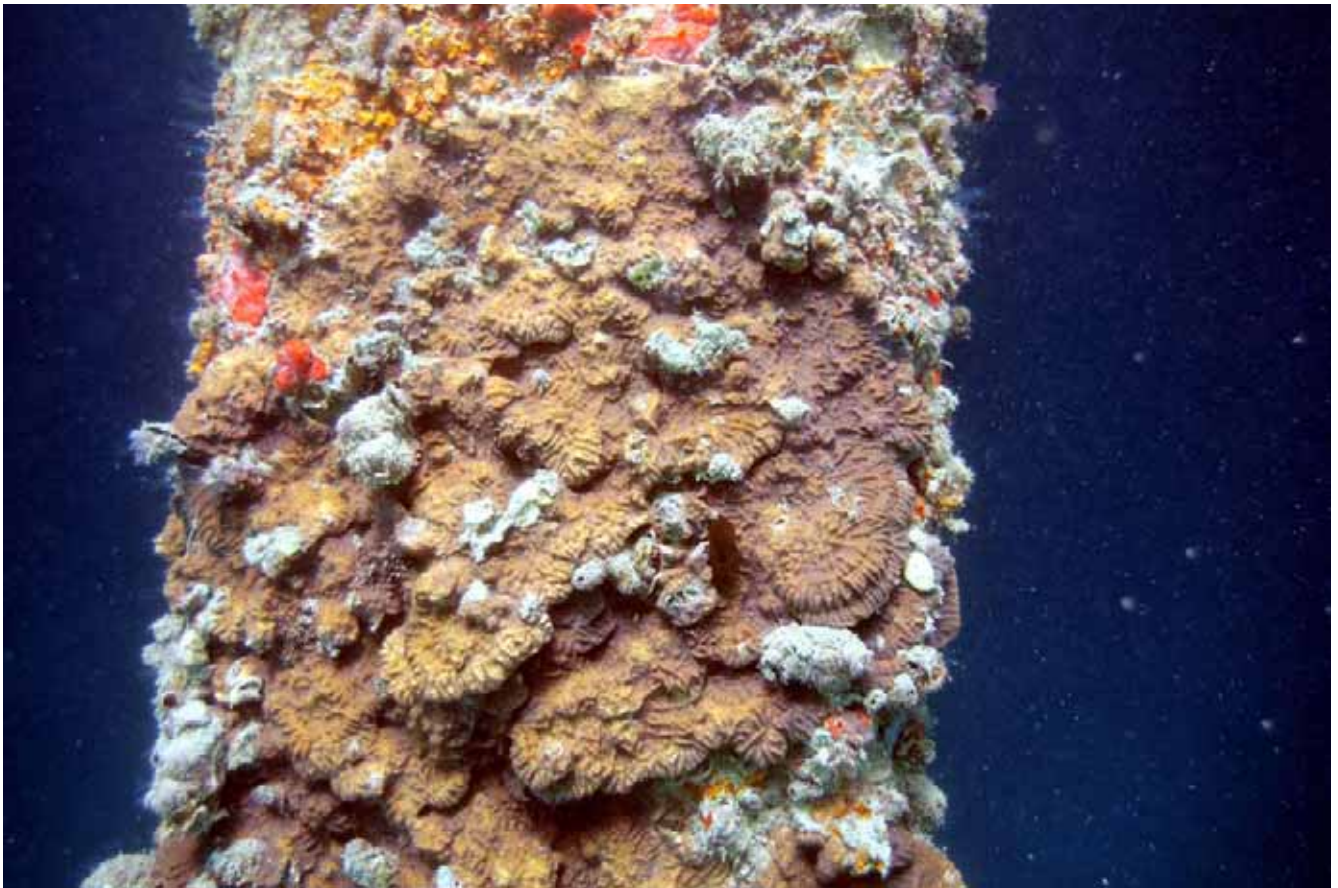
The second most abundant species was *Leptastrea purpurea*, which occurs within the Harbor as small generally round or oval shaped encrustations (Figures 21 and 39). All colonies observed were less than 20 cm in longest diameter (Table 3). Few of the smaller size-classes of both *P. damicornis* and *L. purpurea* exhibited signs of sediment damage.

FIGURE 39. SECTOR P-24. Colonies of *Leptastrea purpurea* (top) and *Pavona varians* (bottom) on concrete piles on Pier 24 in area proposed for placement of PSI drydock. For location of Sector P-24, see Figure 6.

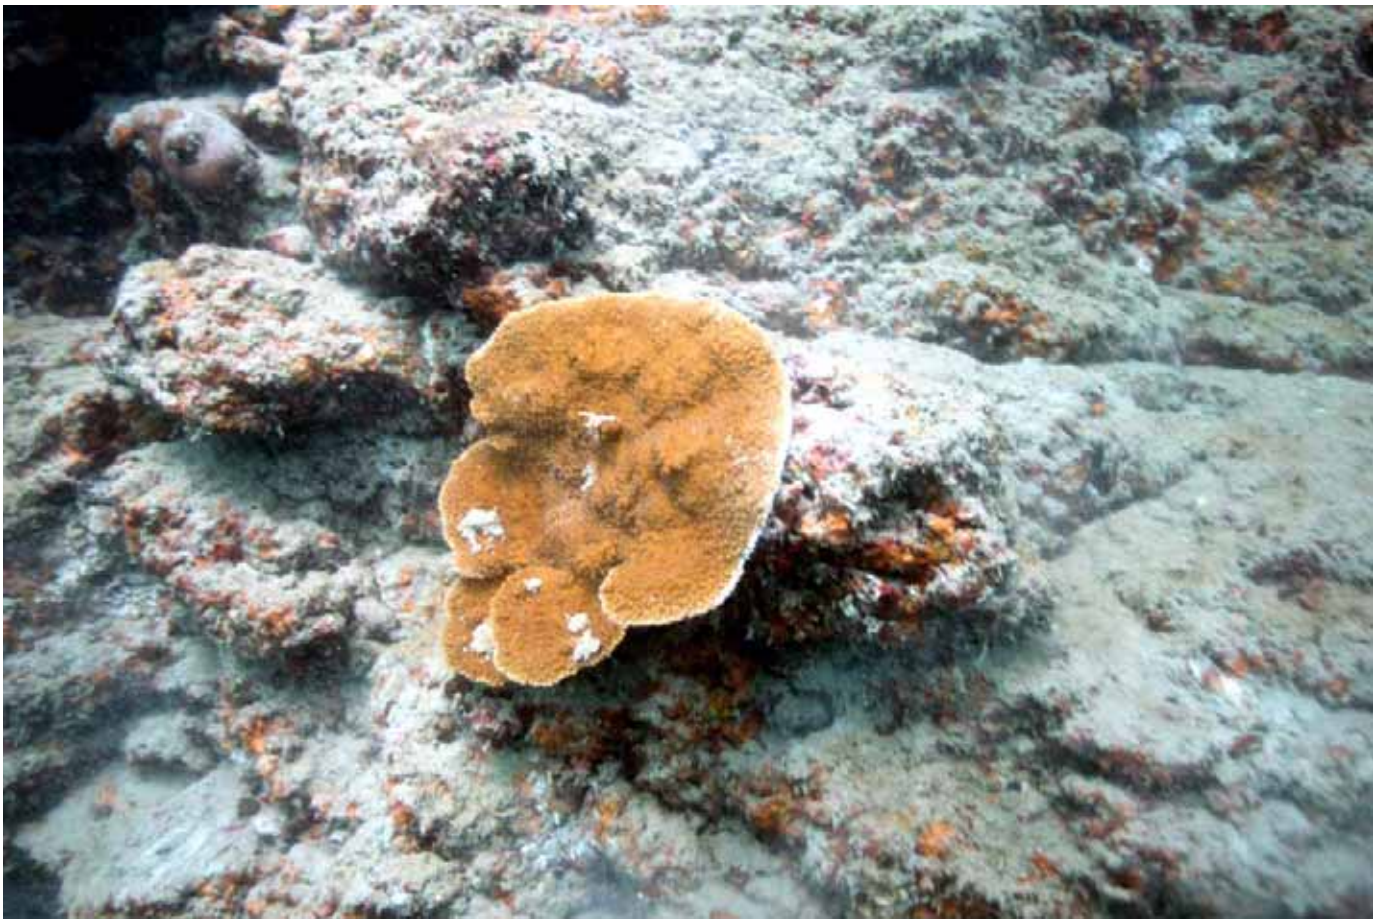
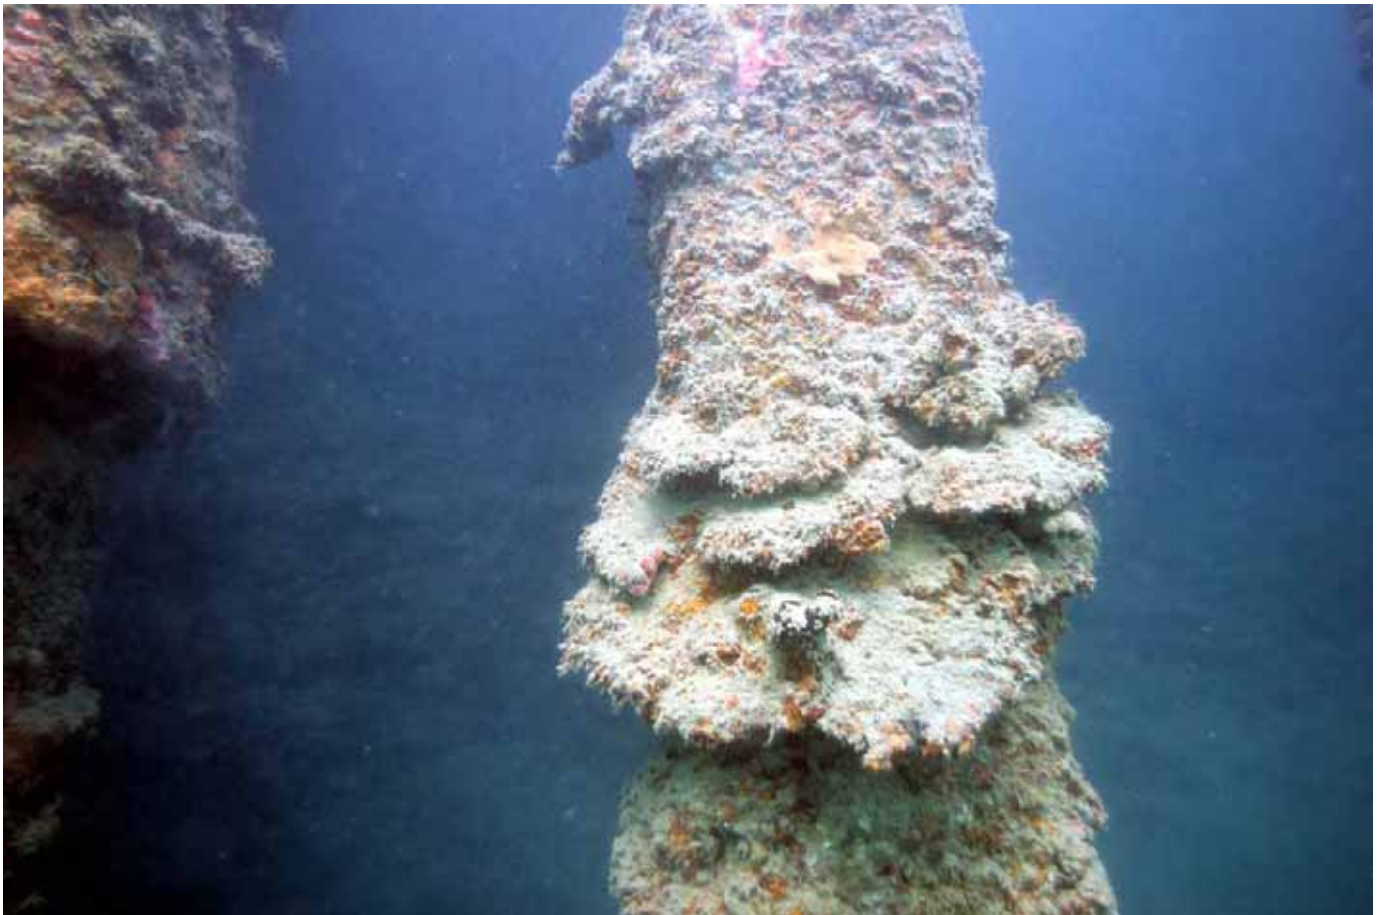
FIGURE 40 SECTOR P-24. Colony of *Montipora capitata* growing of dredged shoreline underneath Pier 24 (top). Bottom photo shows skeletal remnants of overlapping plating colony, likely *Montipora* spp., on concrete piles on Pier 24 in area proposed for placement of PSI dry dock. For location of Sector P-24, see Figure 6.
