**AN ASSESSMENT OF THE MARINE BIOLOGICAL
COMMUNITY STRUCTURE IN THE VICINITY OF THE PROPOSED
KAPALAMA CONTAINER TERMINAL
HONOLULU, HAWAI'I**

**State of Hawaii
Department of Transportation
Harbors Division**

October 15, 2012

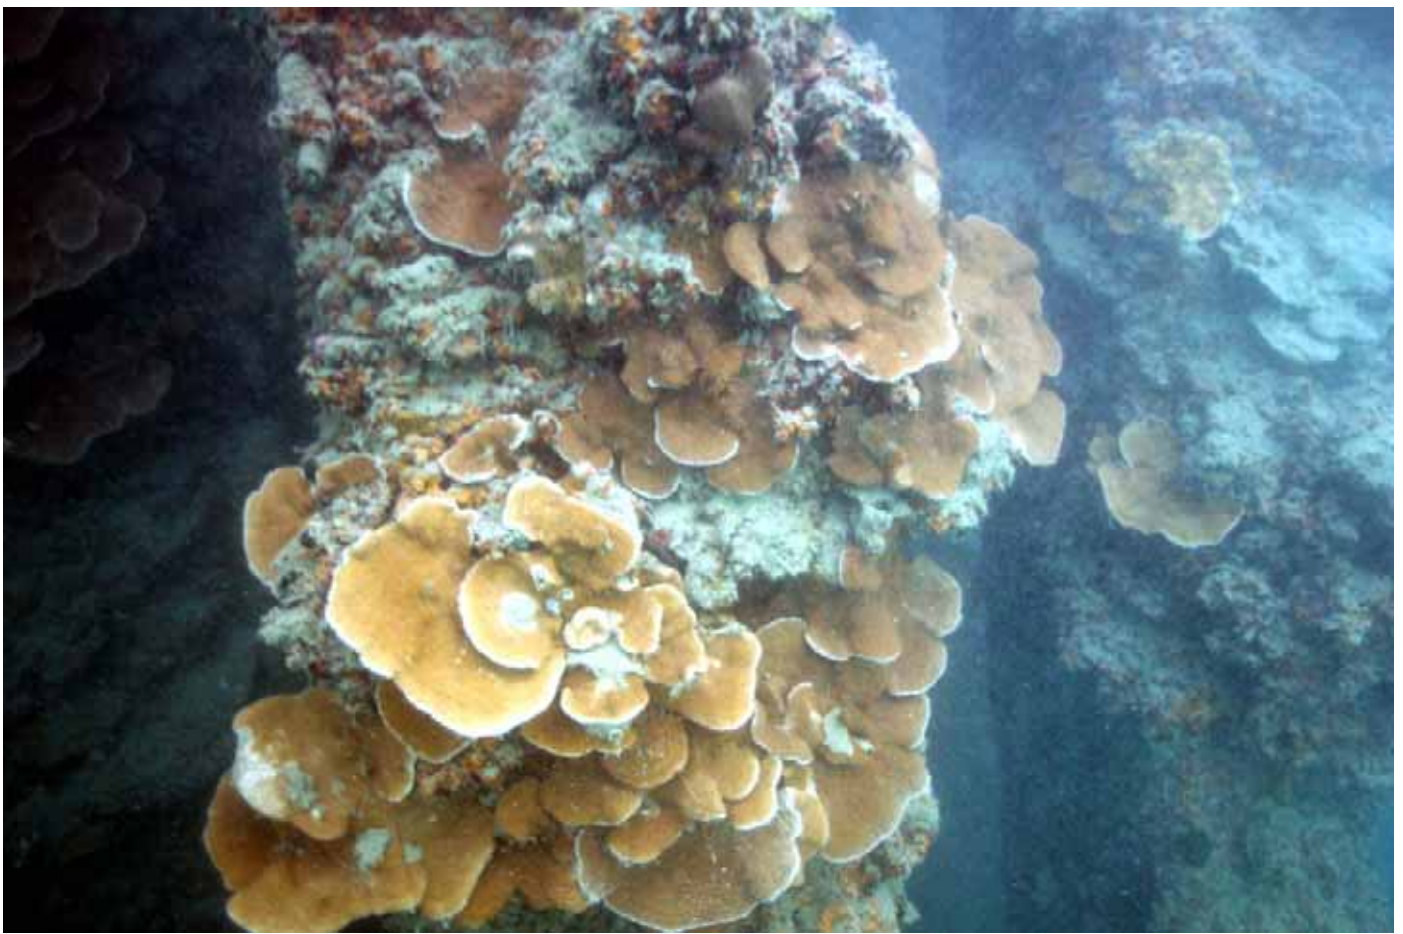
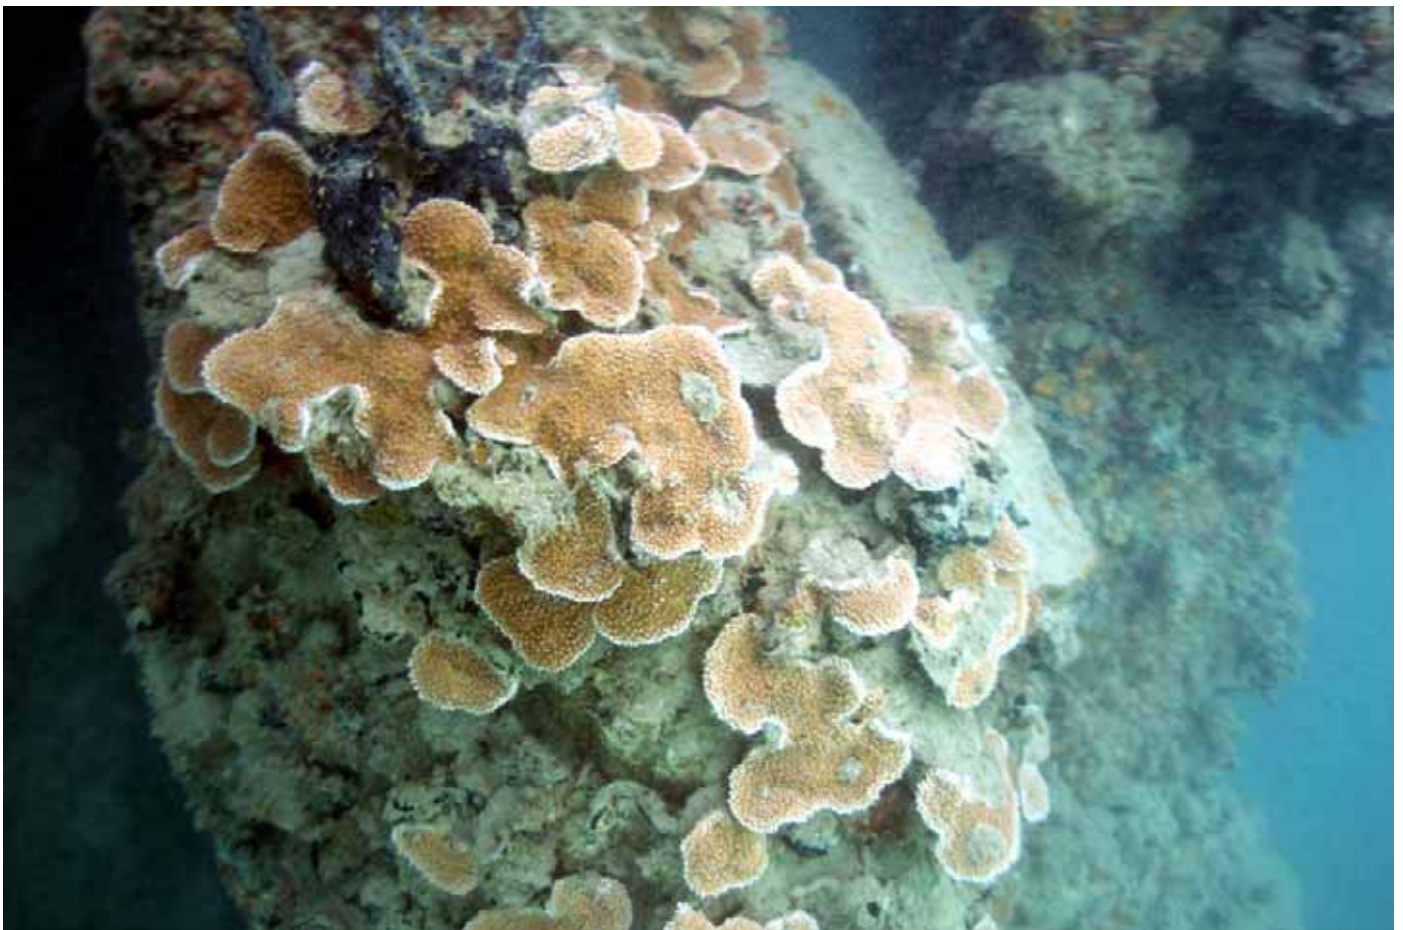
FIGURE 41. SECTOR P-26. Colonies of *Montipora* spp. on pilings comprising Pier 26. Note in bottom photo separation of plates in discrete “sub-colonies” that may be either the resulting remnants of partial mortality of a large colony or settlement of growth of multiple new colonies on older remnant structure. For location of Sector P-26, see Figure 6.

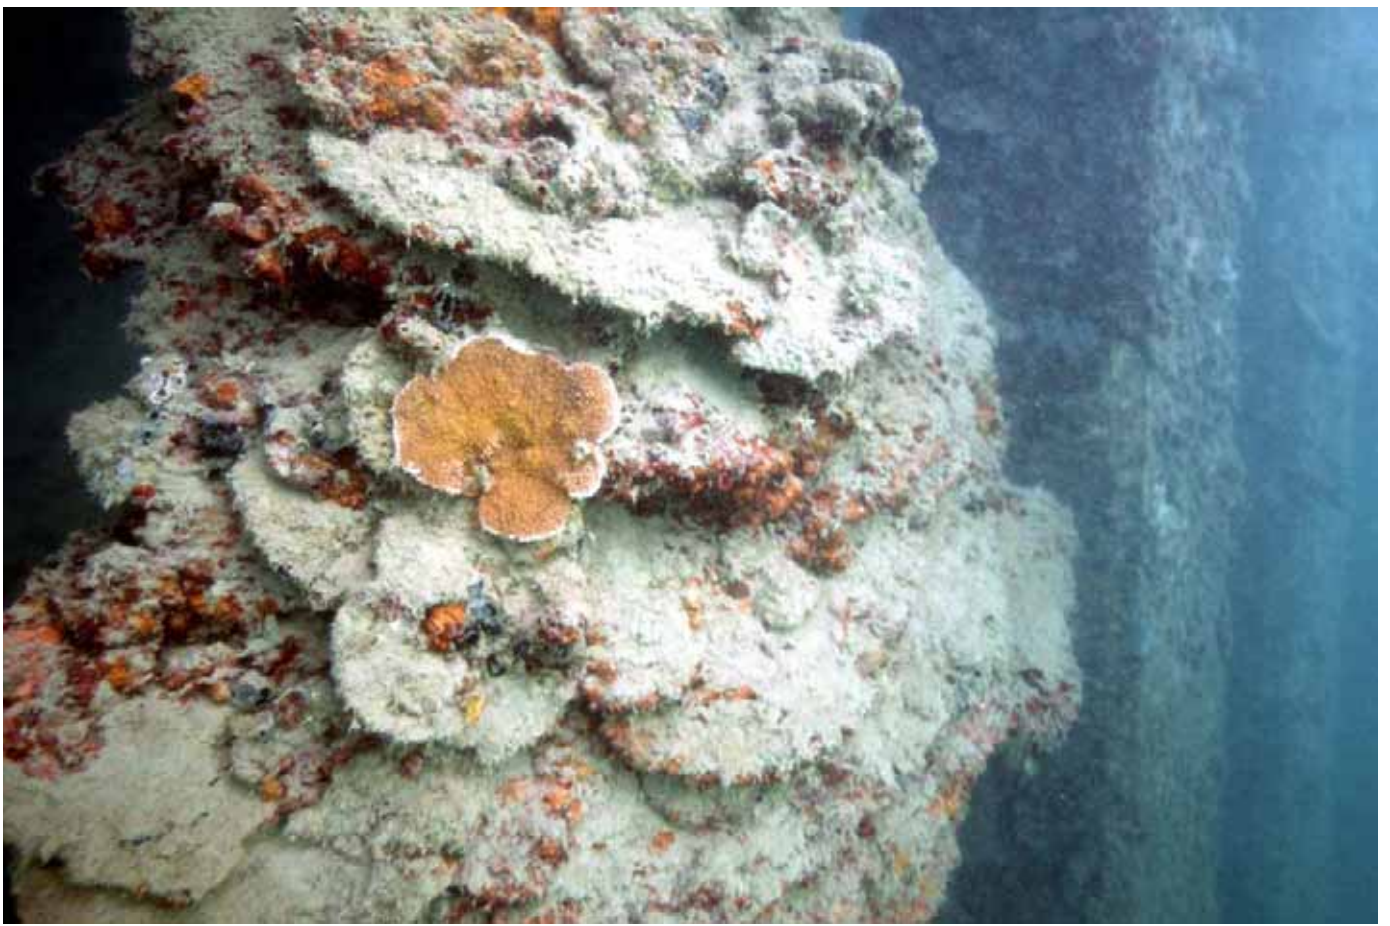
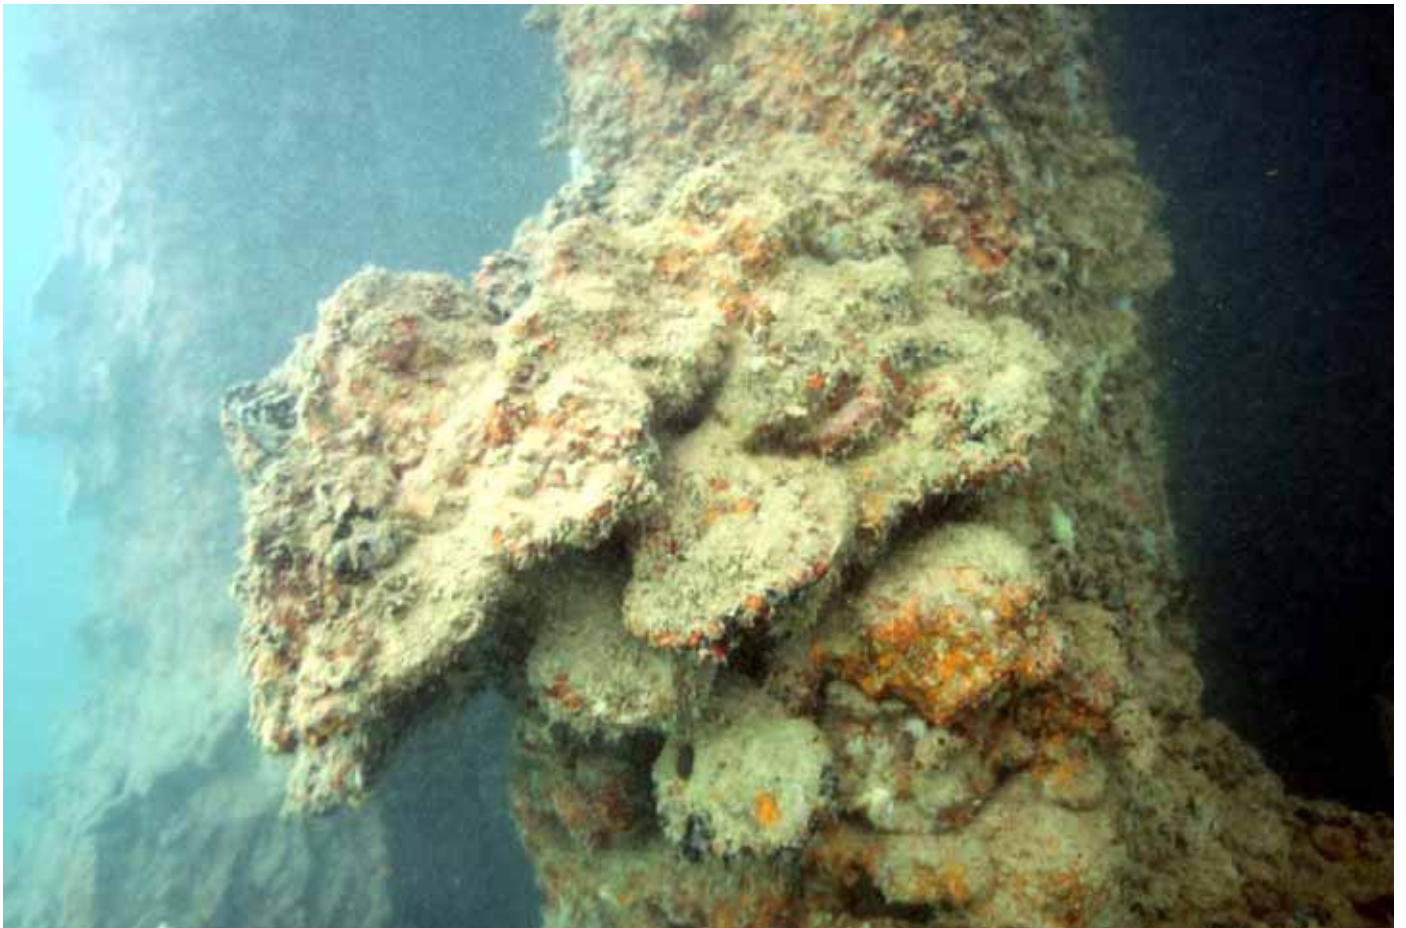
FIGURE 42. SECTOR P-26. Colonies of predominantly dead *Montipora* spp. on pilings comprising Pier 26. Small colony of *M. capitata* in top photo may be either the resulting remnants of partial mortality of a large colony or settlement of growth of multiple new colonies on older remnant structure. For location of Sector P-26, see Figure 6.

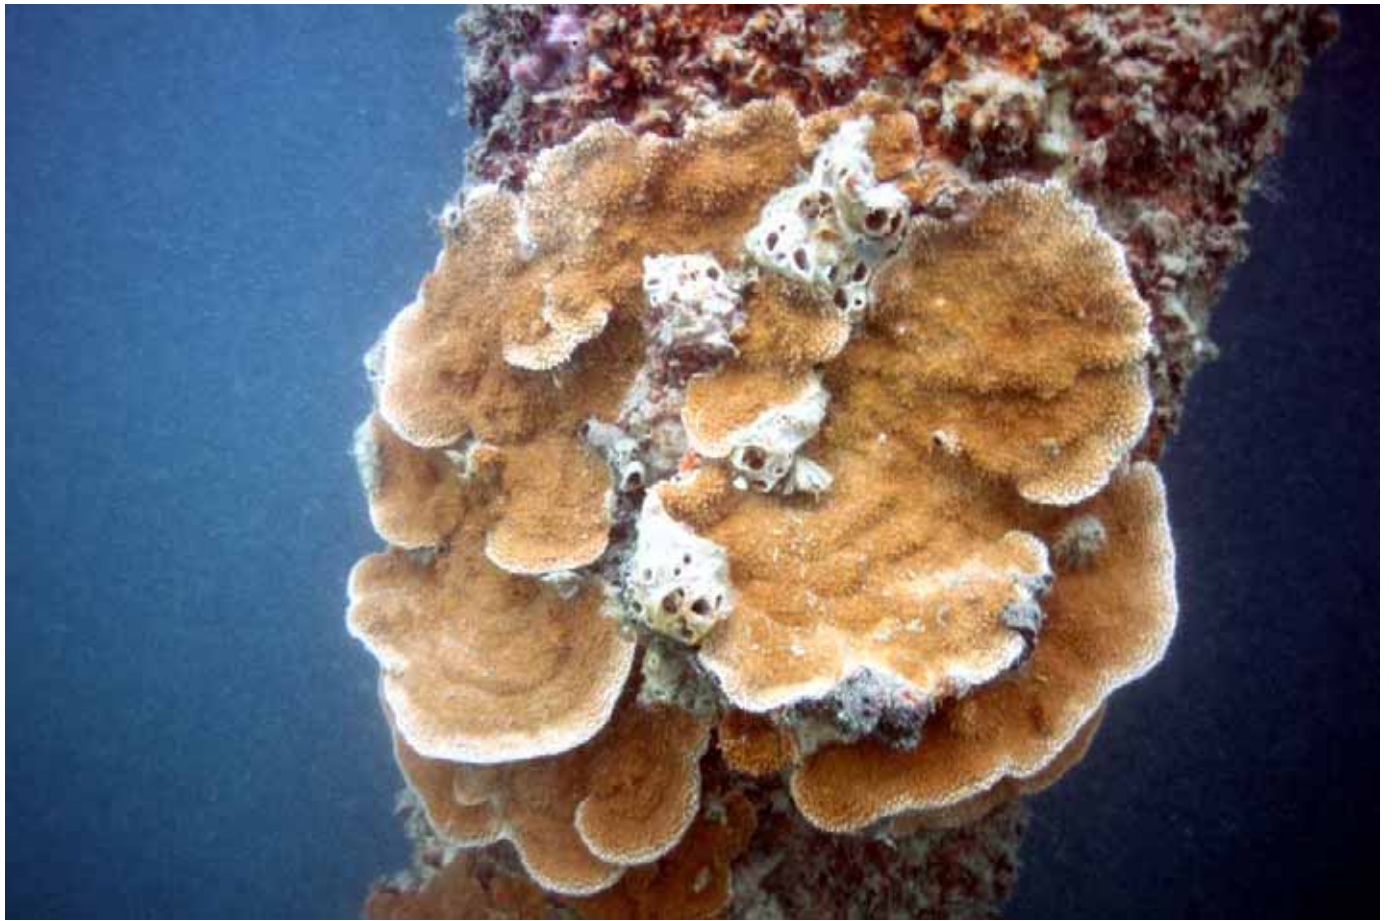
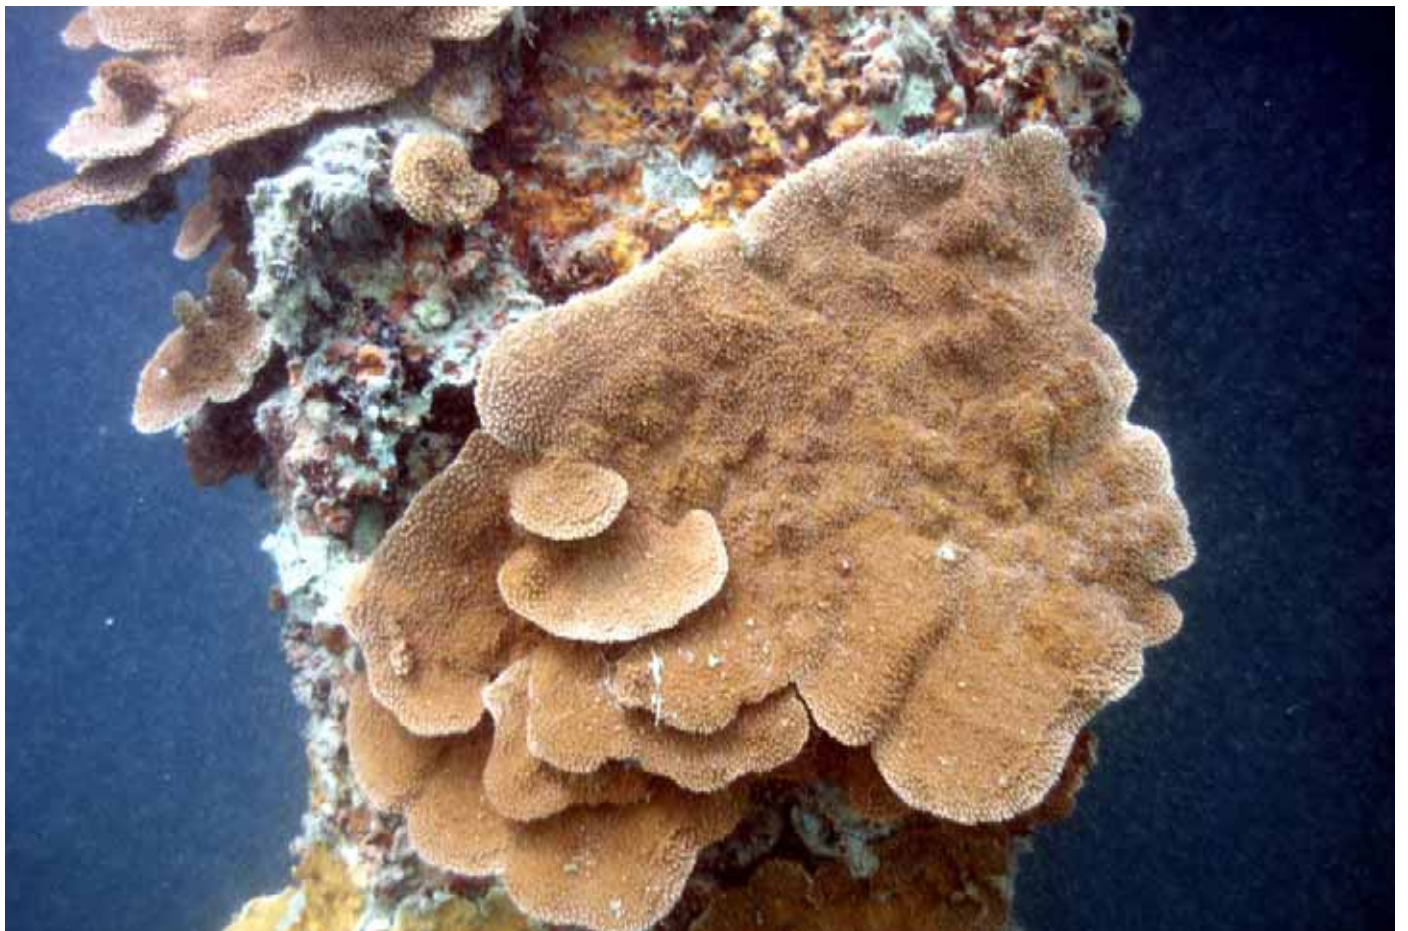
FIGURE 43. SECTOR P-27. Colonies of *Montipora capitata* on pilings comprising Pier 27. Note difference in appearance of colonies compared to those on Pier 26 (Figures 41 and 42) in terms of lack of dead portions of colonies. For location of Sector P-27, see Figure 6.

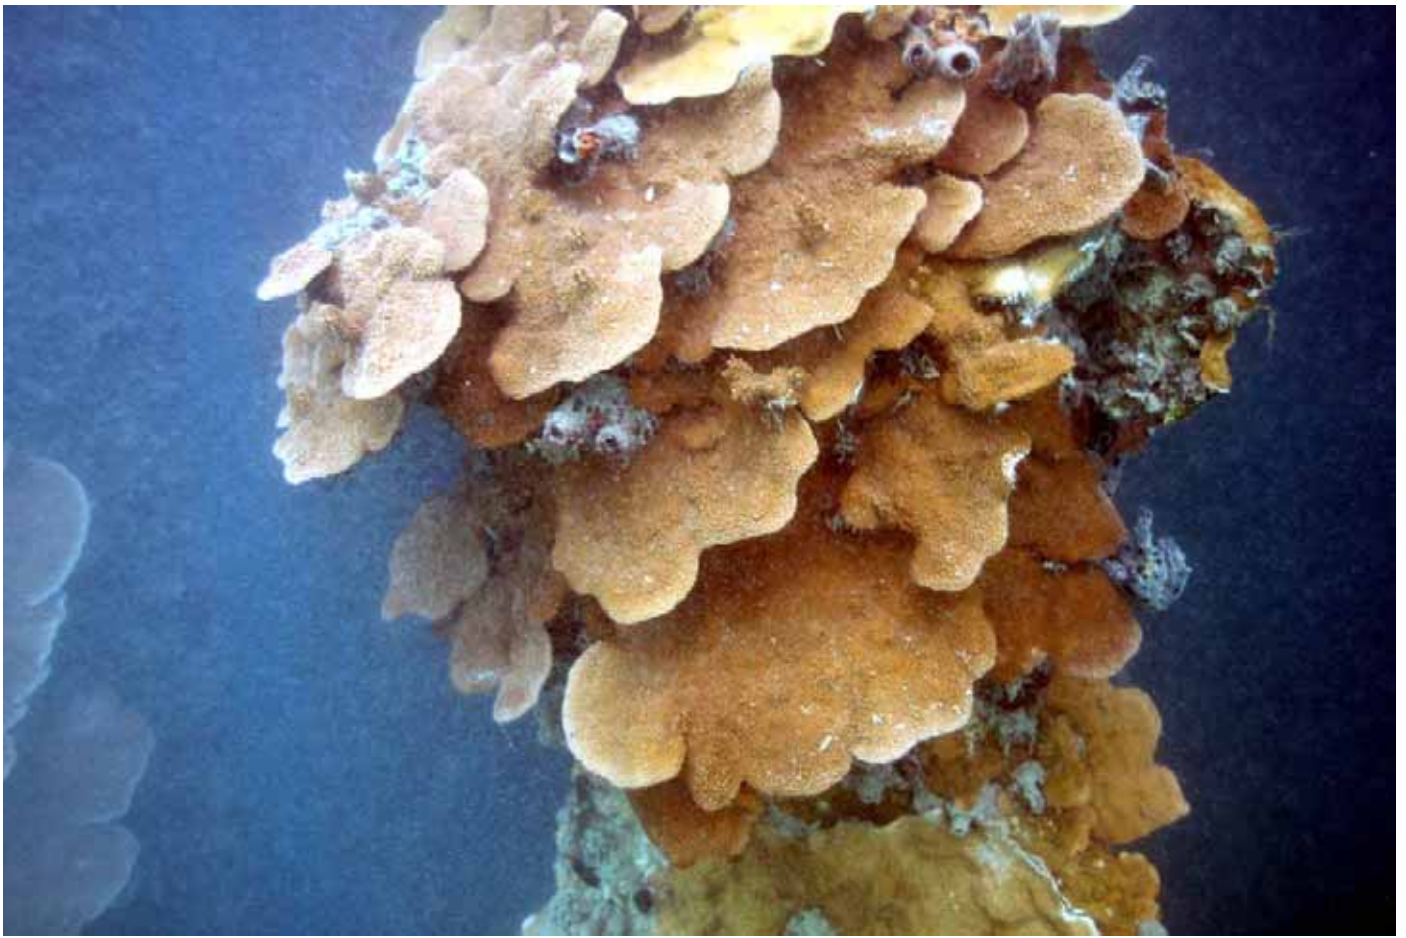
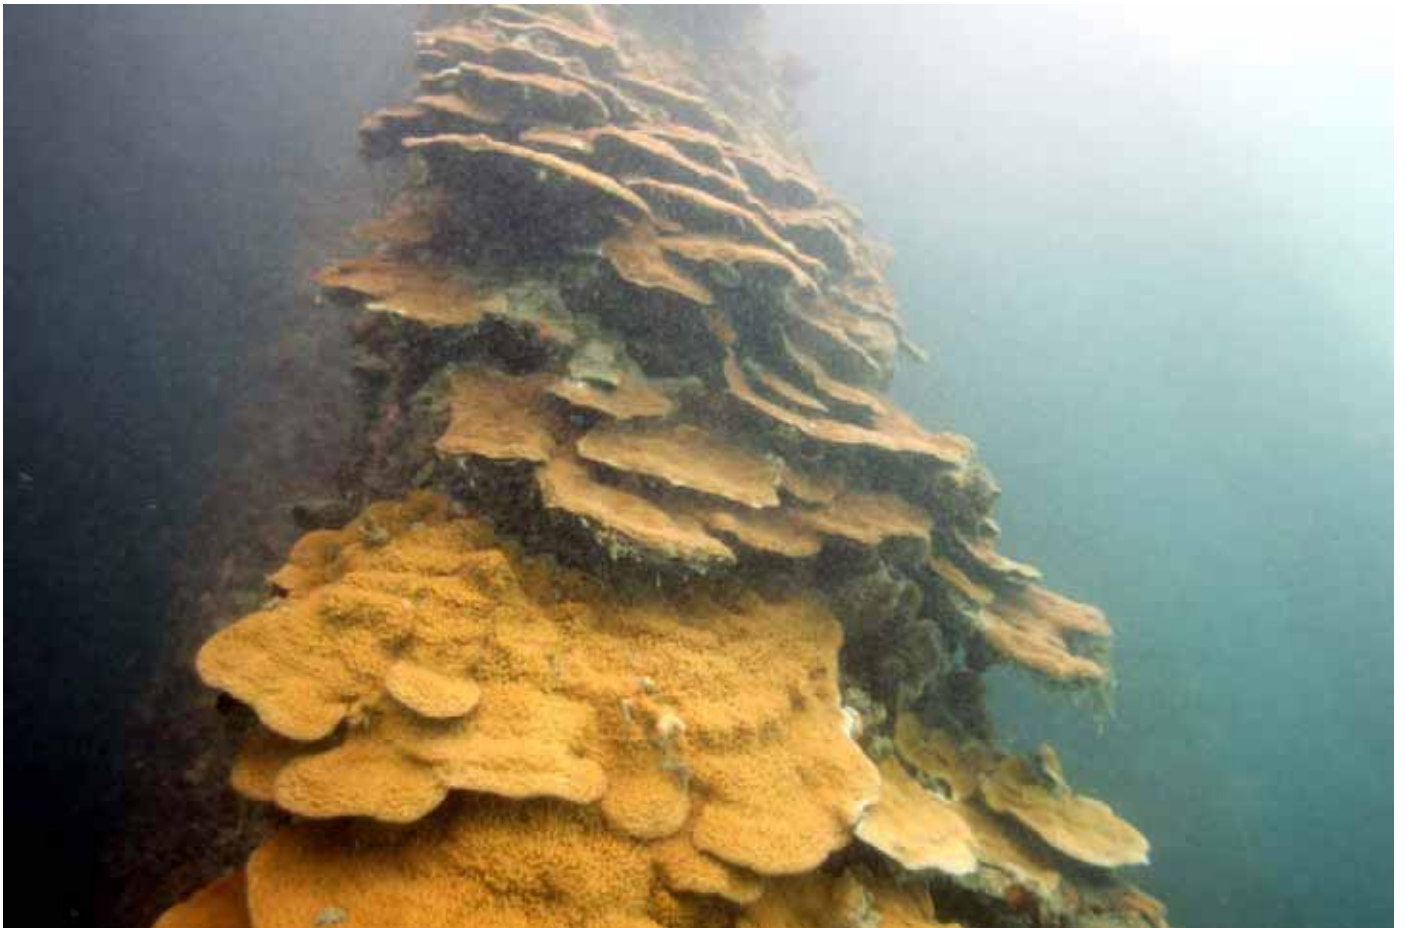
FIGURE 44. SECTOR P-27. Colonies of *Montipora patula* on pilings comprising Pier 27. Note difference in appearance of colonies compared to those on Pier 26 (Figures 41 and 42) in terms of lack of dead portions of colonies. For location of Sector P-27, see Figure 6.

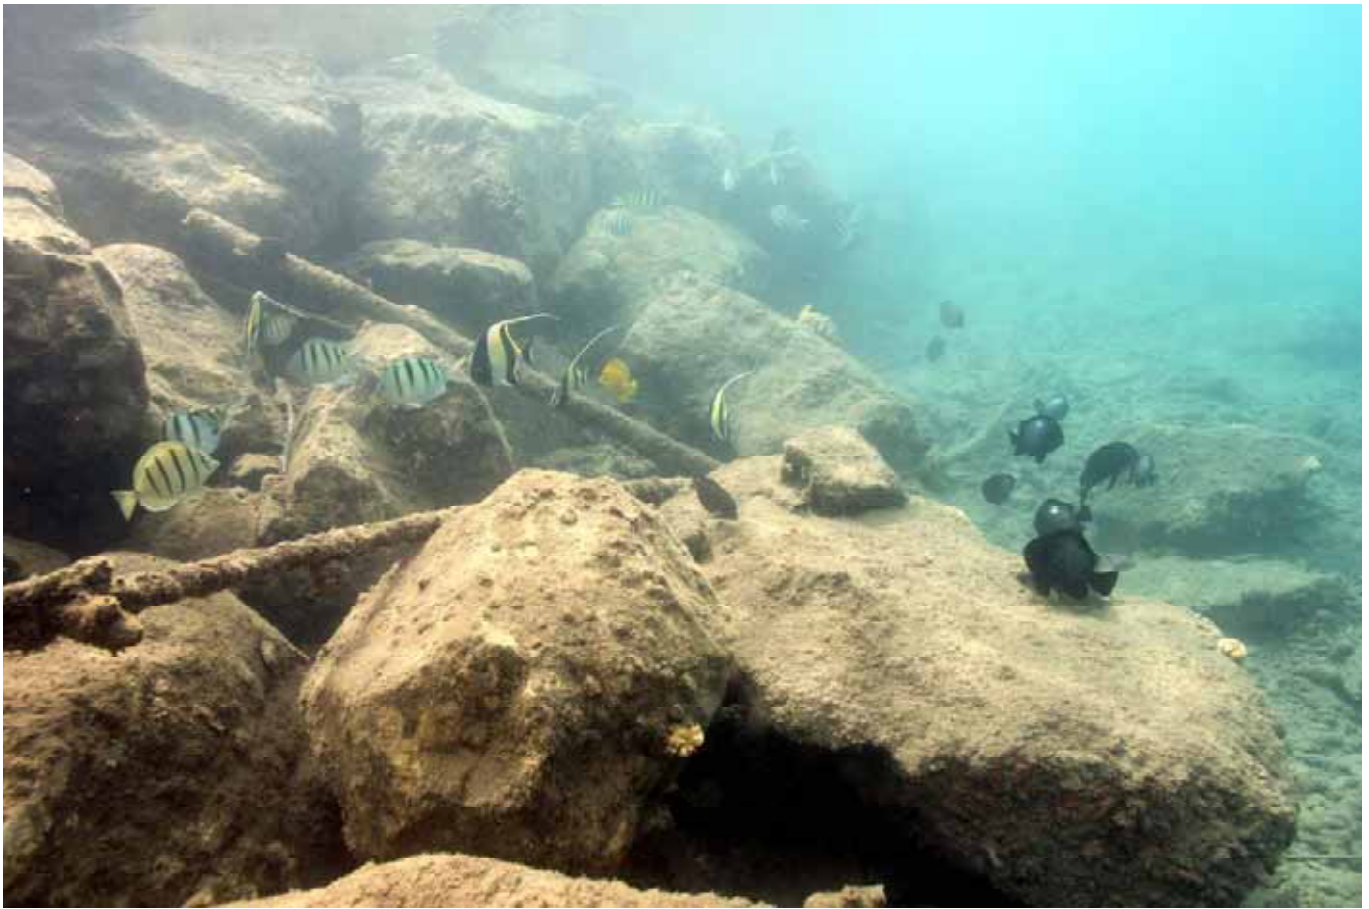
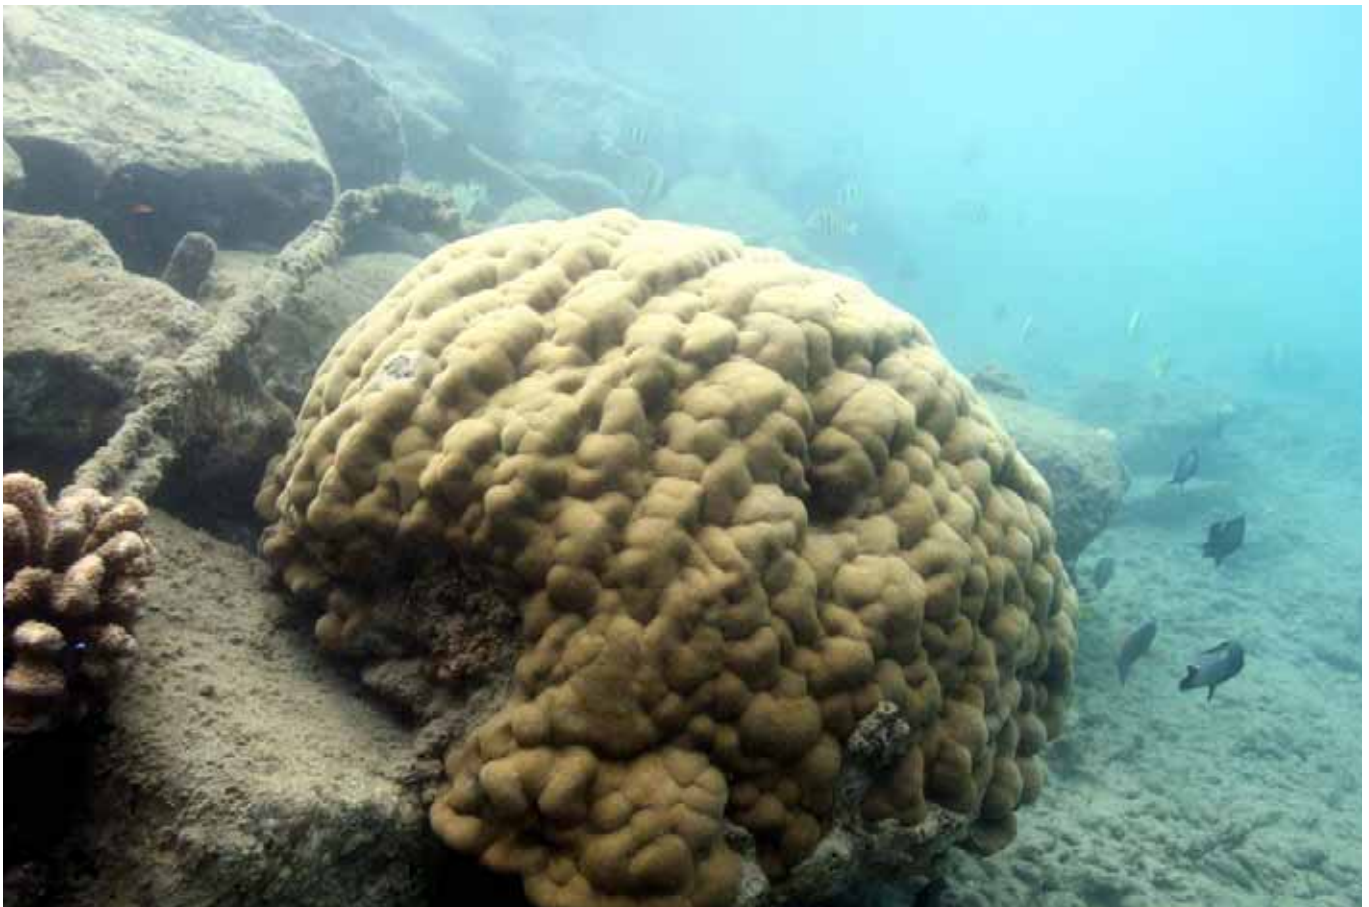
FIGURE 45. SECTOR P-28. Hemispherical colony *Porites lobata* approximately one meter in diameter on boulder shelf (bottom). Corals in this area showed less impact from sediment deposition than anywhere else in the survey region. For location of Sector P-28, see Figure 6.

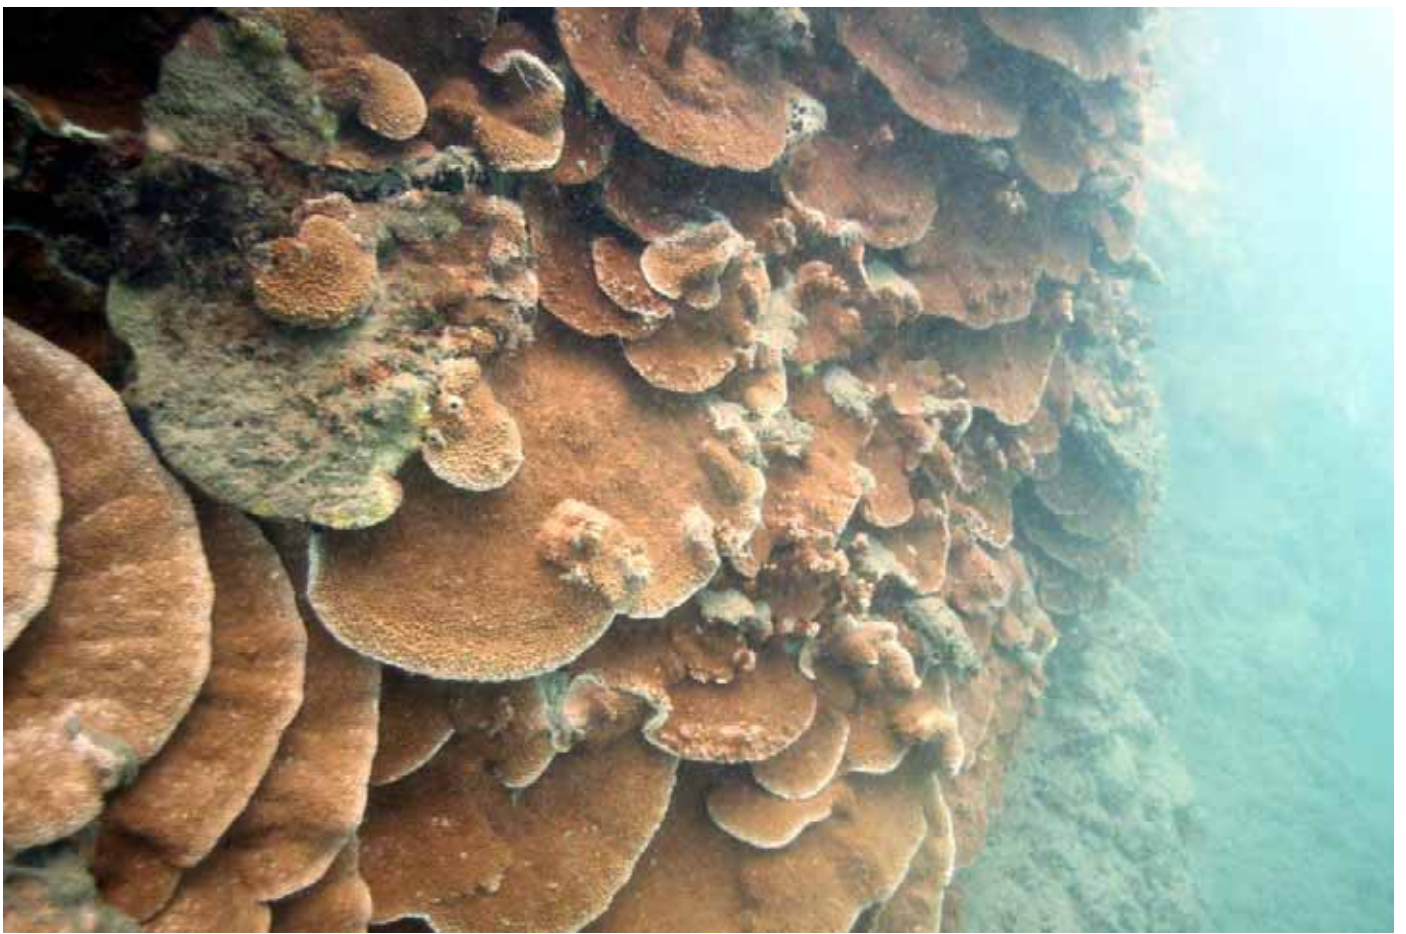
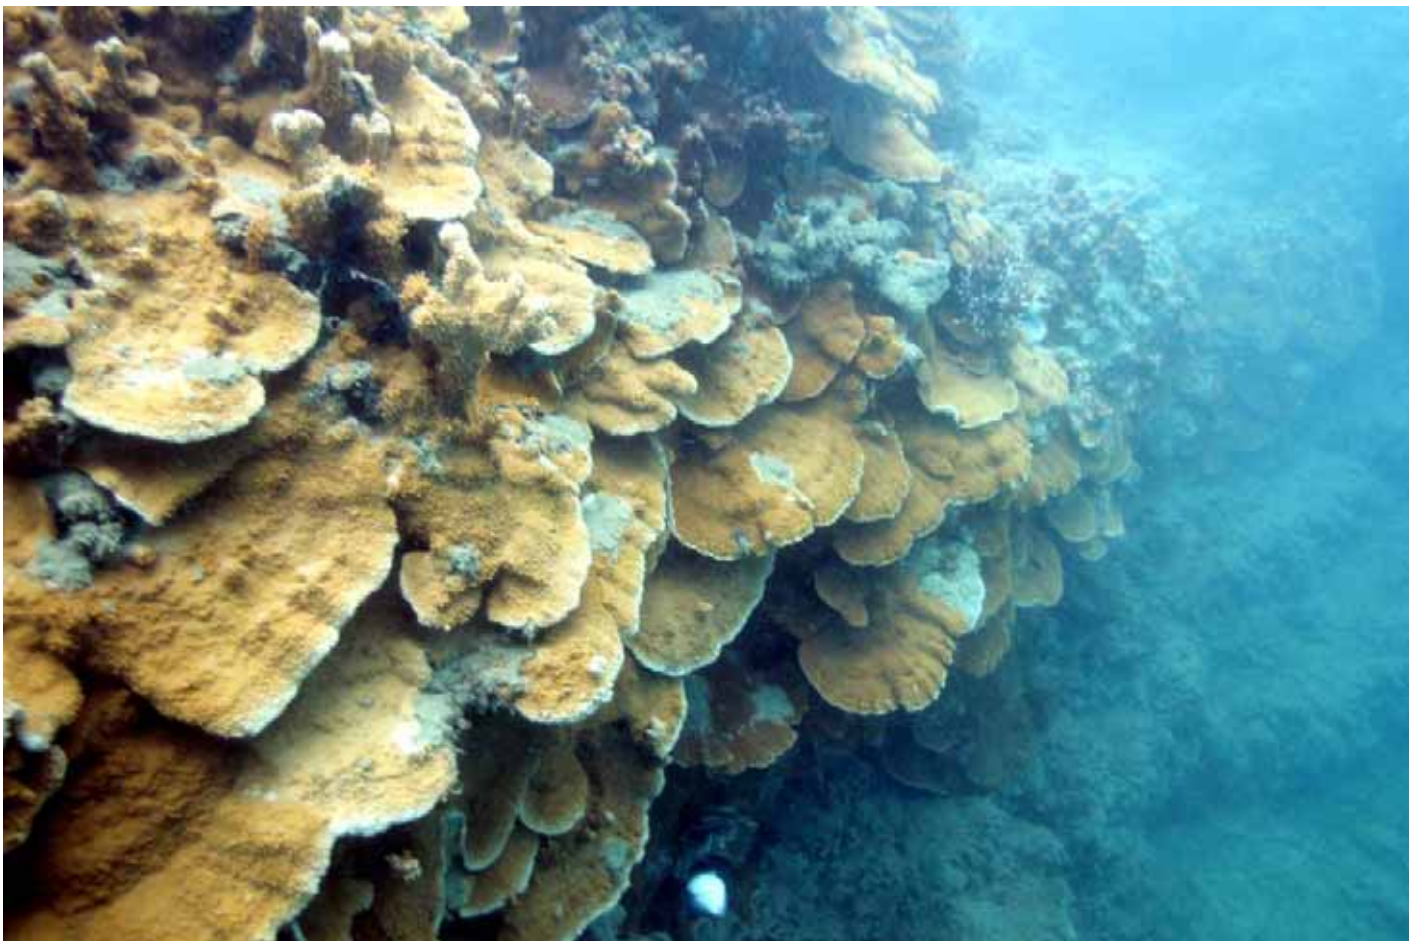
FIGURE 47. SECTOR P-28. Near solid cover of overlapping plates of *Montipora capitata* (top) and *Montipora patula* (bottom) lining dredged edge of Pier 28. For location of Sector P-28, see Figure 6.

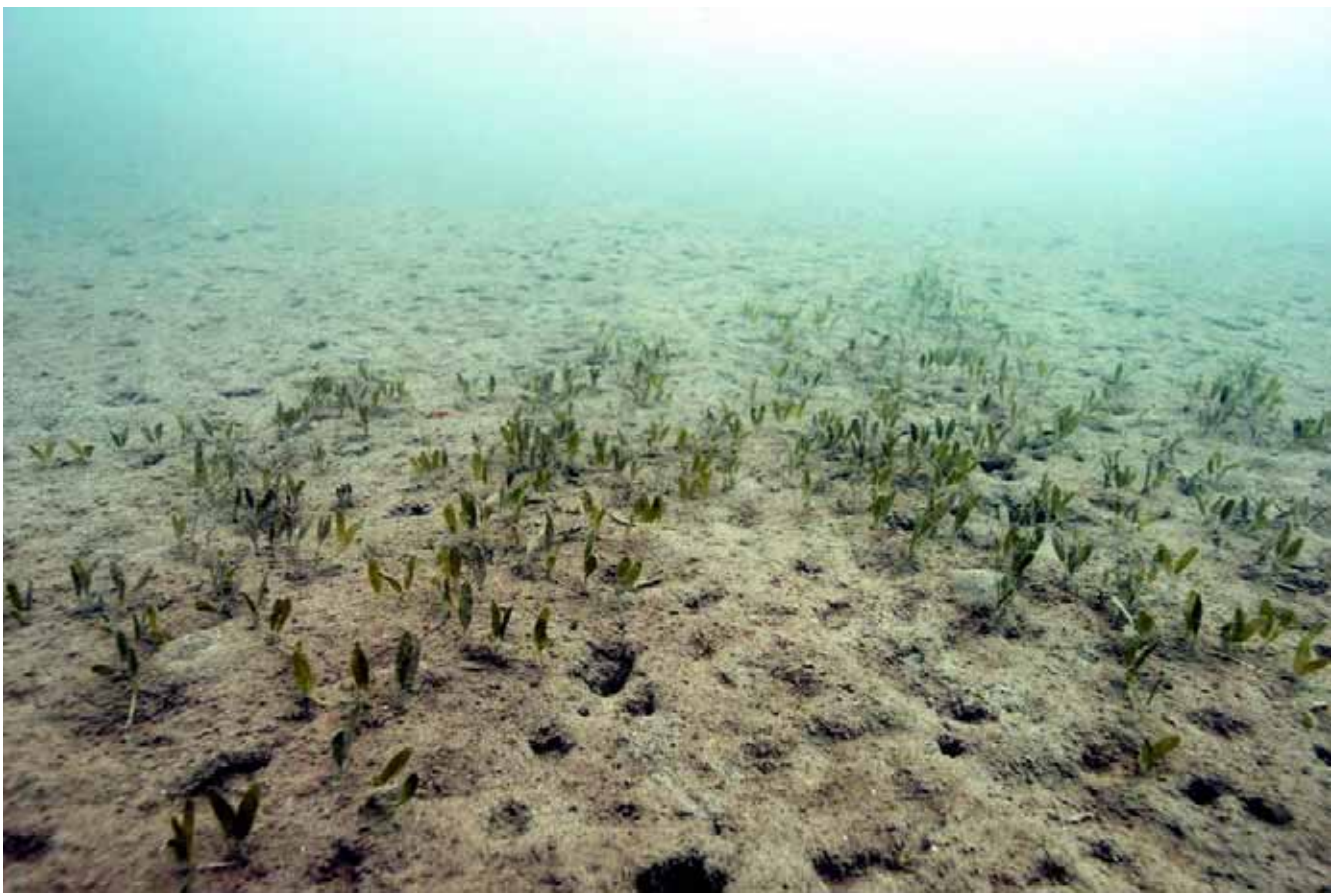
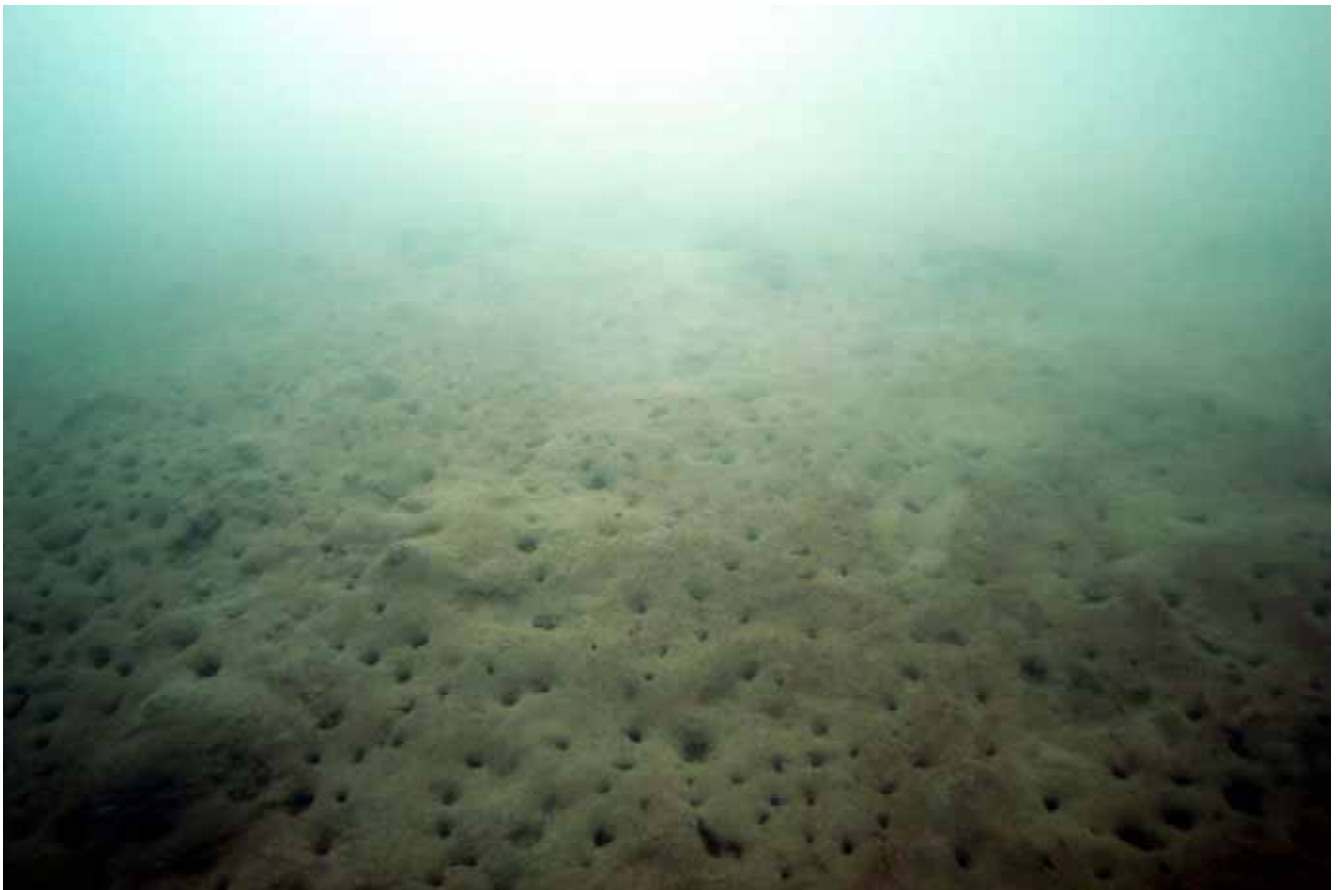
While algal growth was essentially absent from the reef at the juncture of Piers 27 and 28, a small patch of the Hawaiian seagrass *Halophila hawaiiiana* was observed on the harbor floor adjacent to the dredged channel wall (Figure 48). *Halophila* occurs as pairs of leaves on petioles along a continuous rhizome rooted in the sand. While this area was not within the region of quantitative surveys the patch of *H. hawaiiiana* was estimated to be approximately 5 meters in longest dimension, with approximately 100 emergent leaf pairs per square meter. This was the only occurrence of the seagrass noted in the survey.

FIGURE 48. SECTOR P-28. Patch of seagrass *Halophila hawaiiiana* on floor of Honolulu Harbor near the junction of Piers 27-28 (top). Seagrass was not observed in any other regions of the survey area. Bottom photo shows typical view of silt-mud bottom of Honolulu Harbor pocked with numerous openings from burrowing infauna. For locations of Piers 27-28, see Figure 6.
